# CY 2009

Operations and Maintenance Trip Reports and Quarterly Effectiveness  
Evaluation Reports Time Critical Response Action for the Rocket Ridge  
Area at RVAAP-004-R-01 Open Demolition Area #2

## Trip Report

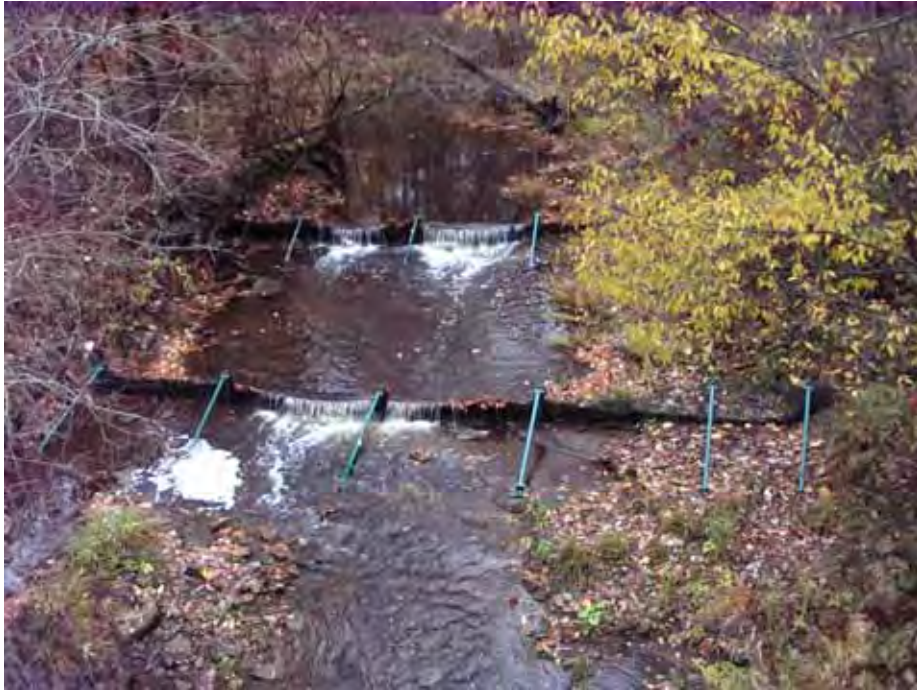
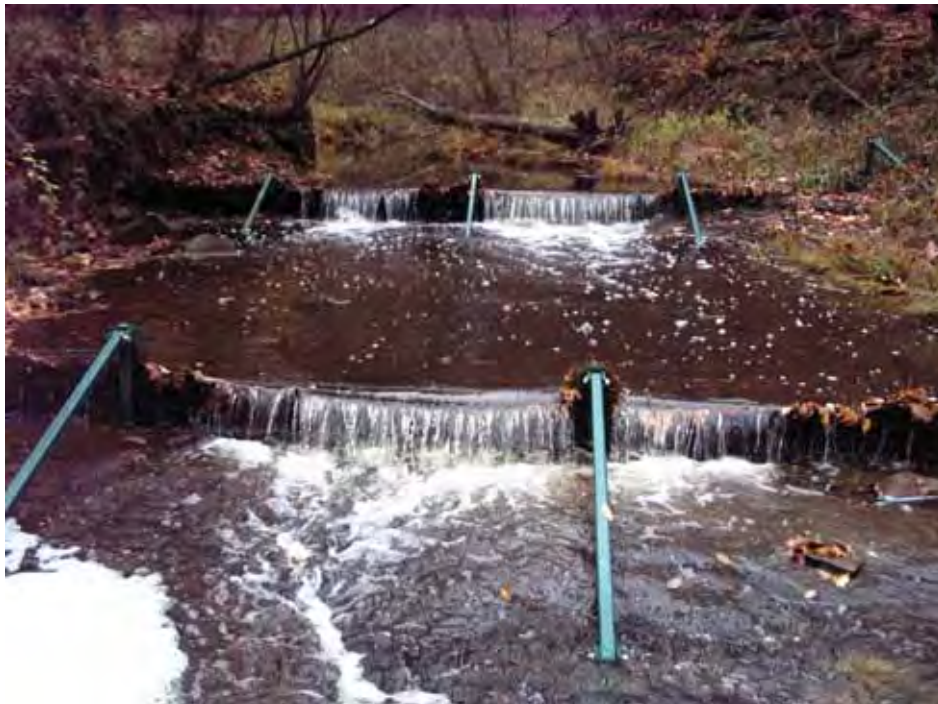
PICTURES SHOWING SAND CREEK BARRIERS UPON ARRIVAL

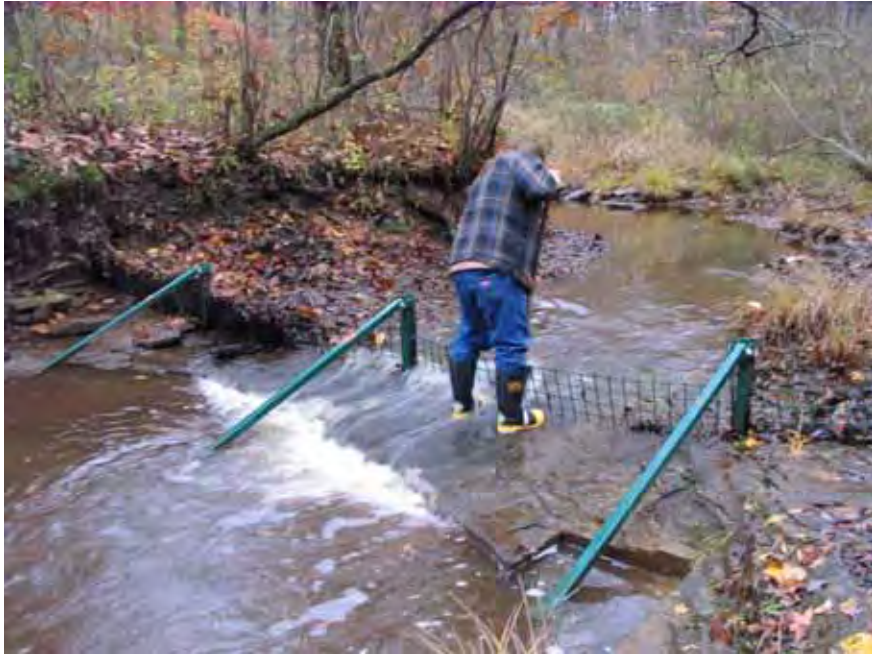
PICTURE SHOWING UXO TECHNICIAN REMOVING ACCUMULATED LEAVES FROM SCREEN.

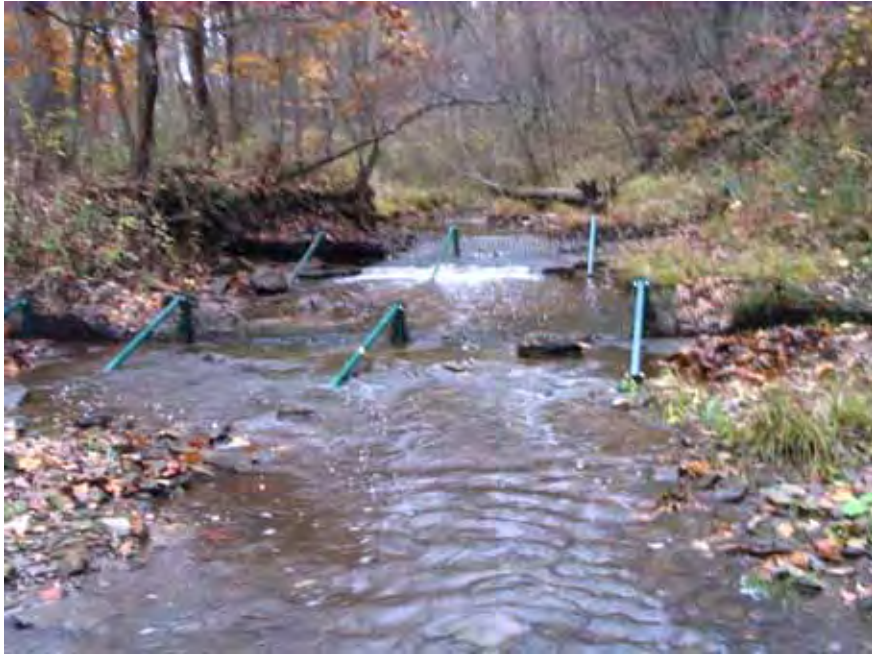
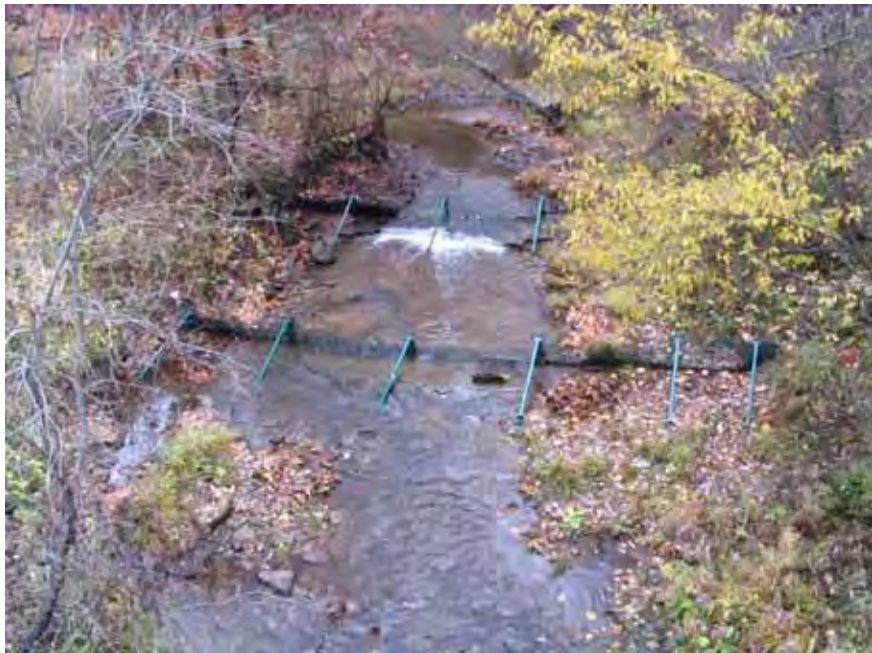
PICTURES SHOWING BARRIERS UPON DEPARTURE

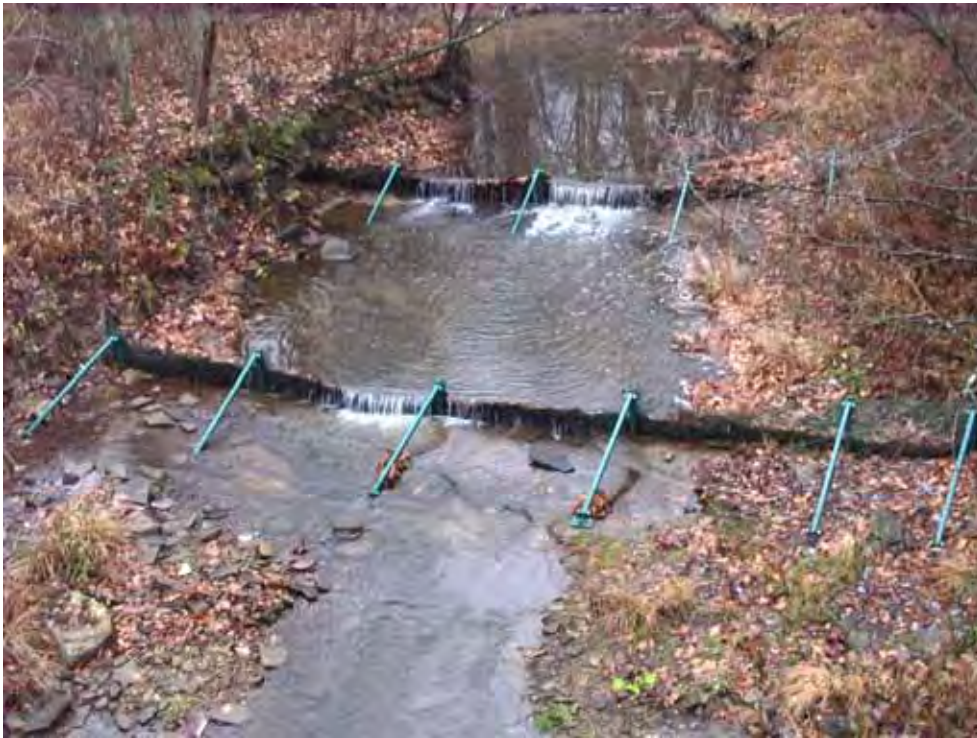
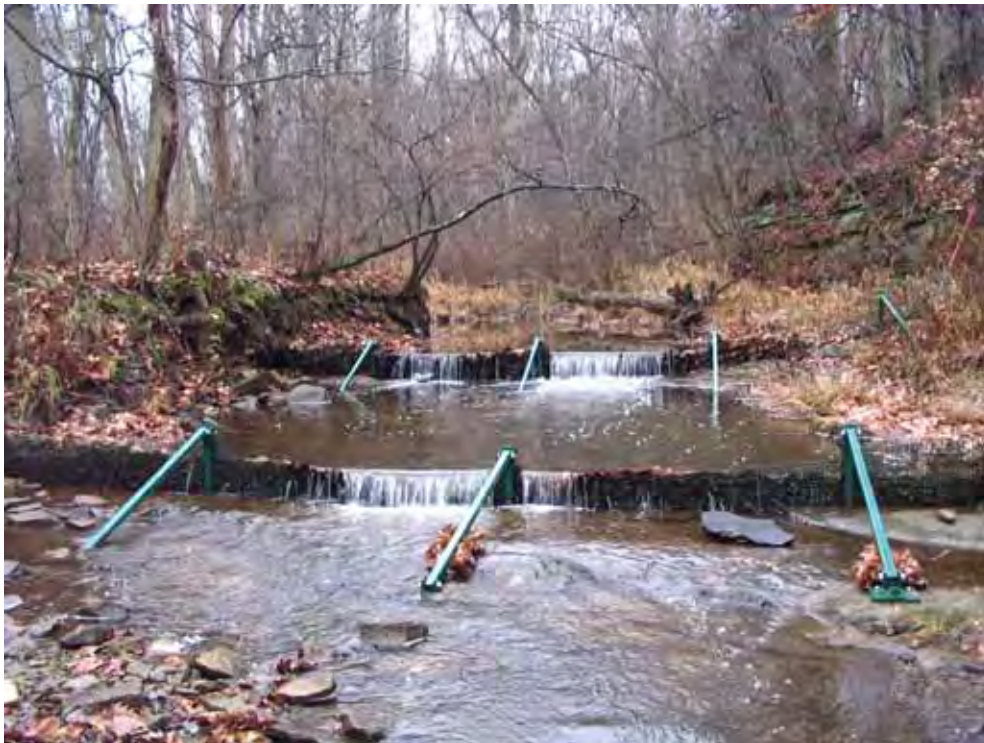
PICTURES SHOWING SAND CREEK BARRIERS UPON ARRIVAL

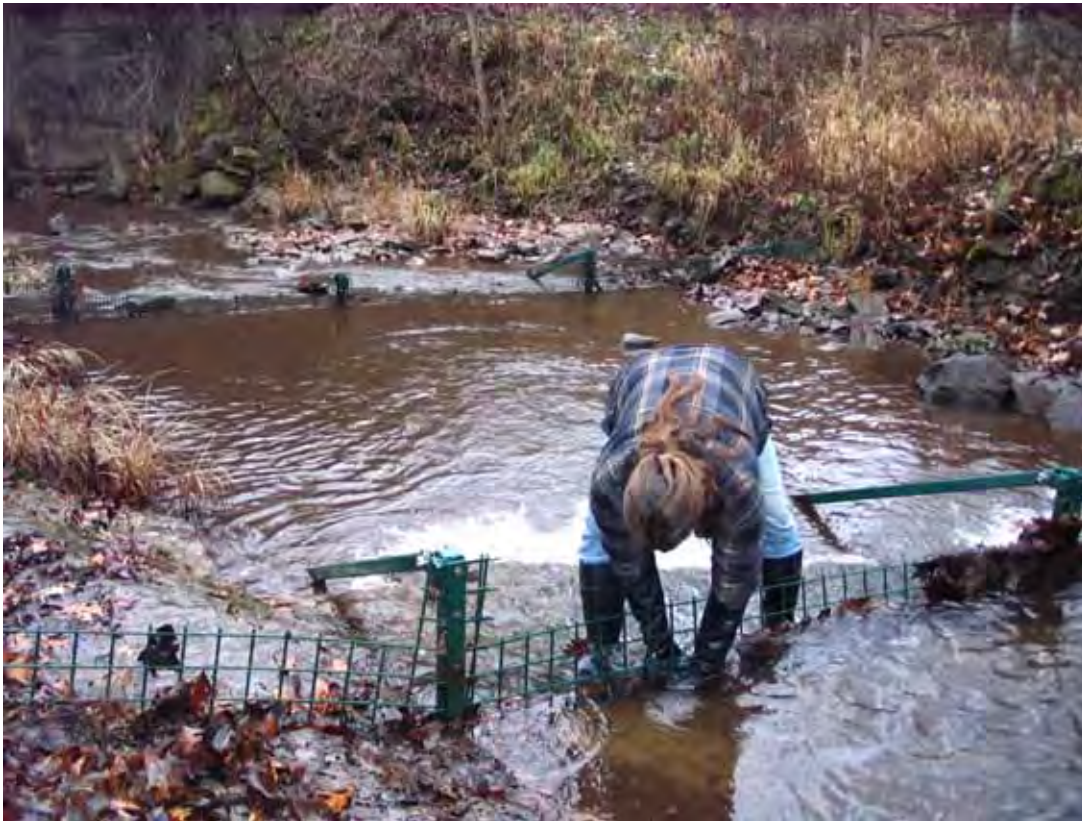
PICTURE SHOWING UXO TECHNICIAN REMOVING ACCUMULATED  
LEAVES FROM SCREEN.

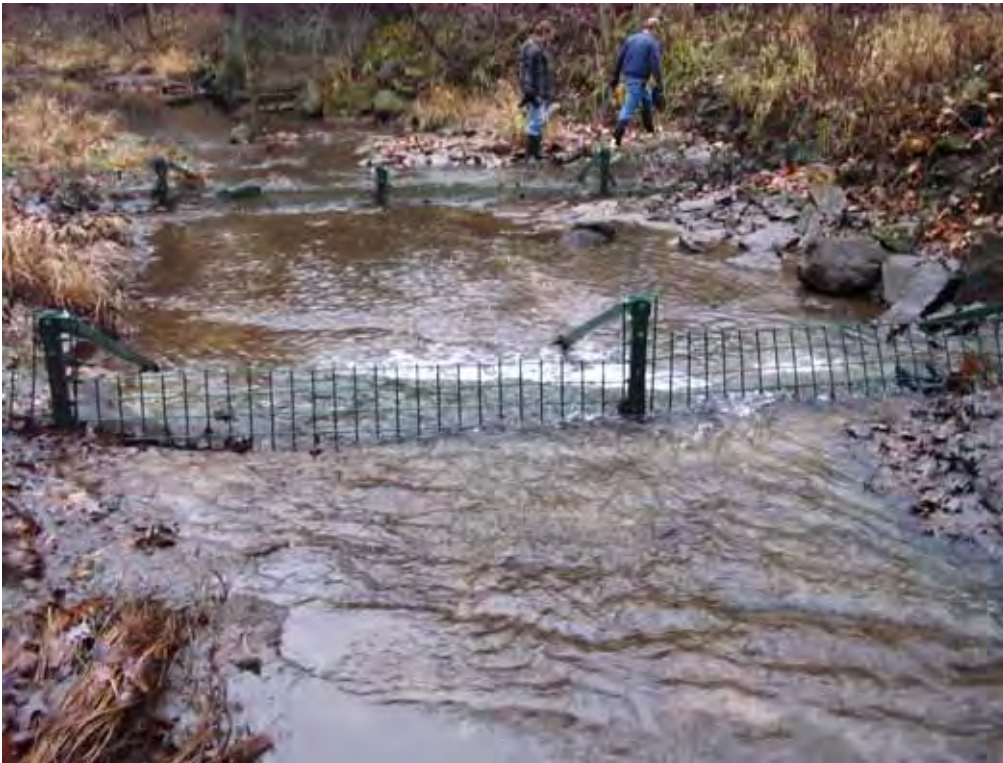
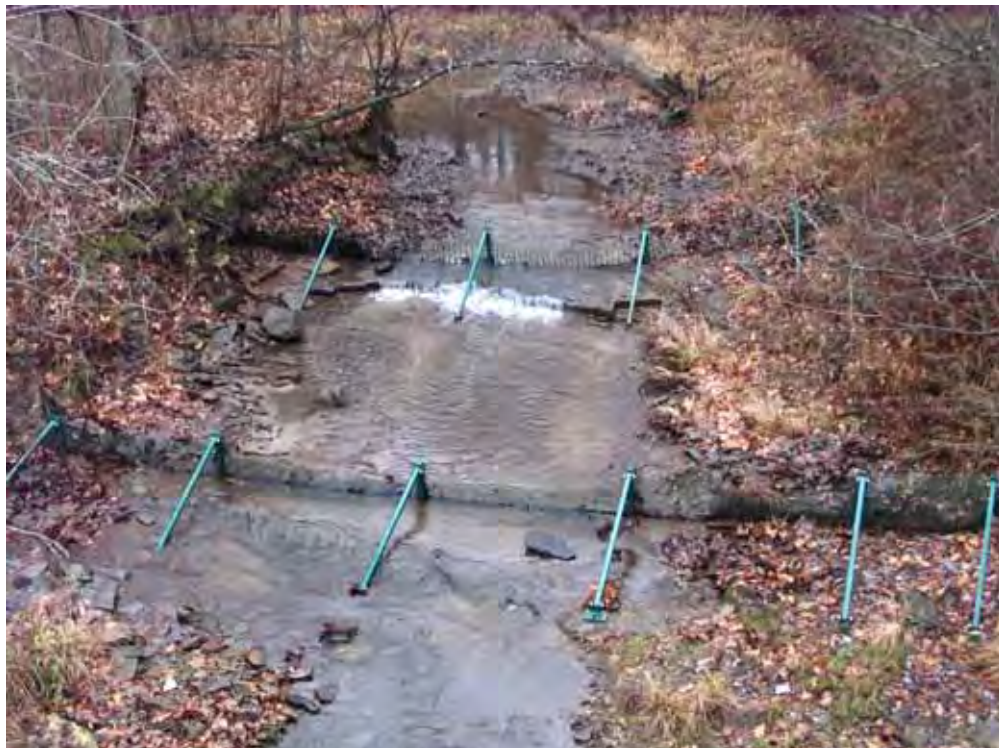
PICTURES SHOWING BARRIERS UPON DEPARTURE

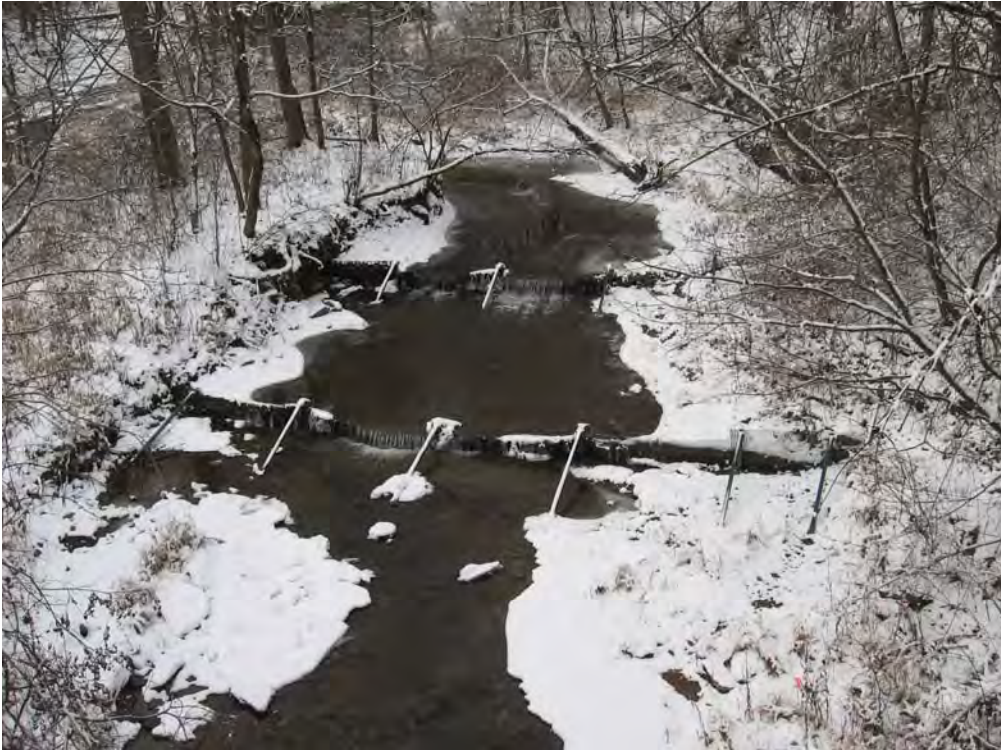
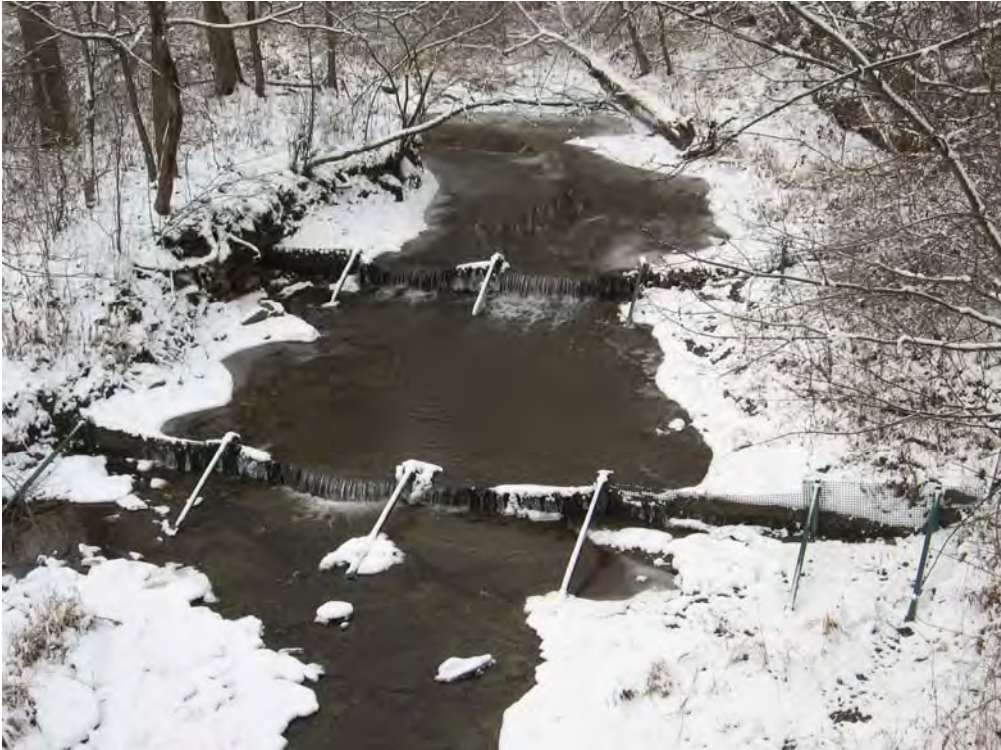
PICTURES SHOWING SAND CREEK BARRIERS UPON ARRIVAL.

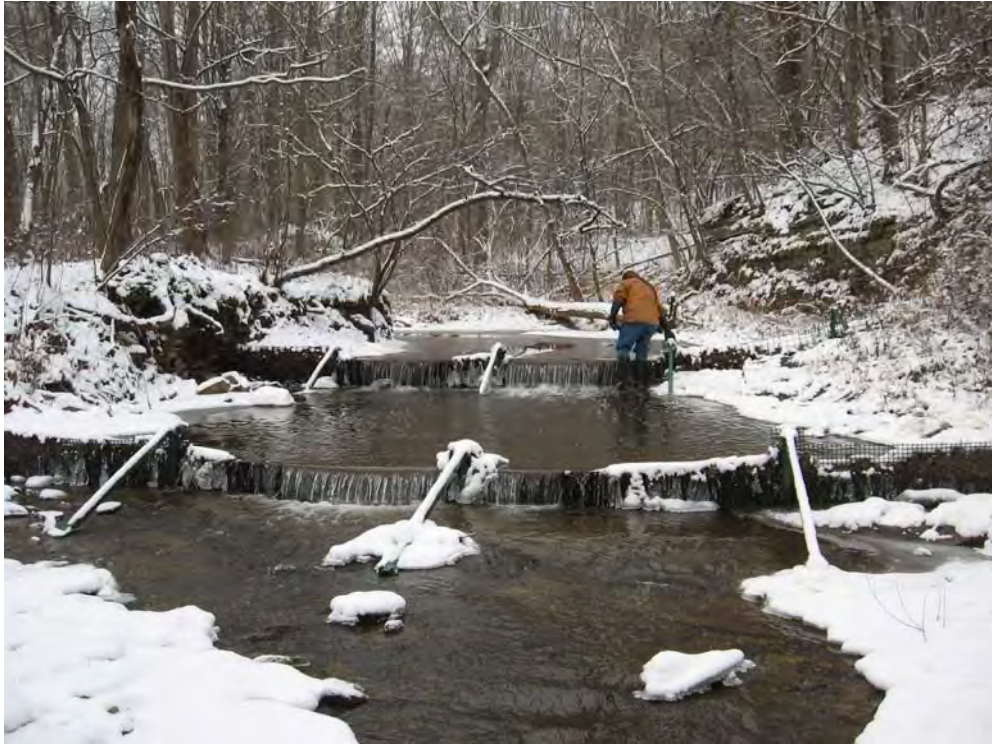
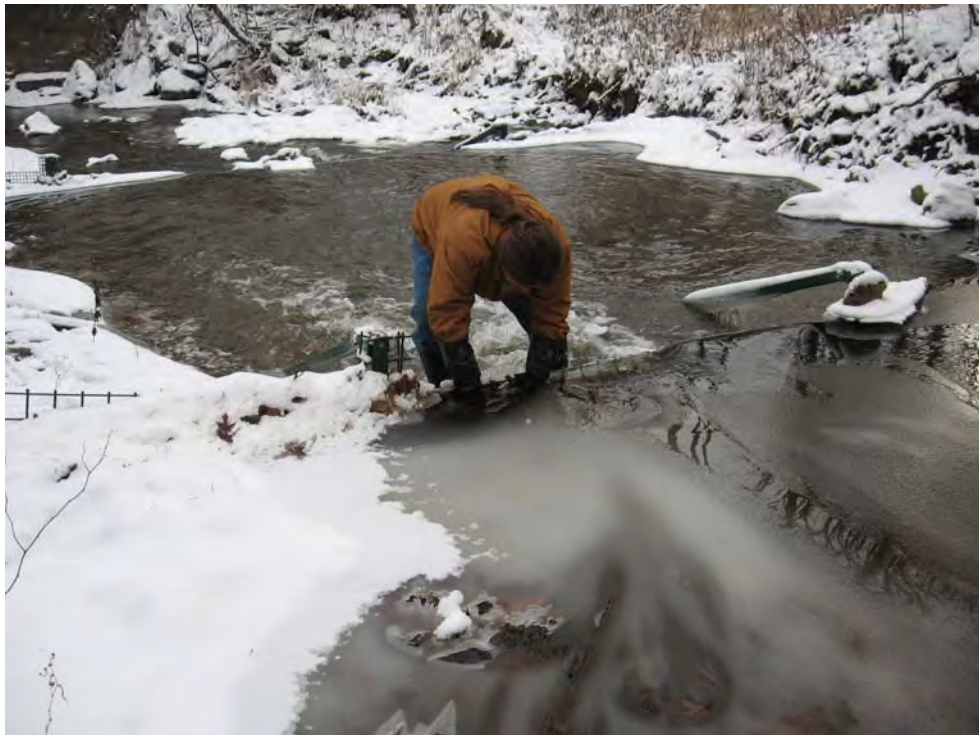
PICTURE SHOWING UXO TECHNICIAN REMOVING ACCUMULATED  
DEBRIS FROM SCREENS.

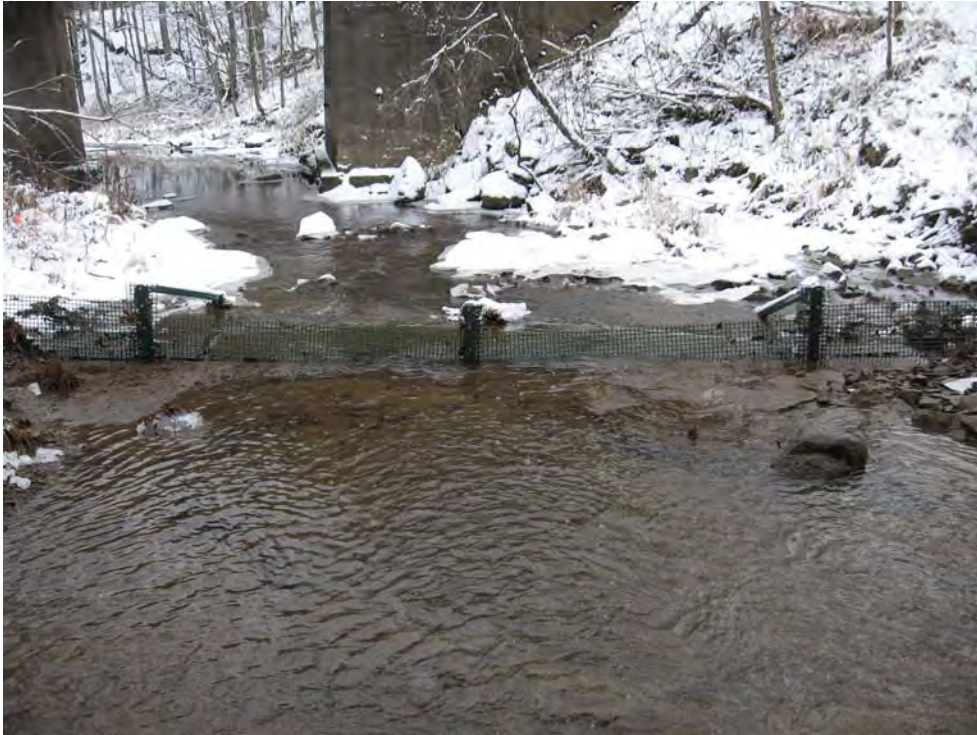
<b>Prime Contract No:</b>			<b>Report No.</b>	3
<b>PIKA JOB #:</b>	09-46-169		<b>Date:</b>	12-21-09
<b>Project:</b>	Operation and Maintenance of the Sand Creek Barrier System			
<b>Environmental Conditions:</b>				
Weather Conditions (Bright Sun, Clear, Overcast, Rain, Snow):		Cloudy		
Temperature:		29° F		
Wind (Still, Moderate, High):		Still		
Humidity (Dry, Moderate, Humid):		Dry		
<b>Field Activities:</b>				
<b>Description of debris inspection &amp; removal activities:</b> Removed leaves, sticks, mud and some ice/snow from barrier. No MEC/MD found.				
<b>Barrier Integrity:</b> Barrier is intact. Slight bend in both screens however; barrier integrity has not been compromised.				
<b>Assessment of any changes since previous visit:</b> Silt is starting to accumulate in front of the down stream screen (see picture).				
<b>Repairs made or need to be made:</b> None

PICTURE SHOWING SILT BEGINNING TO ACCUMULATE ALONG DOWN STREAM SCREEN (LEFT).

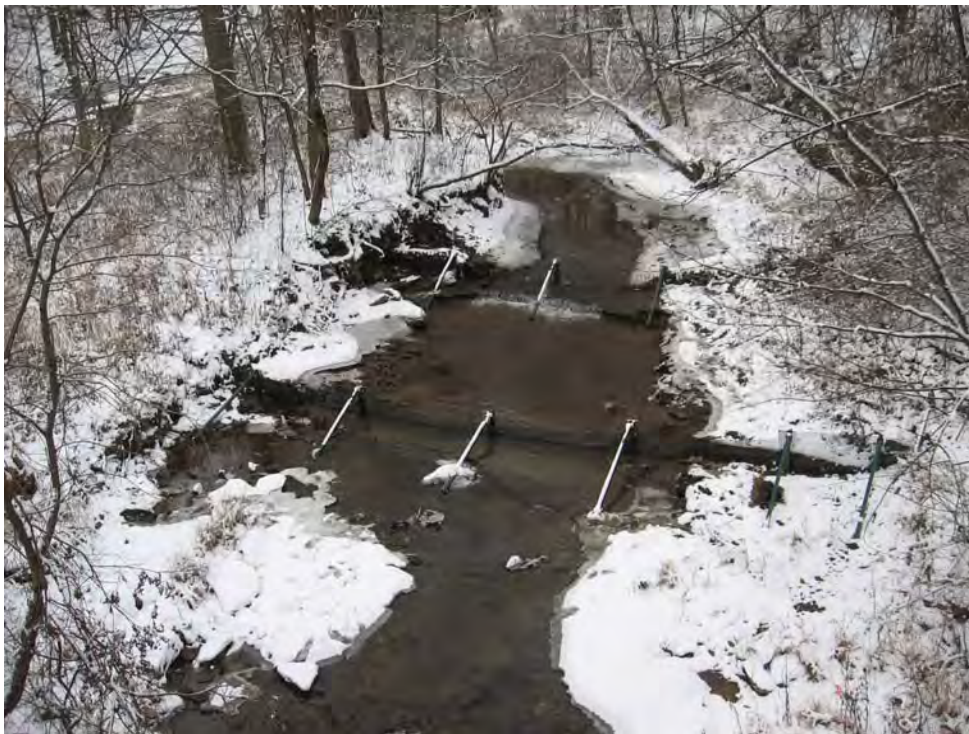
PICTURES SHOWING BARRIERS UPON DEPARTURE.

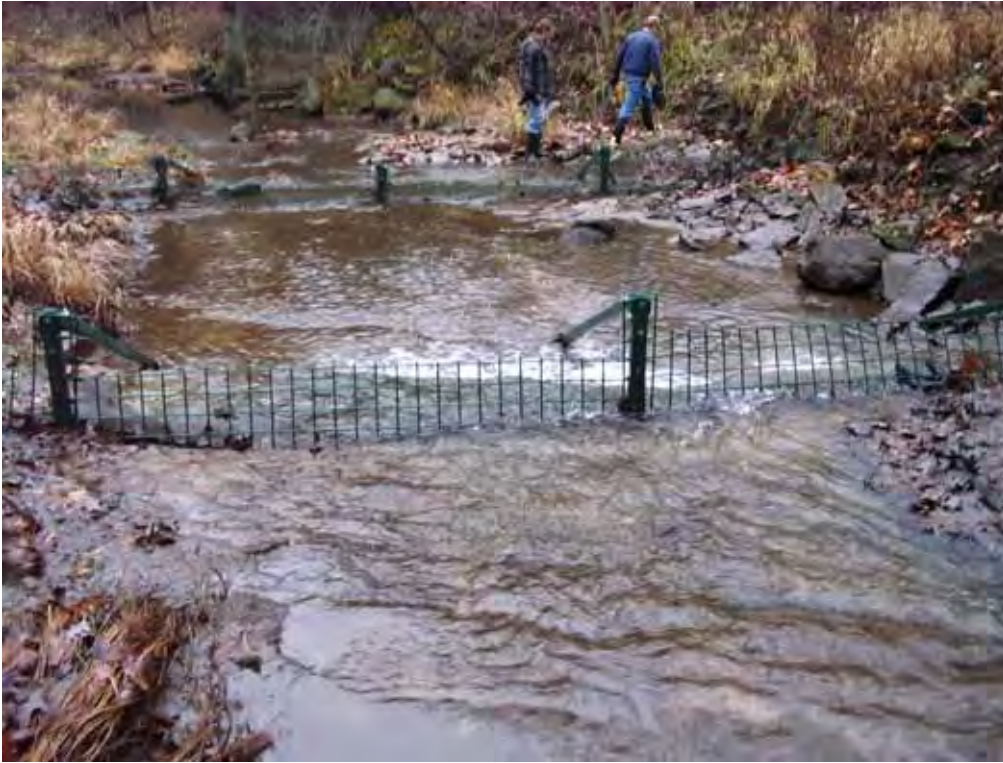
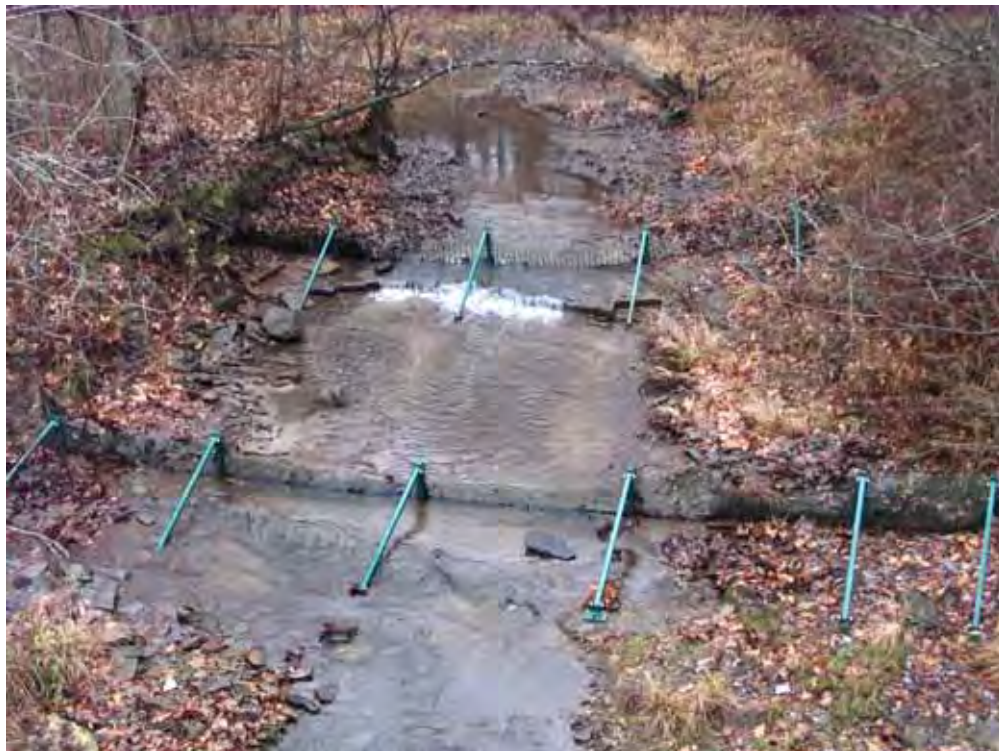
PICTURES SHOWING BARRIERS UPON DEPARTURE

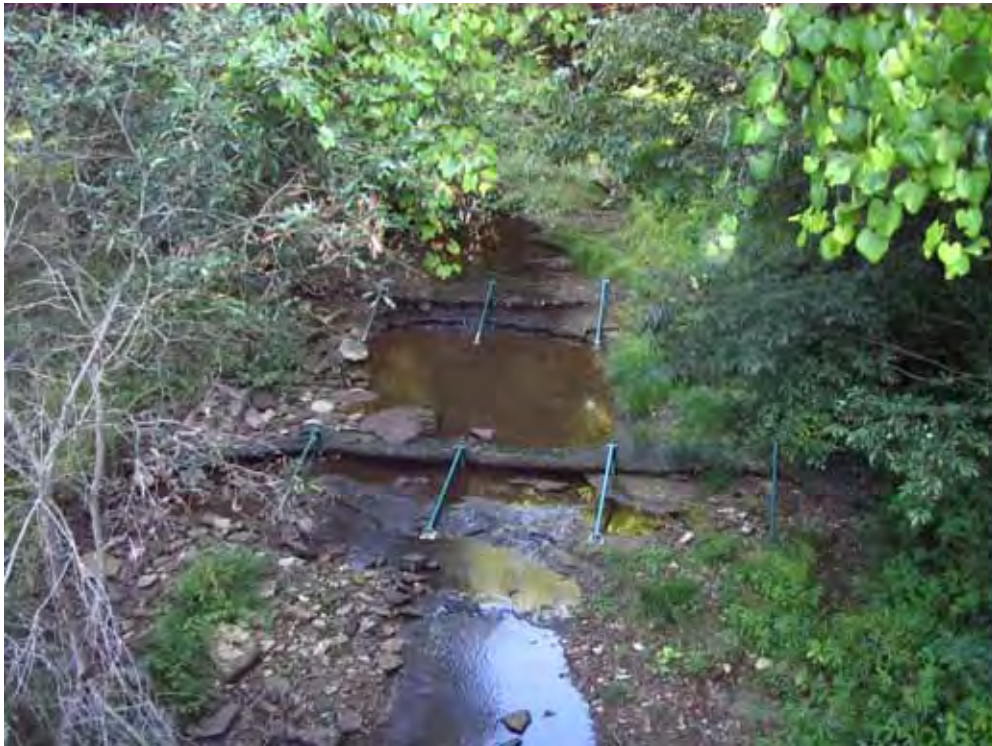
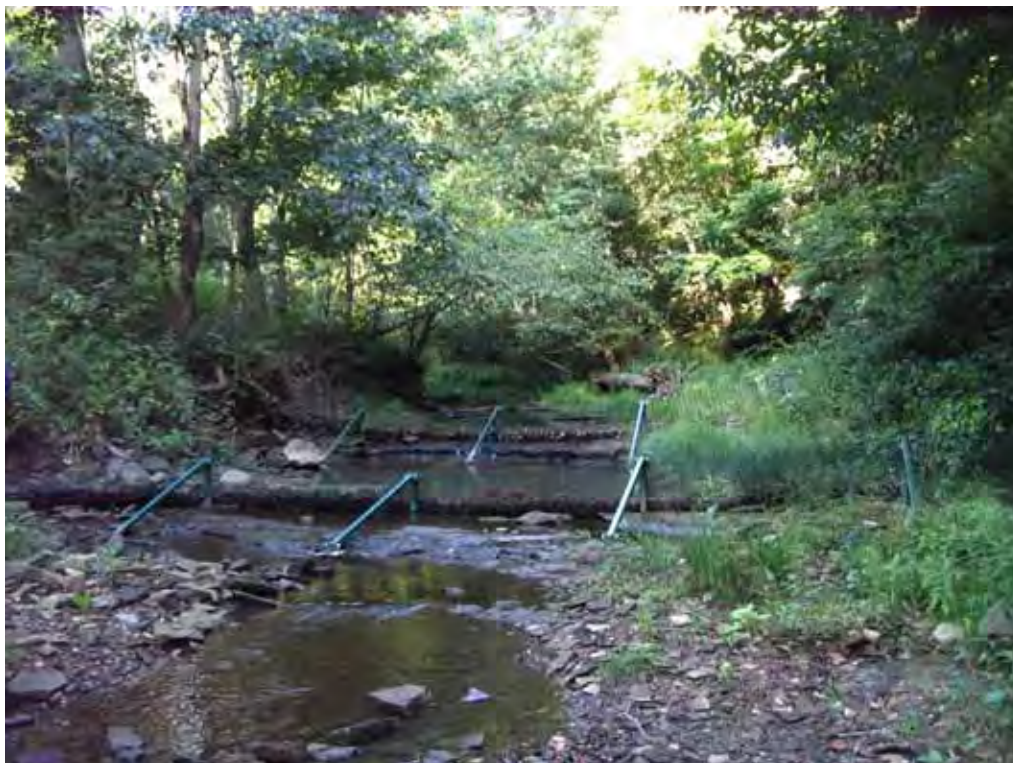
View of barriers upon arrival.

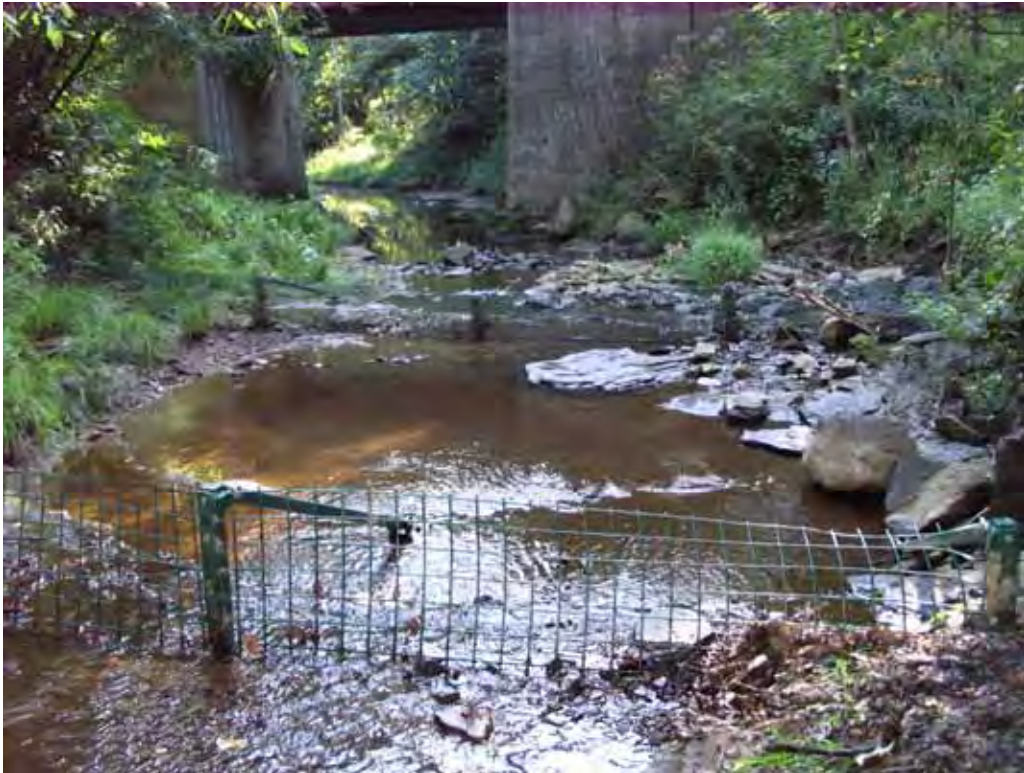
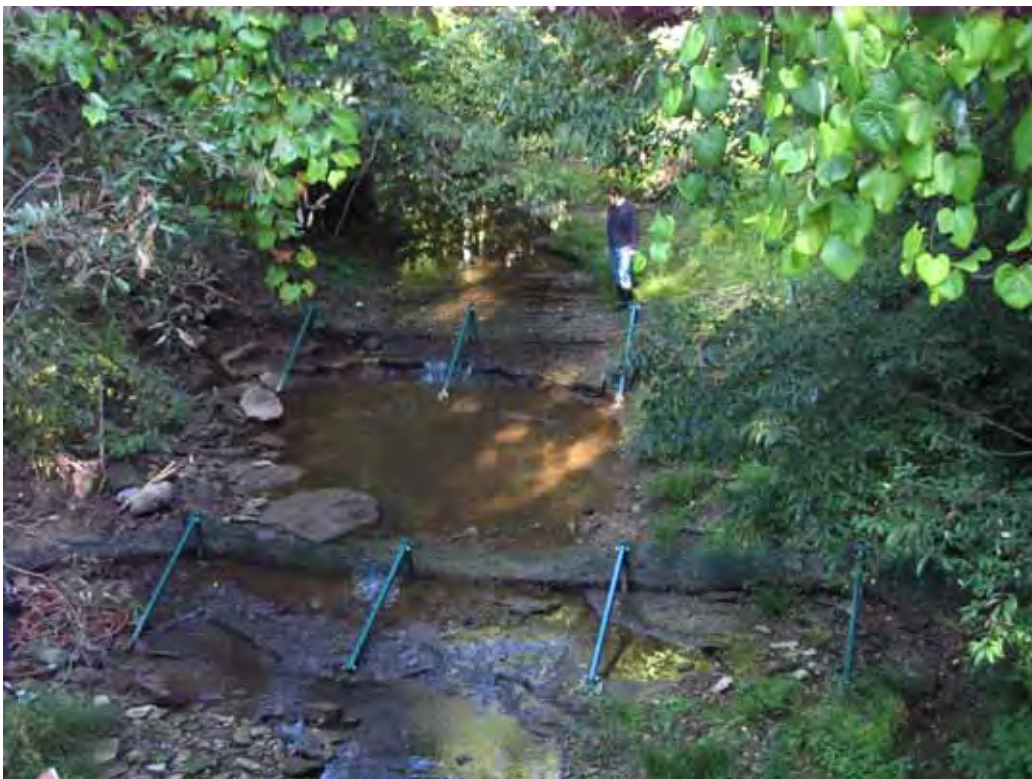
View of screens after cleaning and upon departure.

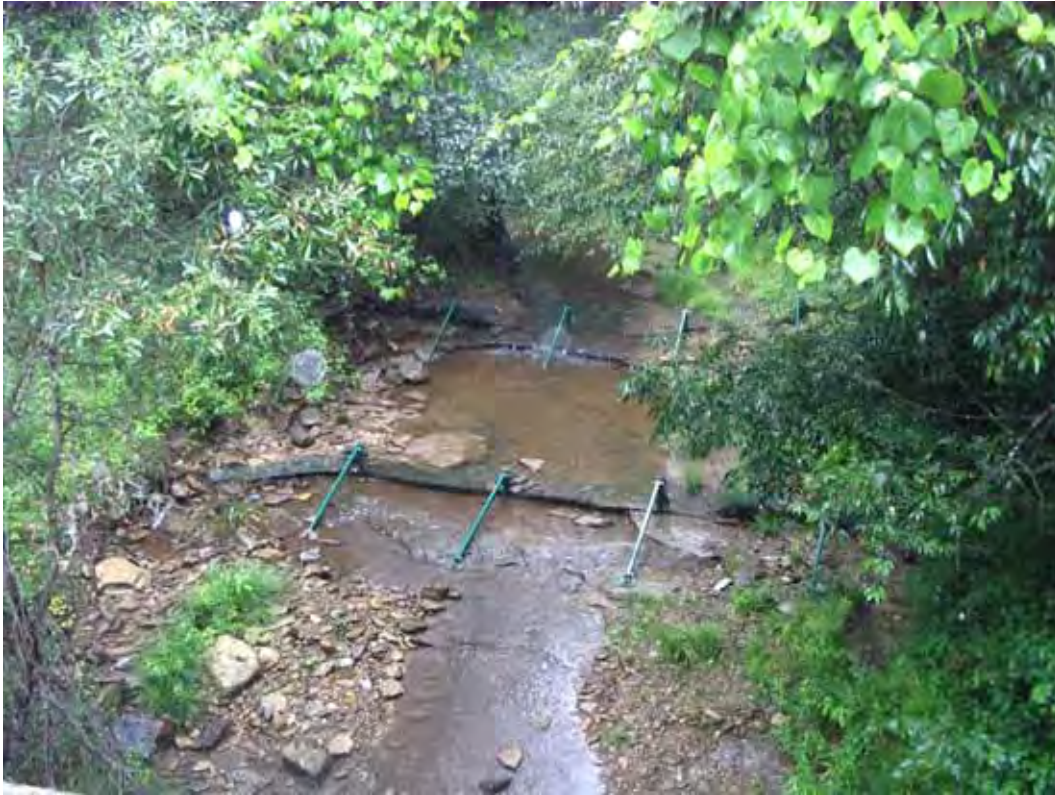
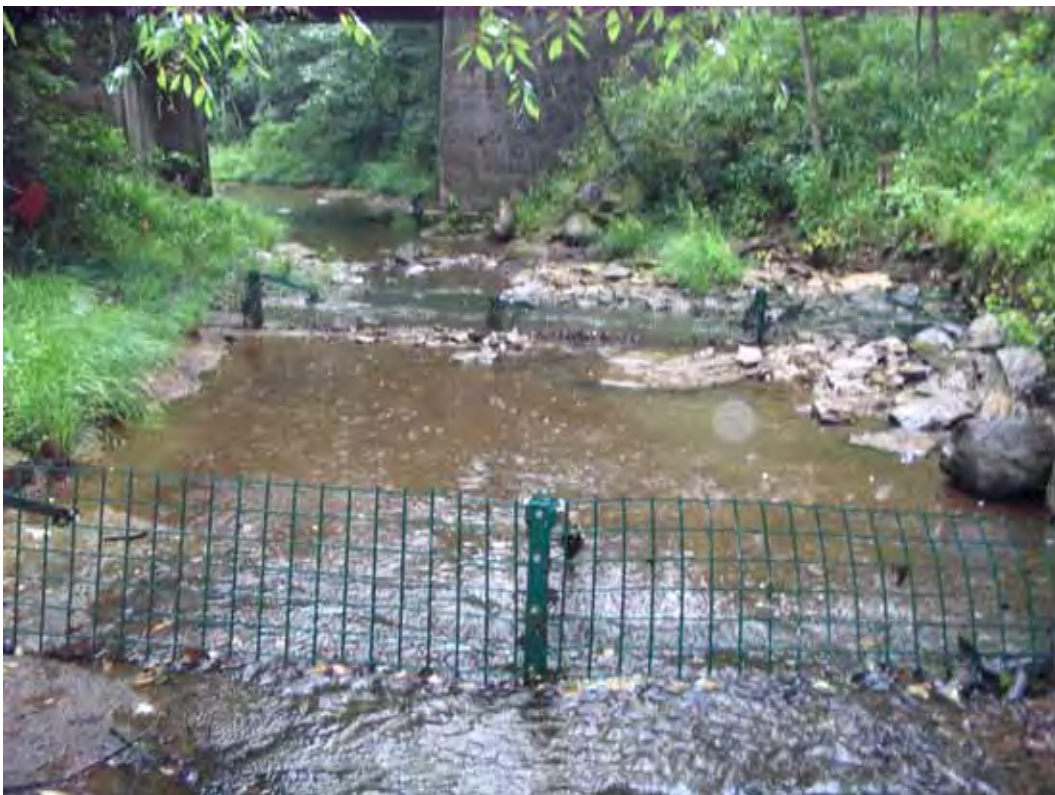
View of barriers upon arrival.

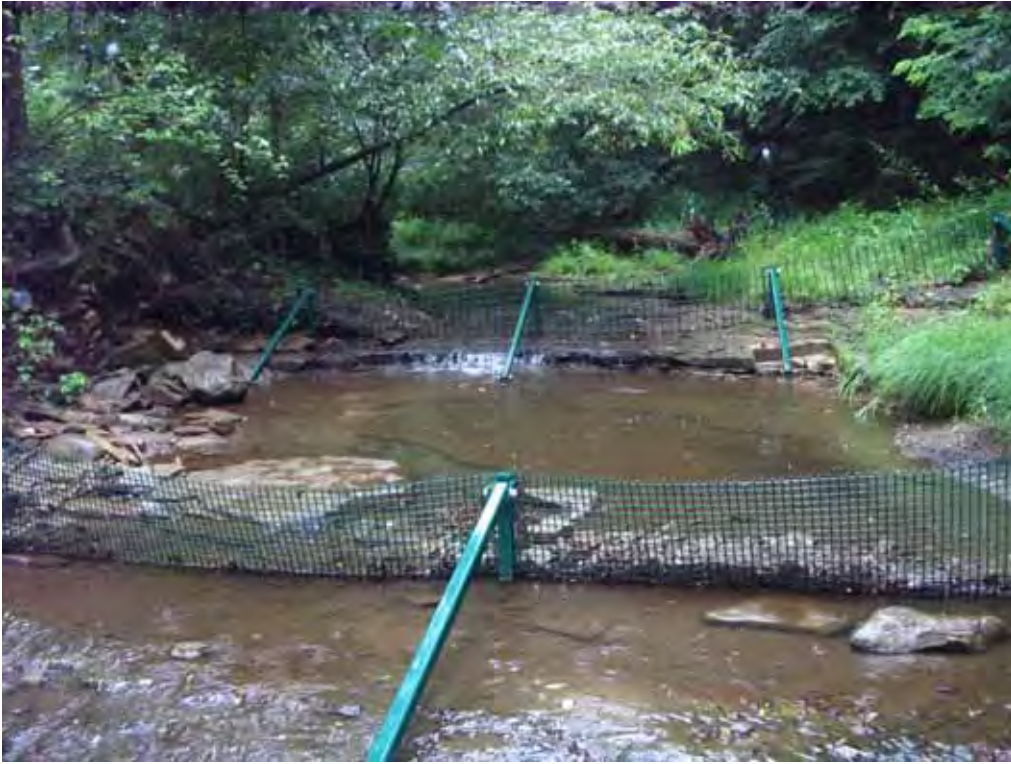
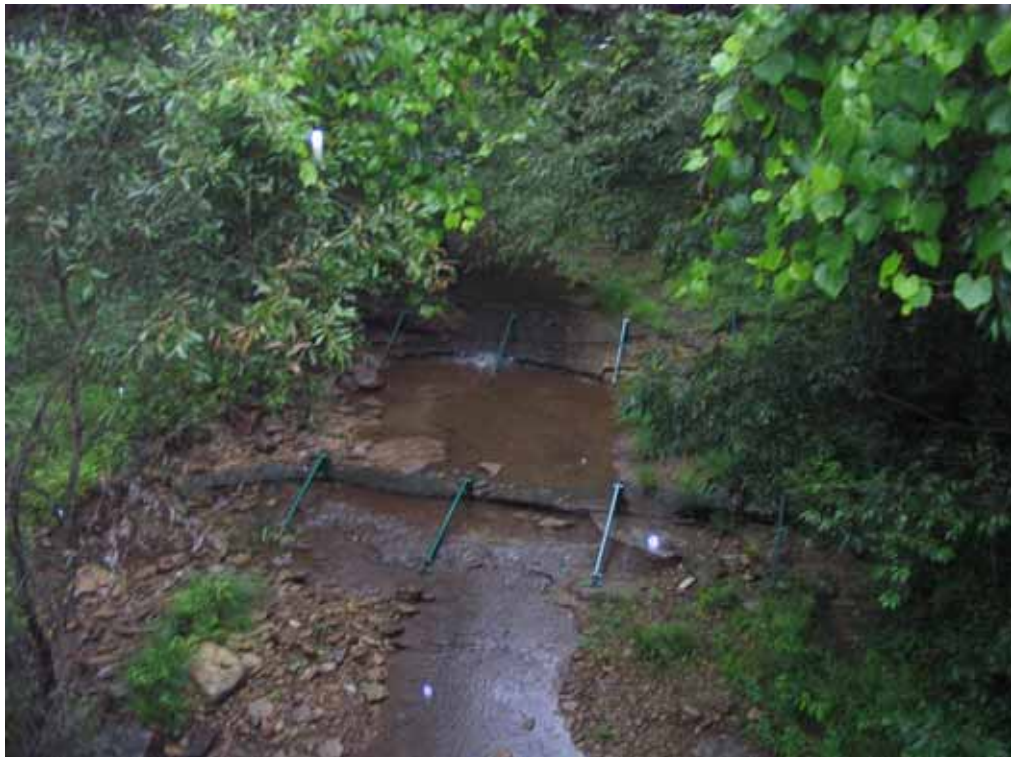
View of screens after cleaning and upon departure.

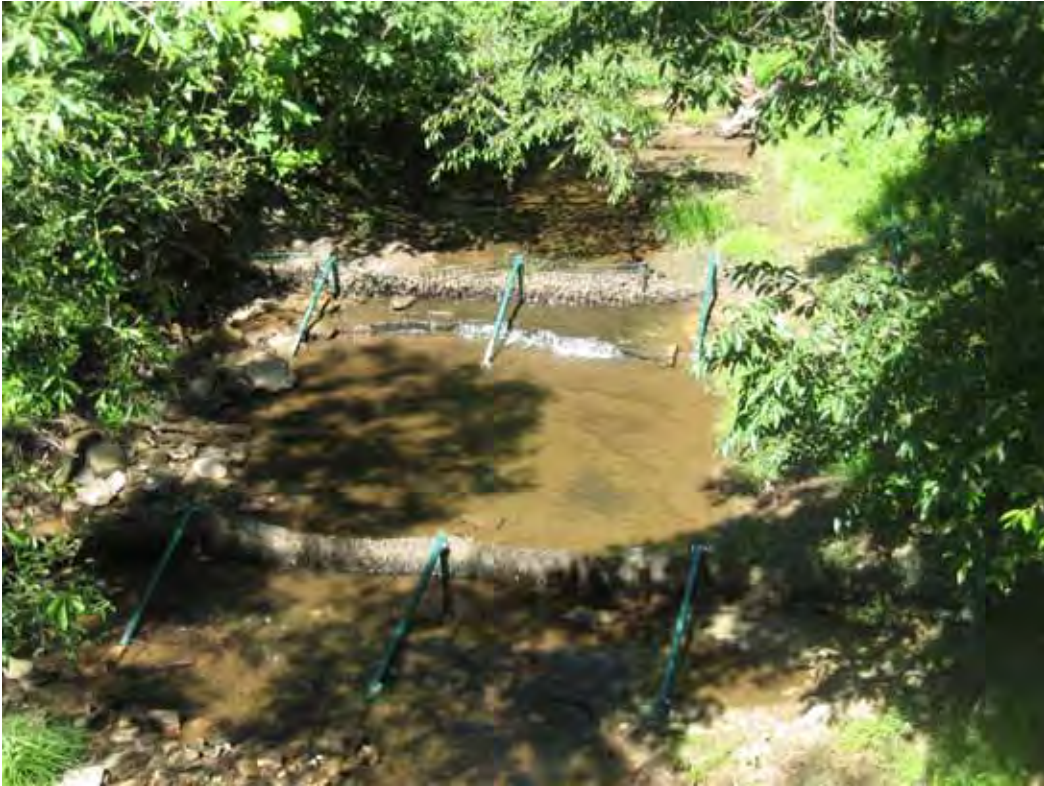
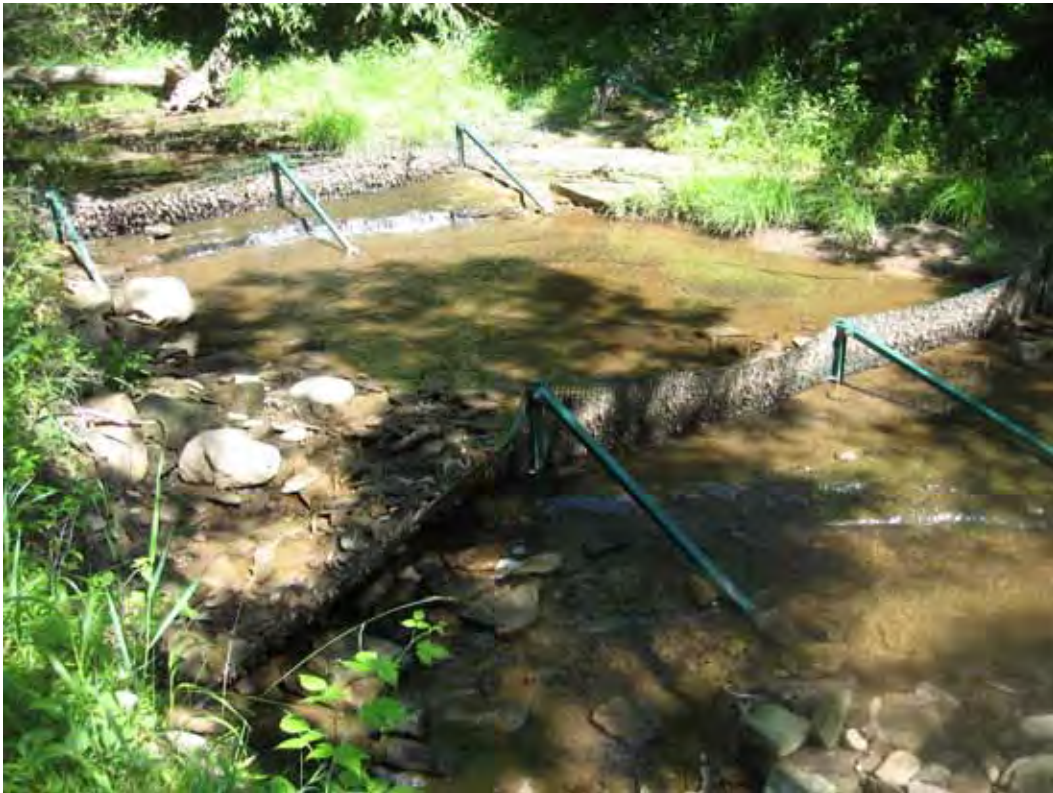
View of barriers upon arrival.

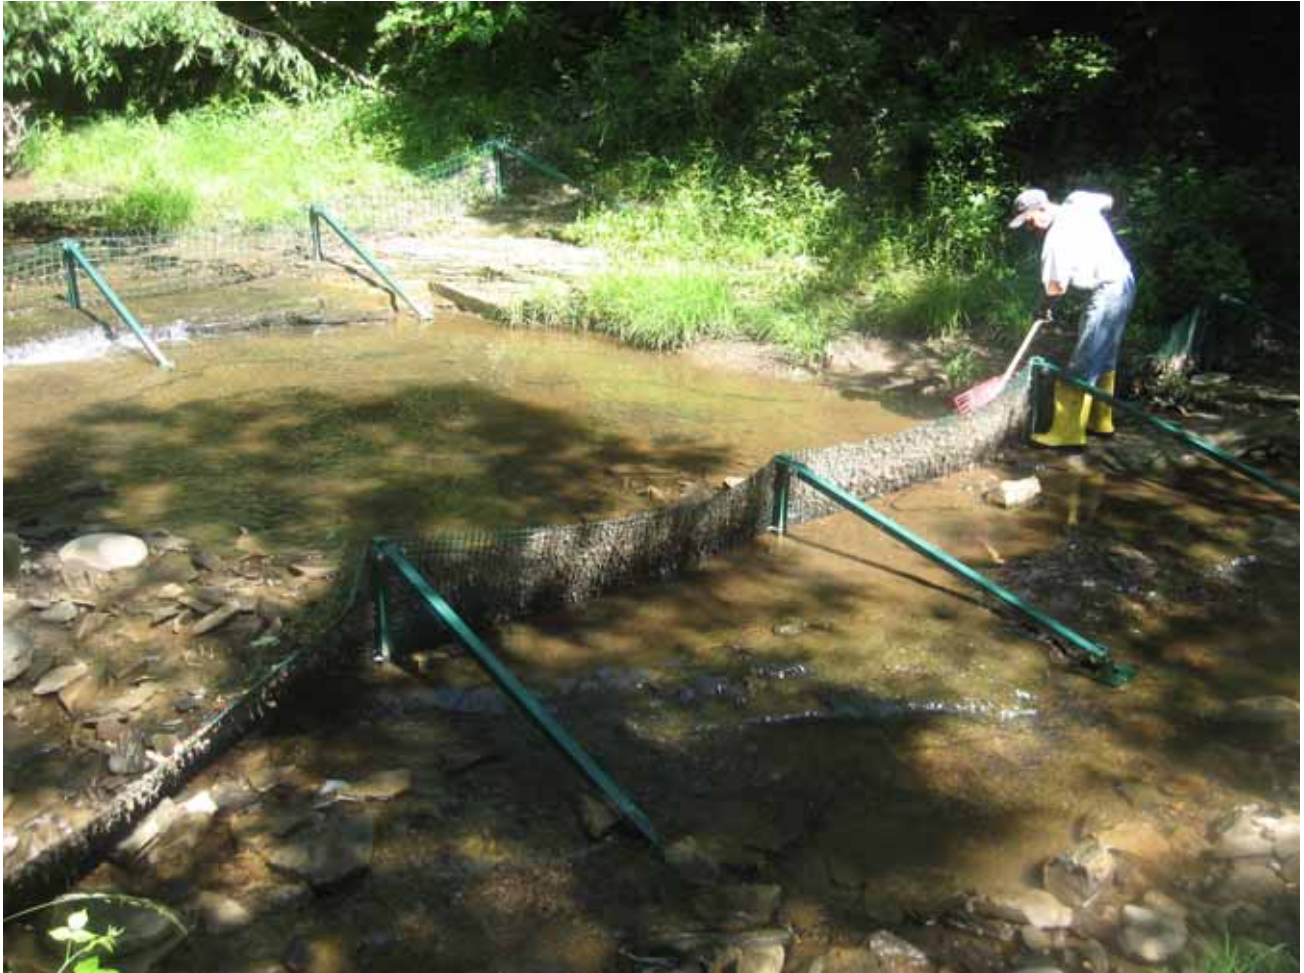
Picture showing cleaning of screen.
