# CY 2009

Operations and Maintenance Trip Reports and Quarterly Effectiveness  
Evaluation Reports Time Critical Response Action for the Rocket Ridge  
Area at RVAAP-004-R-01 Open Demolition Area #2

## Trip Report

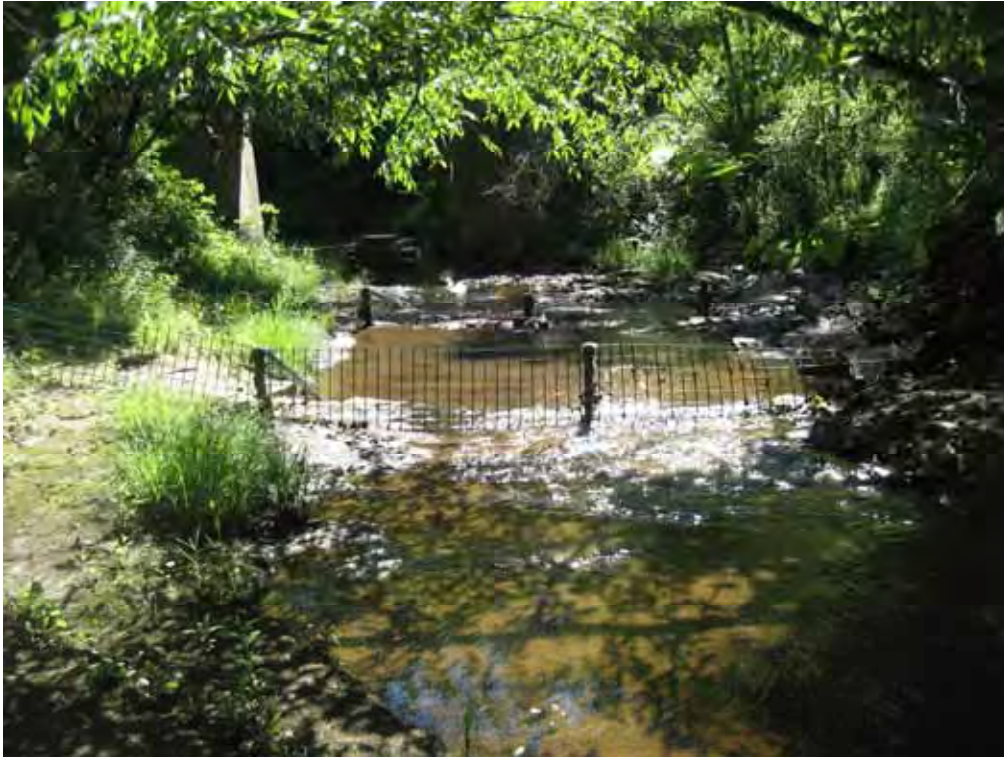
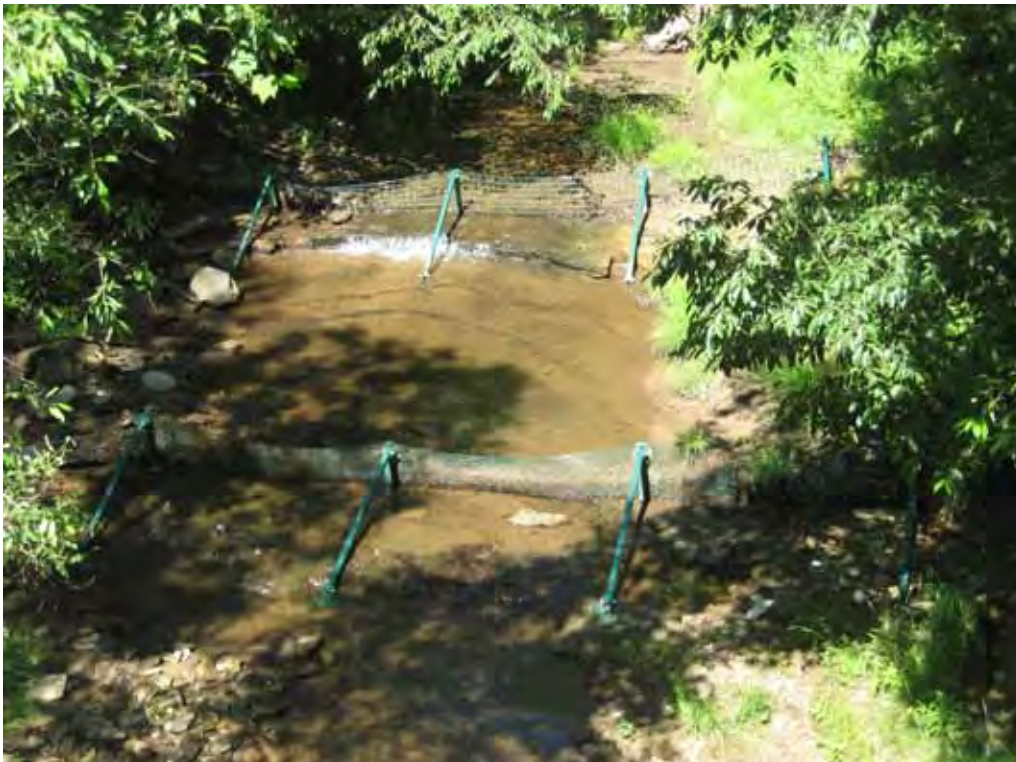
Screens after cleaning and upon departure.

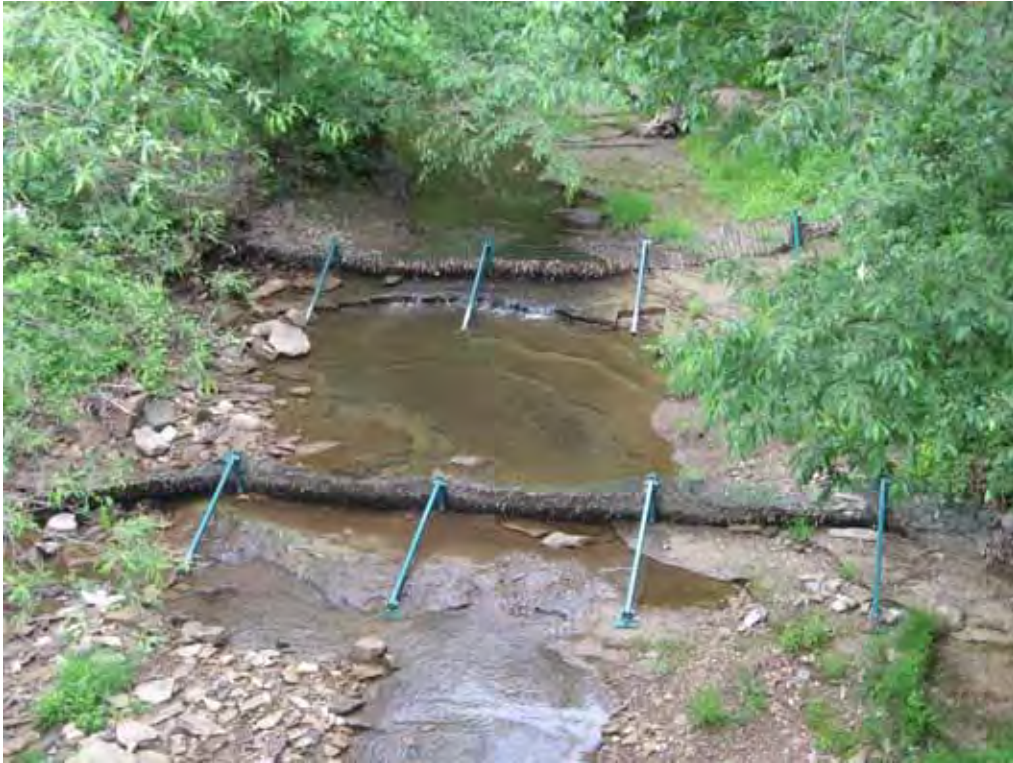
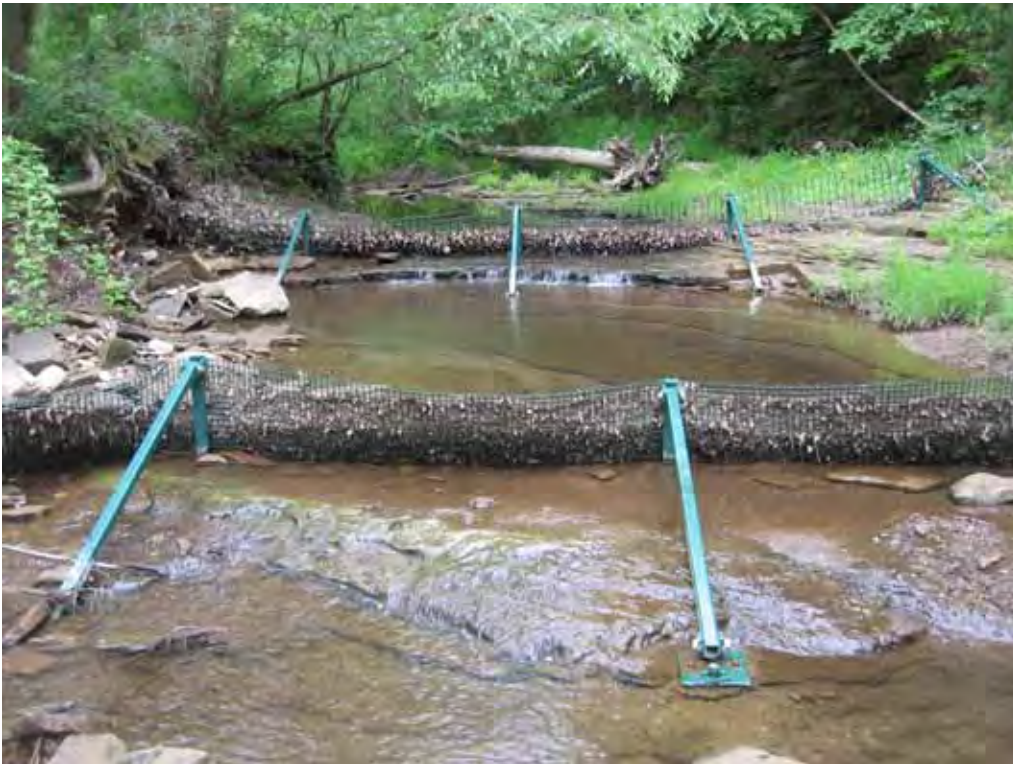
View of barriers upon arrival.

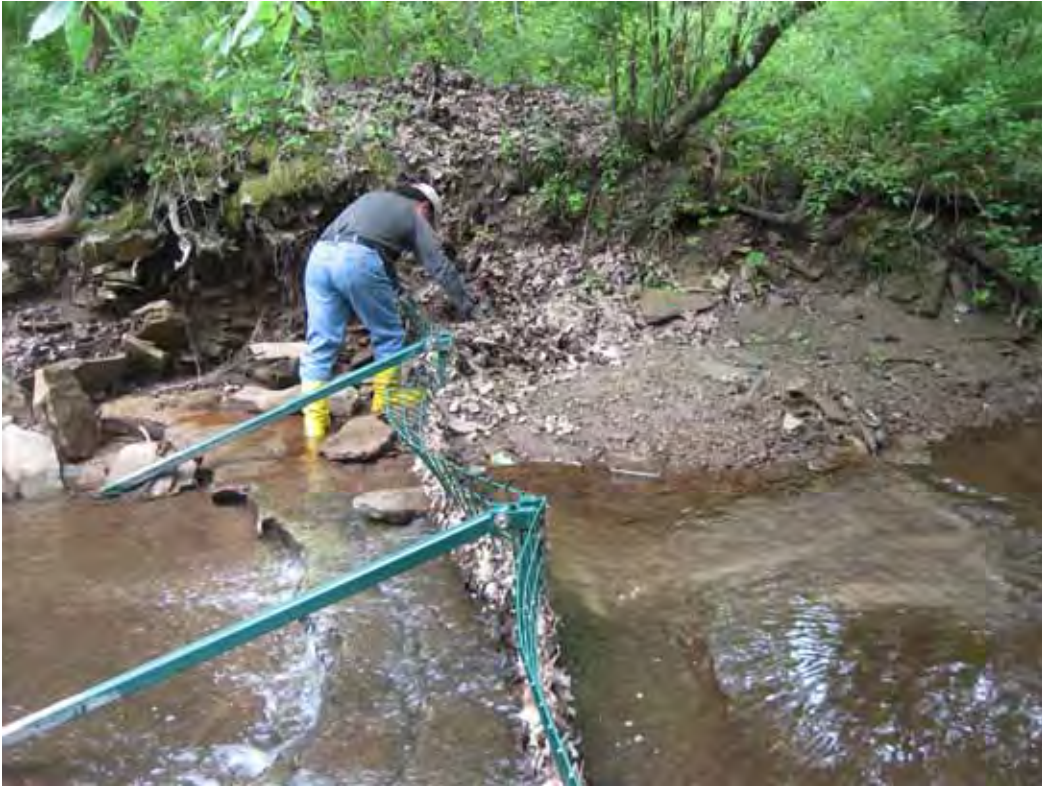
Picture showing cleaning of screen.

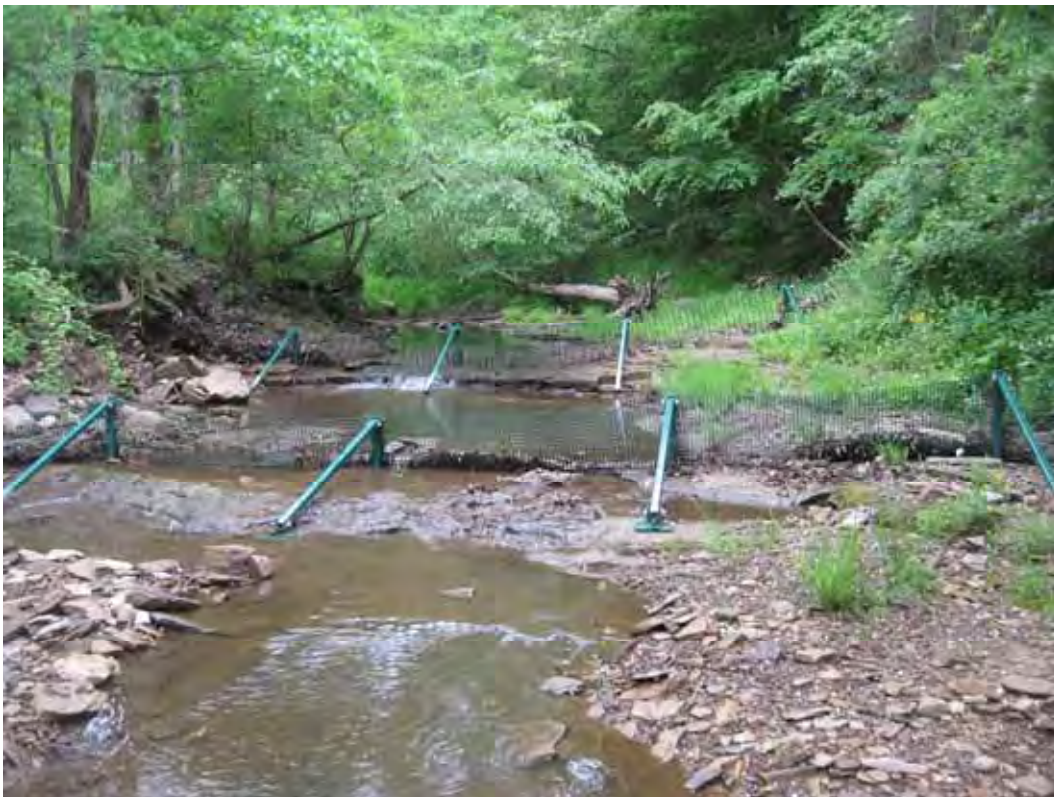
Screens after cleaning and upon departure.

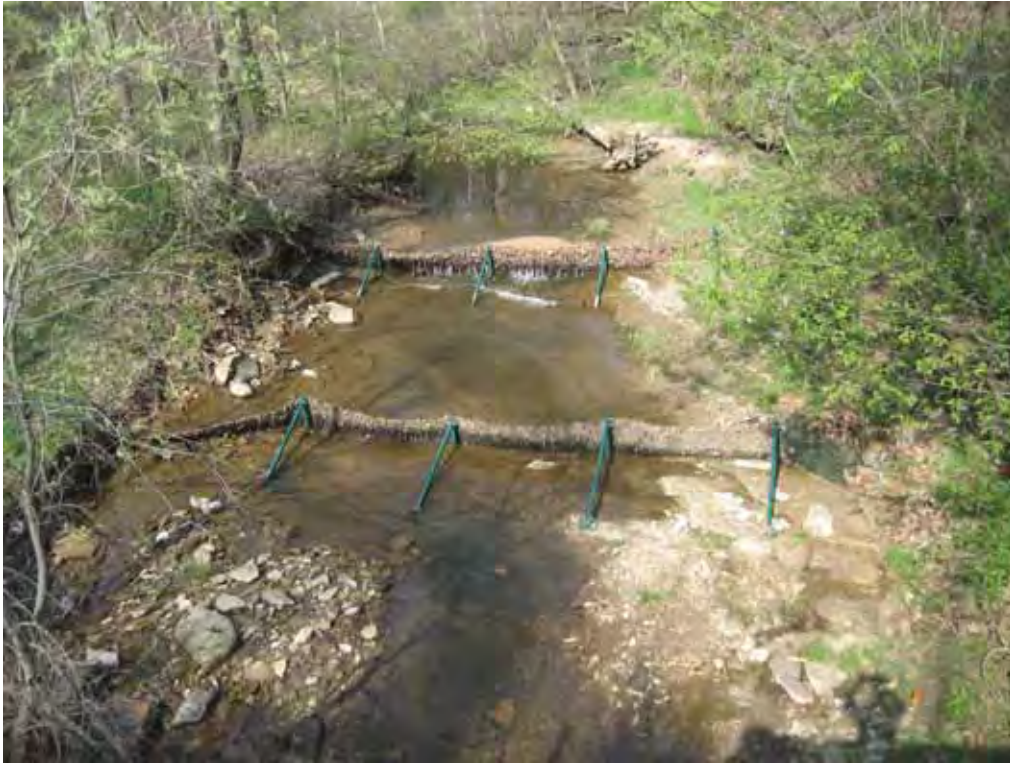
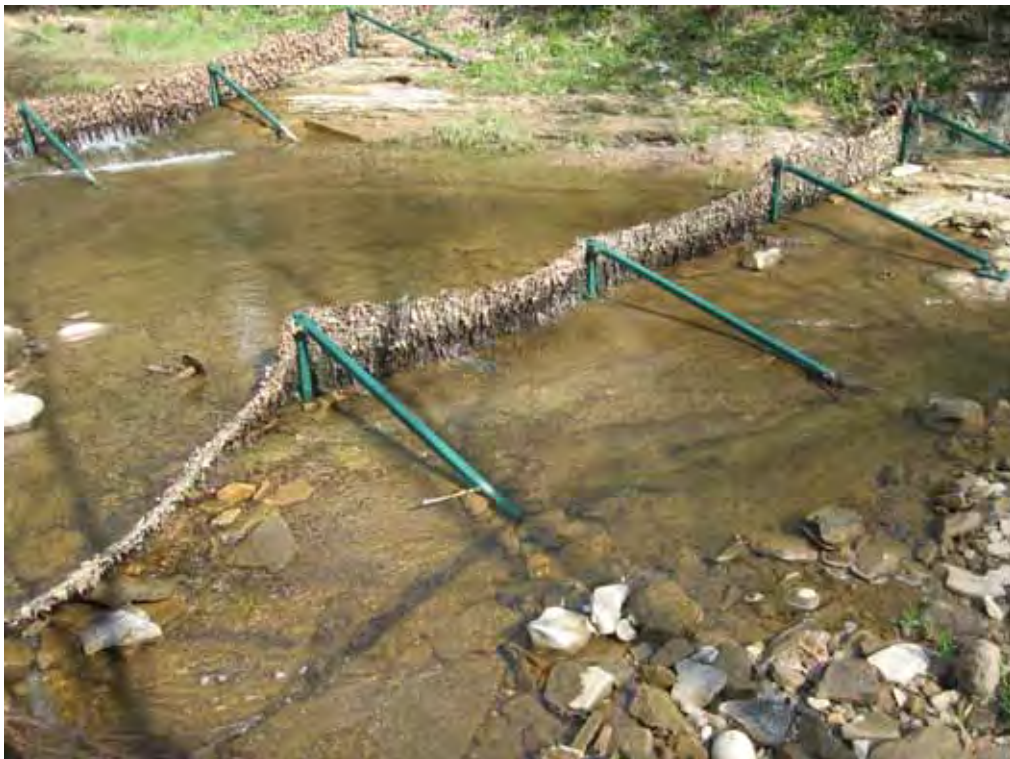
View of barriers upon arrival.

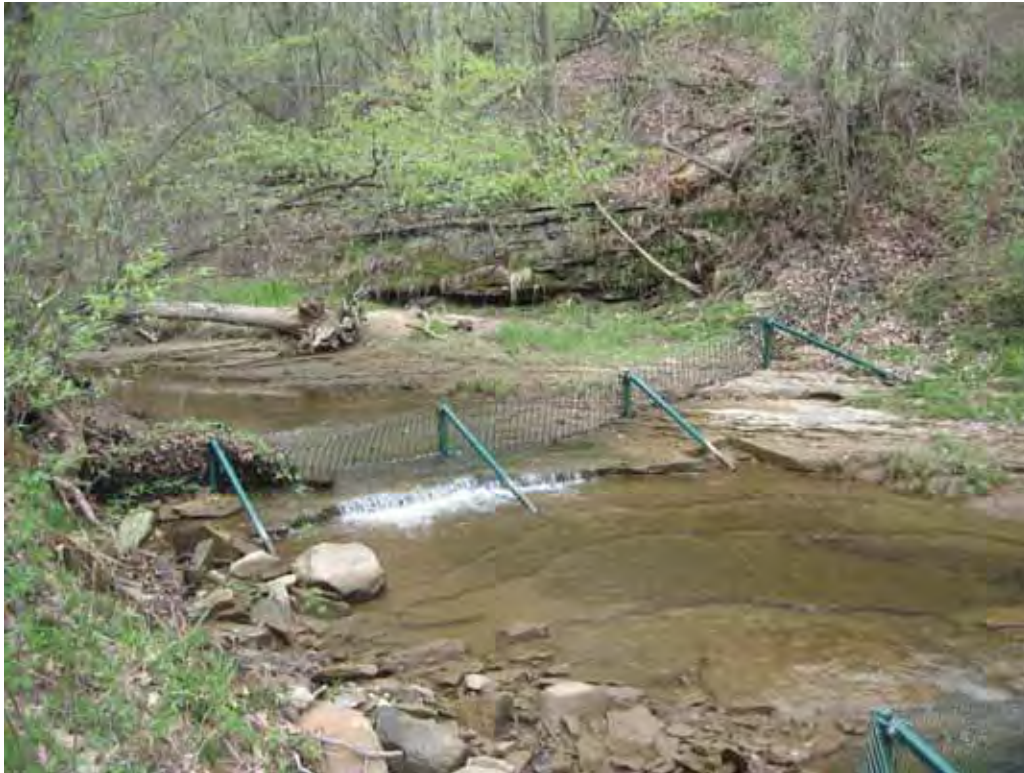
Close-up of top screen after cleaning.

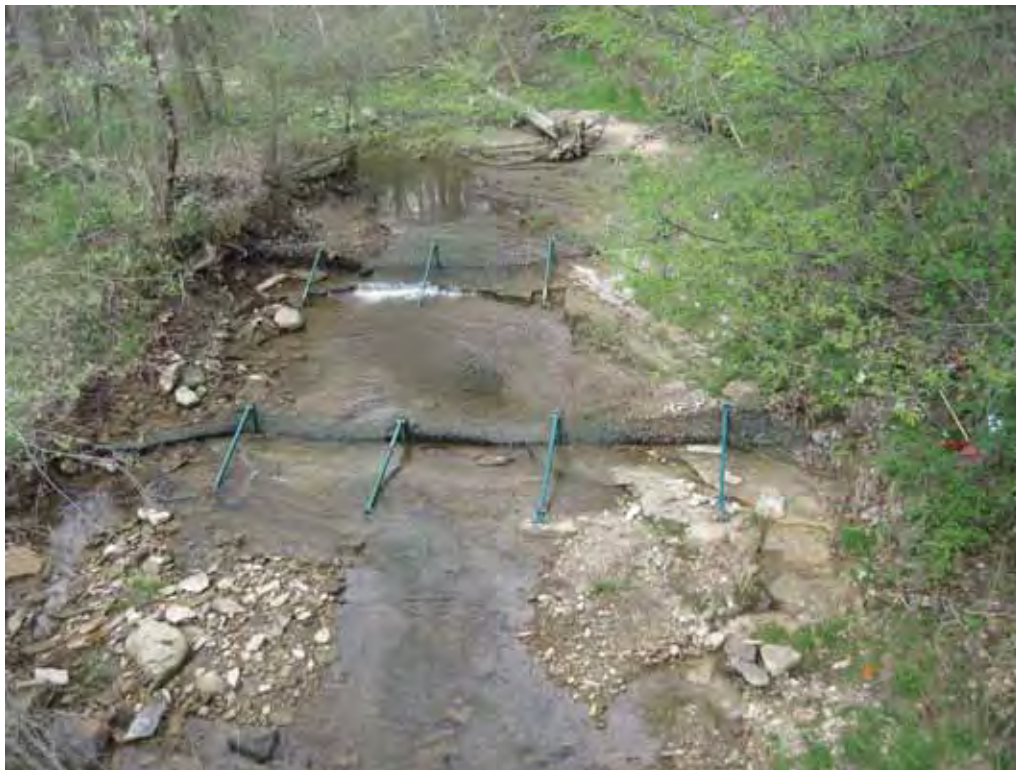
Picture showing both screens after cleaning.

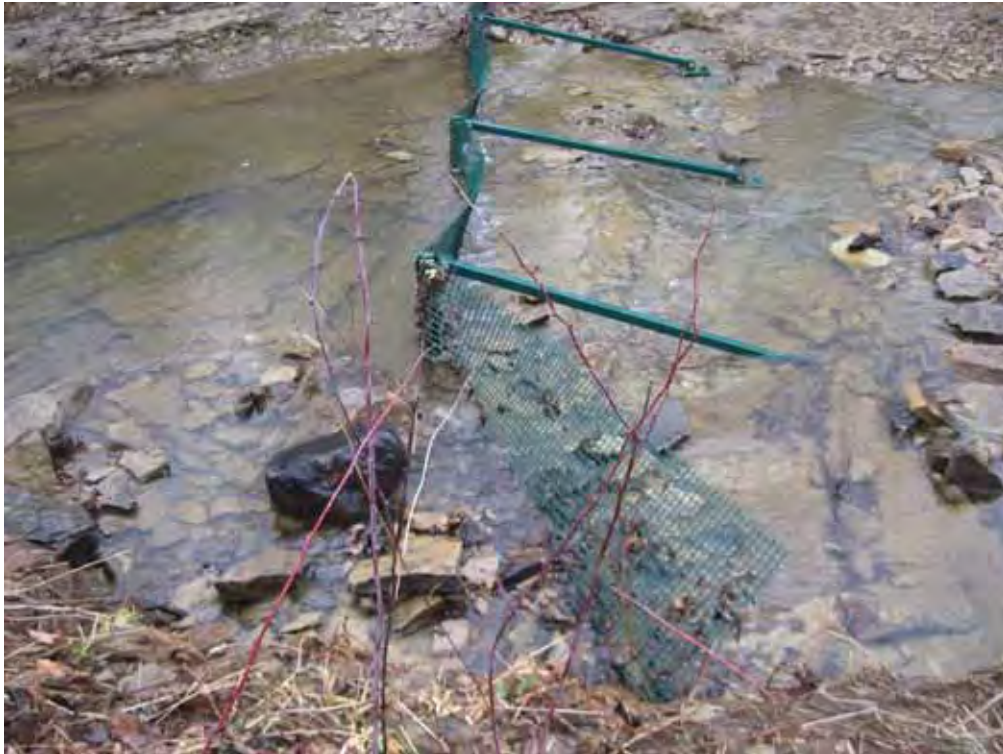
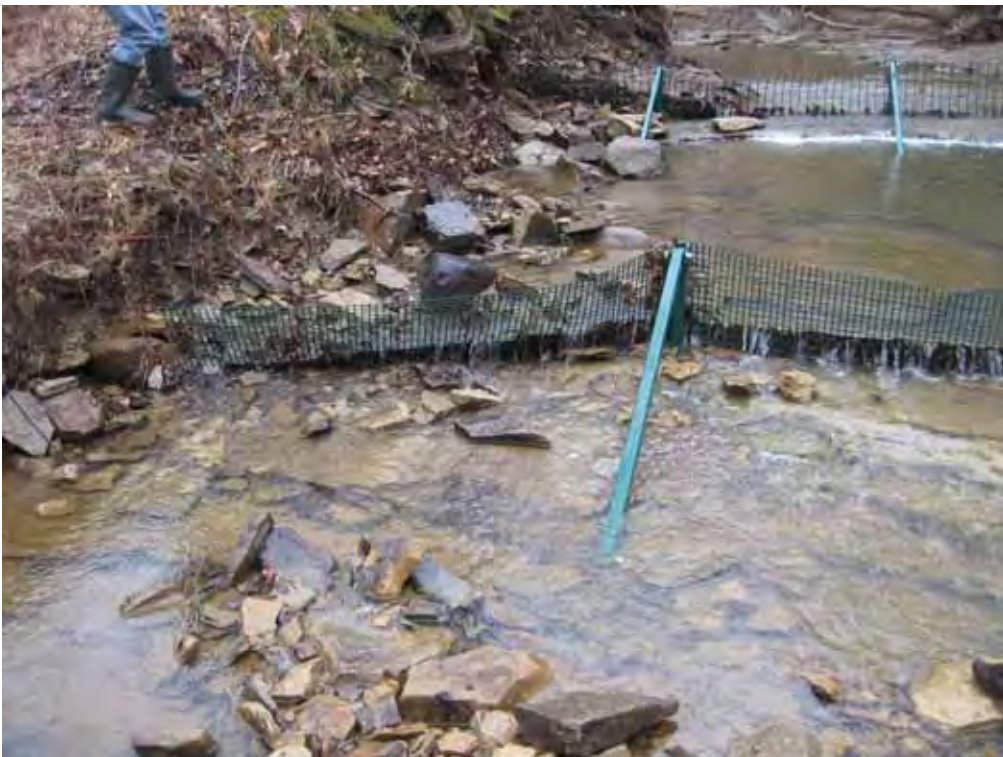
Pictures showing section of bottom screen detached from bank.

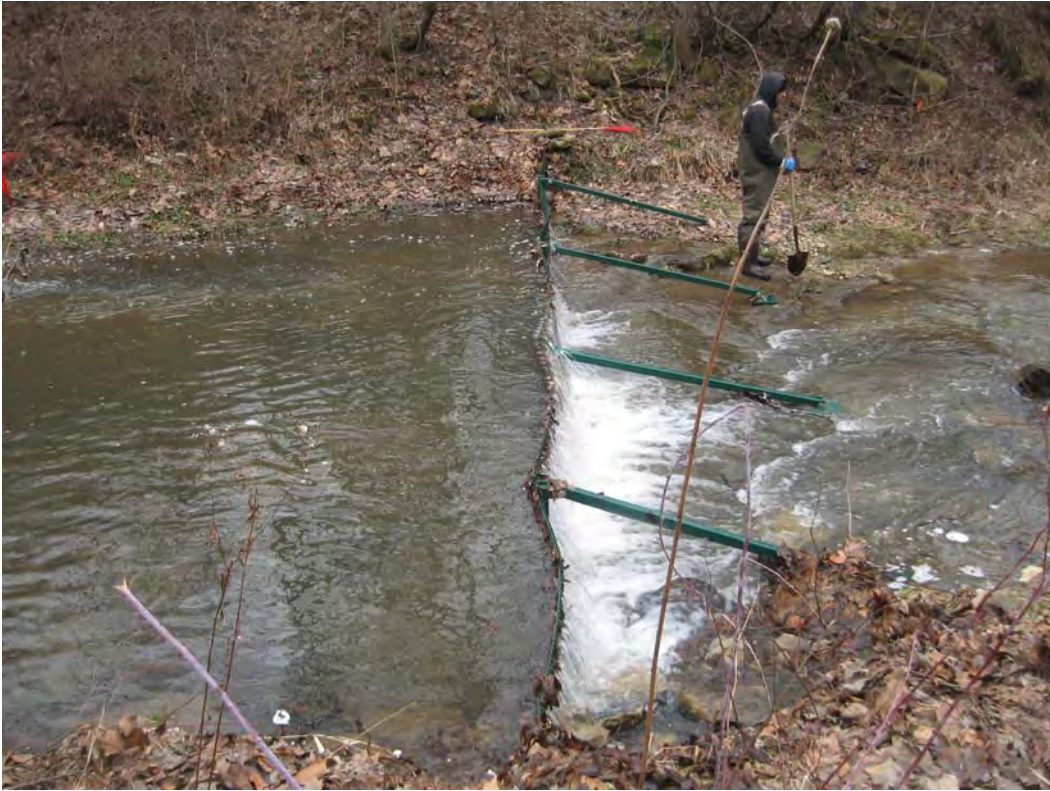
Screens bowing

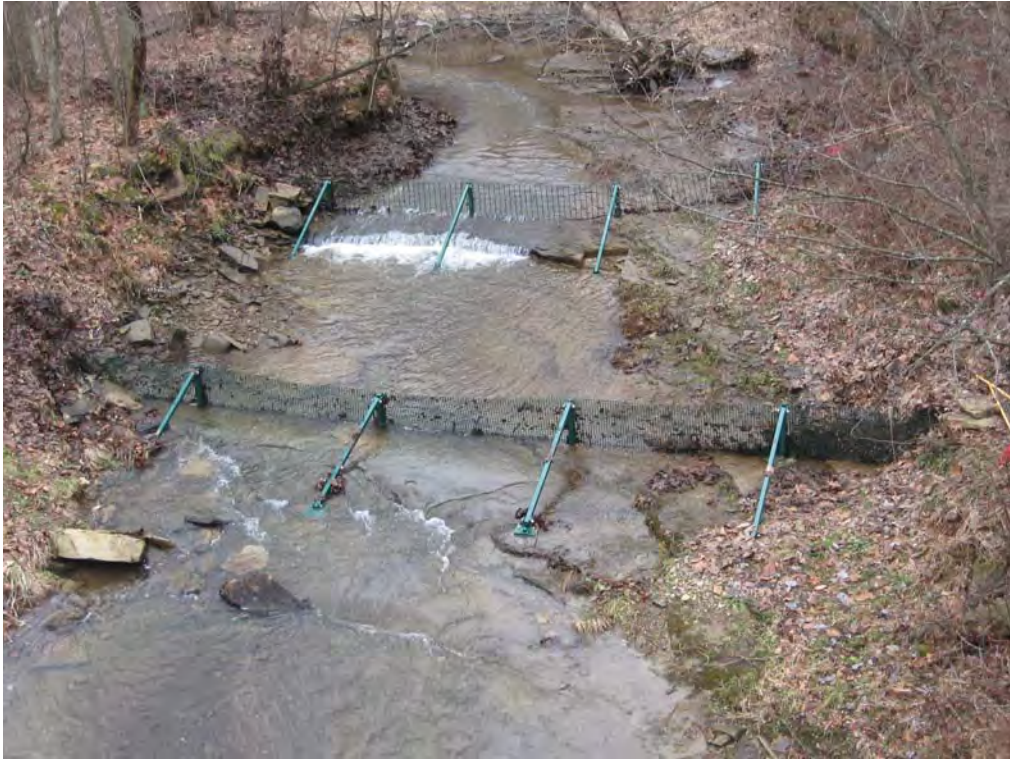
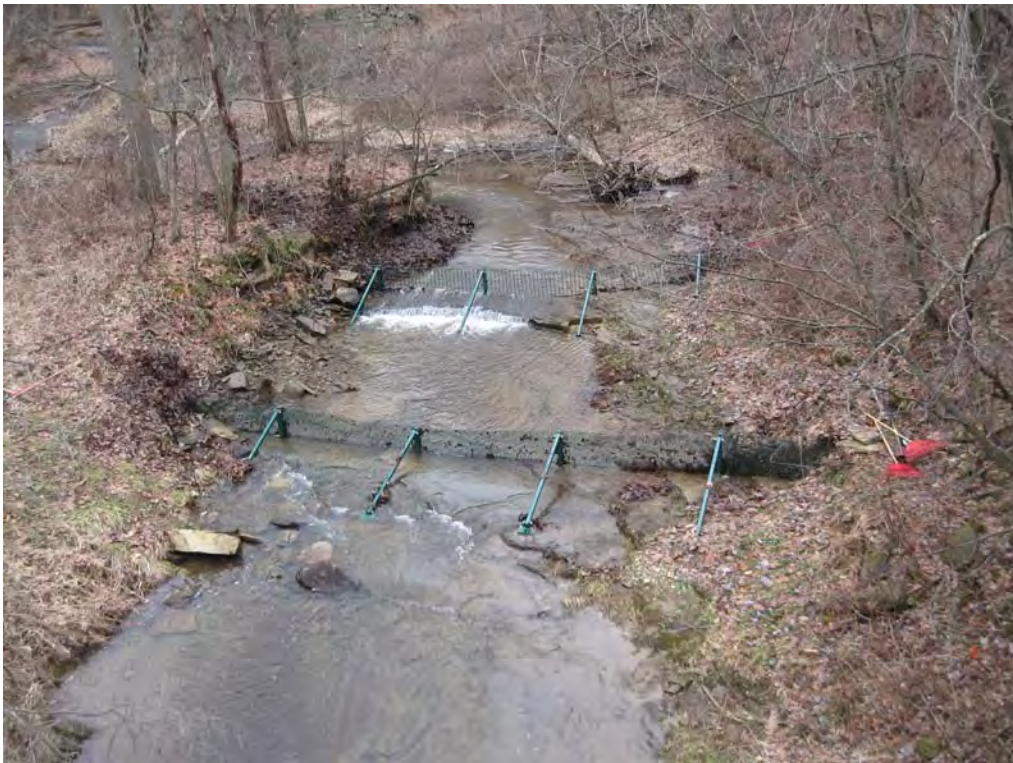
Overview of barriers following cleaning operations.  
Note: Remaining debris seen on screens is frozen to the screens.

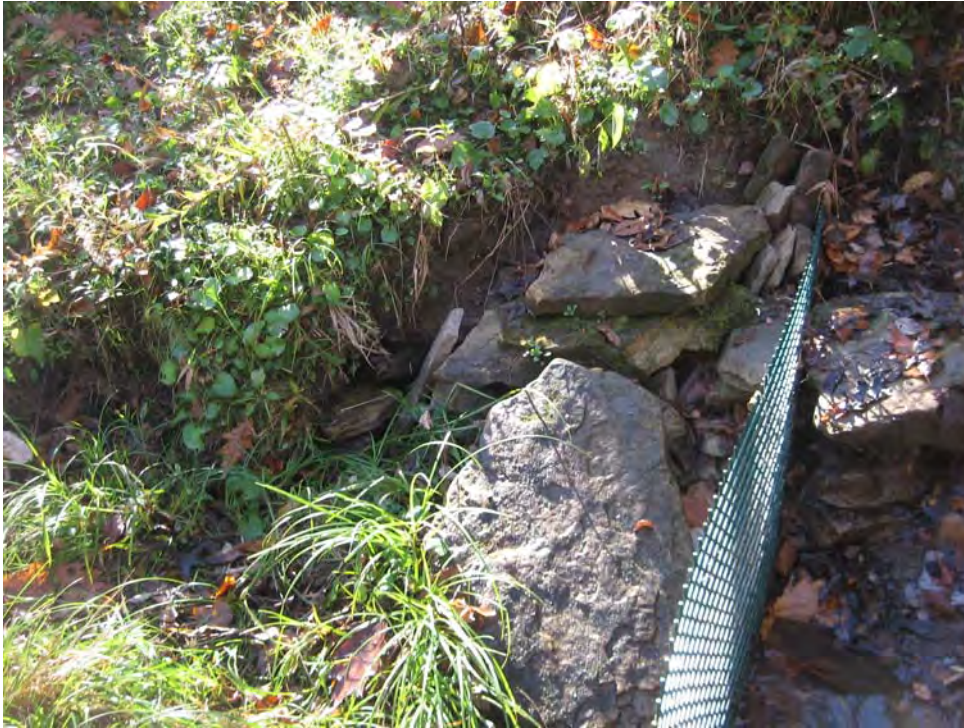
Washout area at barrier

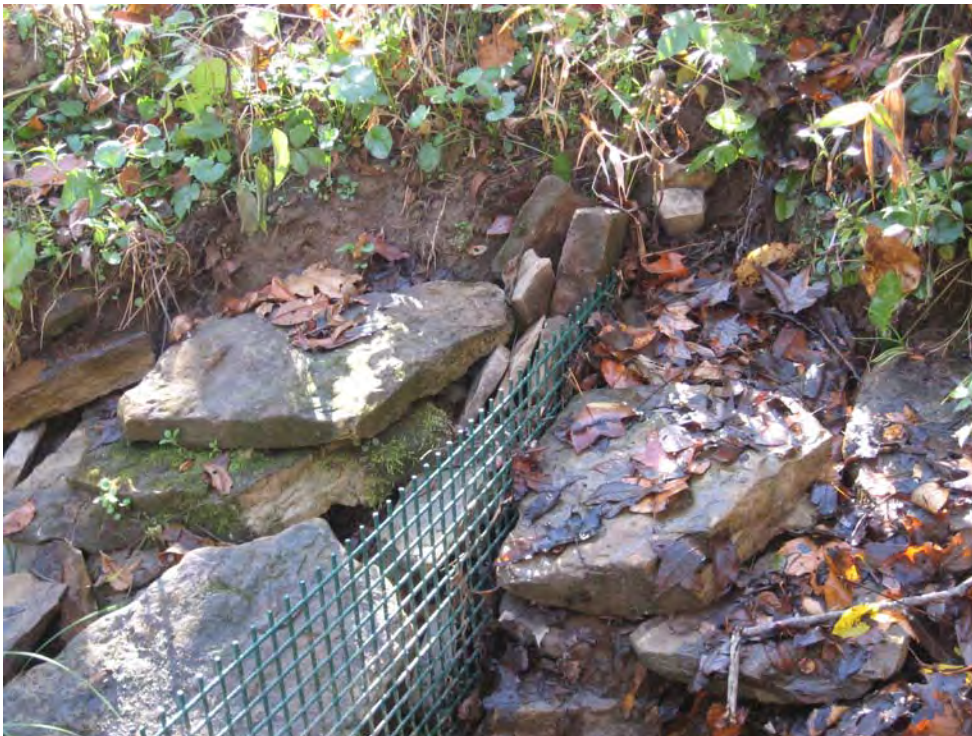
Washout area reinforced with rocks

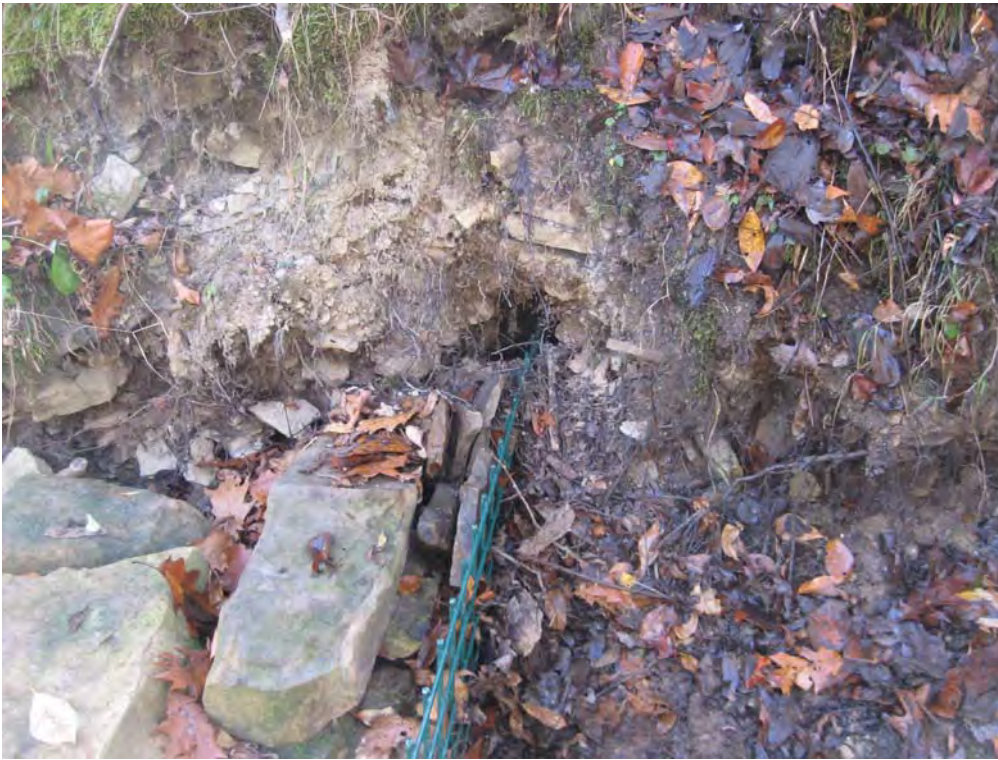
Washout area at barrier

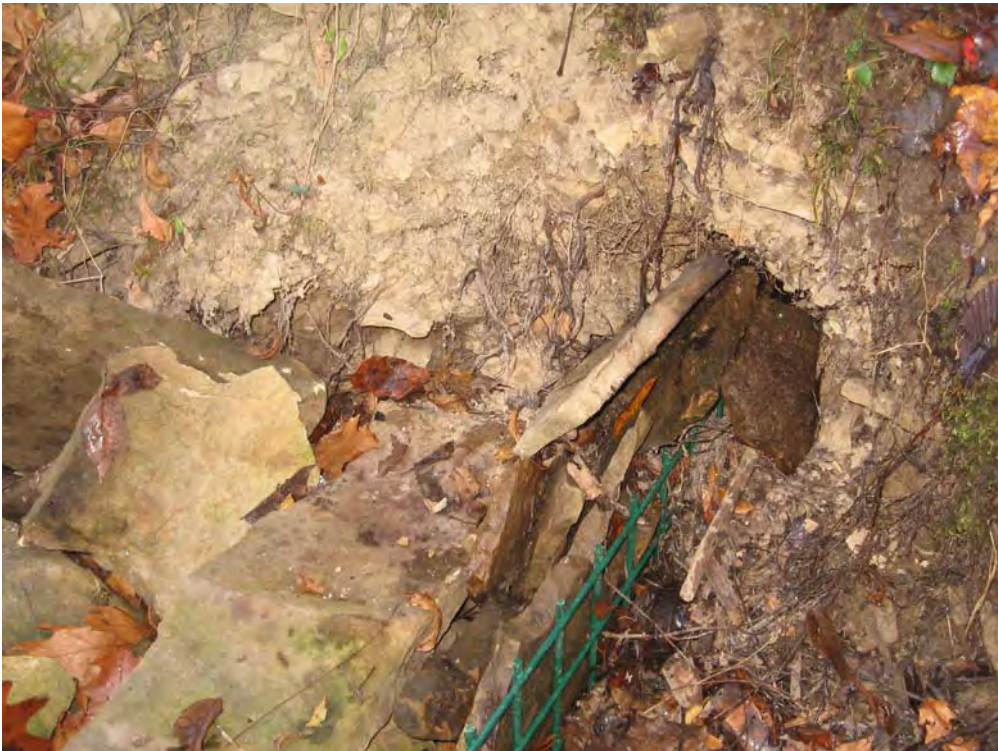
Washout area reinforced with rocks

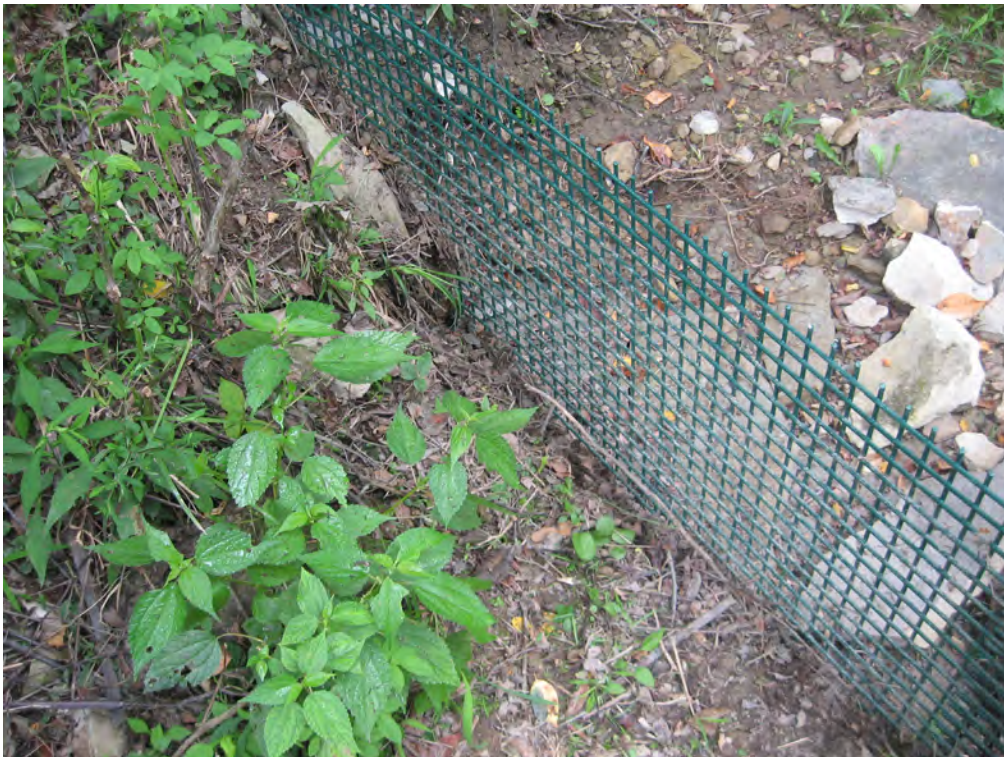
Washout area at second barrier

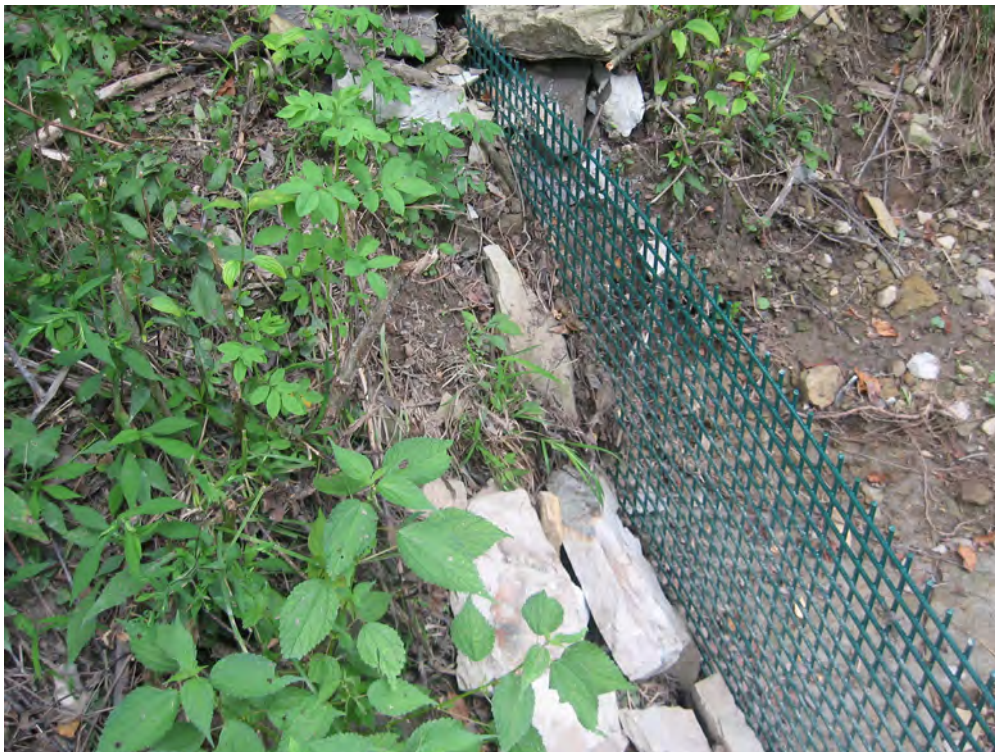
Washout area reinforced with rocks

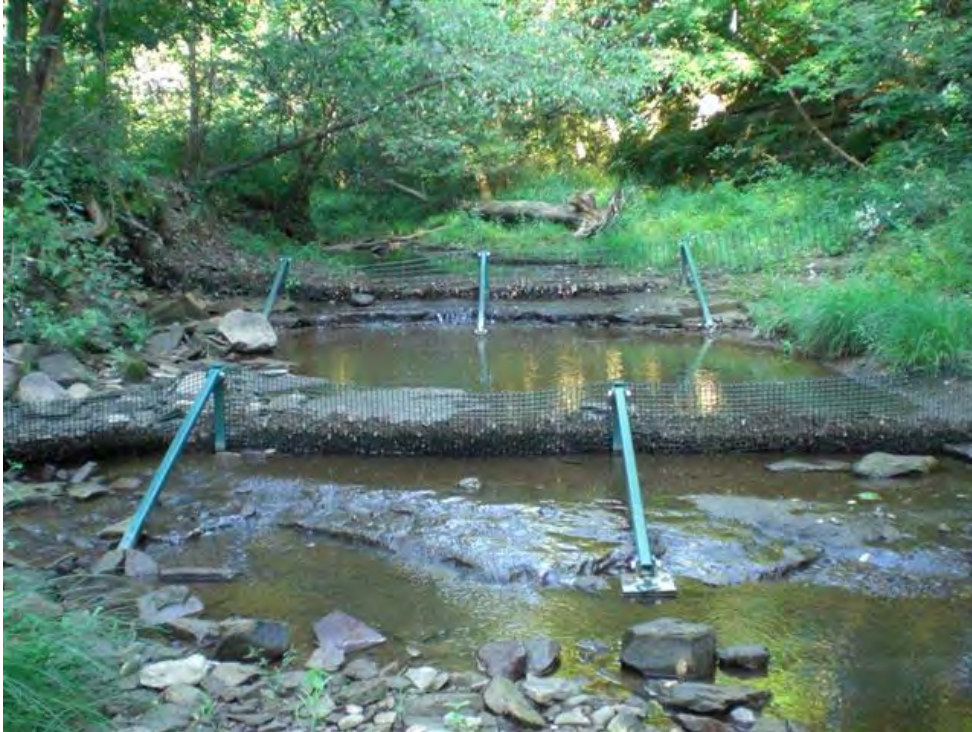
Photo 1: Sand Creek Barrier System (2 September 2009, before O&M)

**Materials found on the screens:** Leaves, branches, sticks, sand and gravel. No munitions-related materials were found at the barrier (see Photo #1 in Attachment 1).

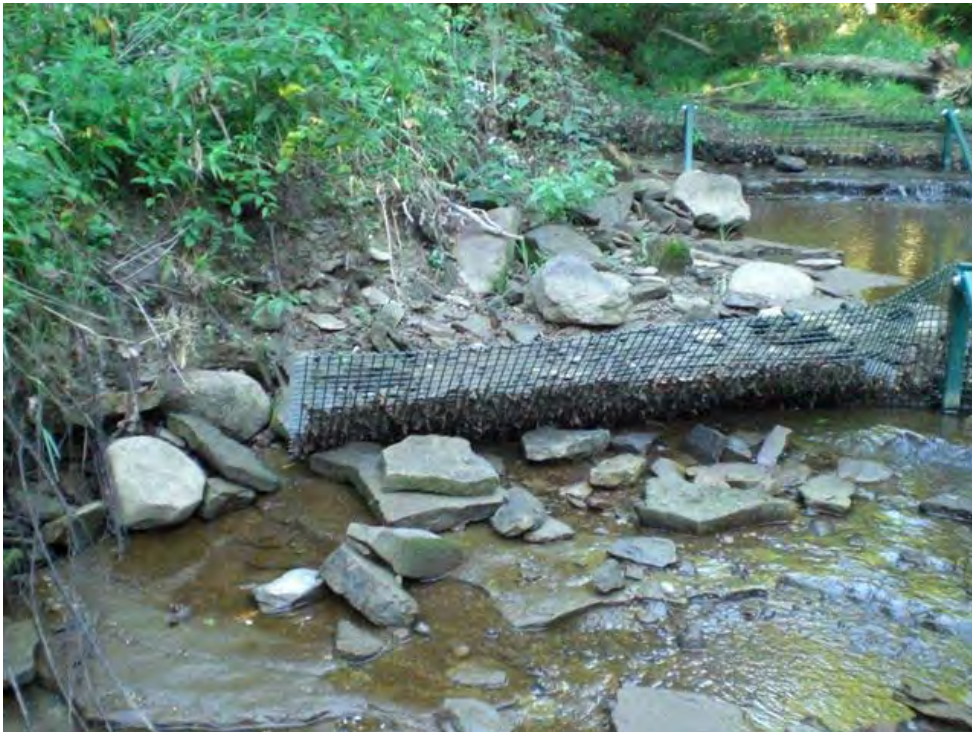
**Downstream (1-inch grid) barrier:** All posts and back braces were intact. The end panels had detached from the creek banks (see Photos #2 and #3). The tops of the panels were bowed in the direction of the water flow. Sand and gravel, approximately 2-3 inches deep, had accumulated in front of the third panel from the south.

Photo 2: Downstream barrier, south end panel (2 September 2009, before O&M)

- One new post and back brace were installed at the south end of the downstream barrier. The new post is approximately 6.5 feet south of the next post. The screen panel that was detached from the creek bank was attached to the new post. A new panel was installed and keyed into the bank in front (upstream) and at 45 degrees to the barrier line (see Photo #4).

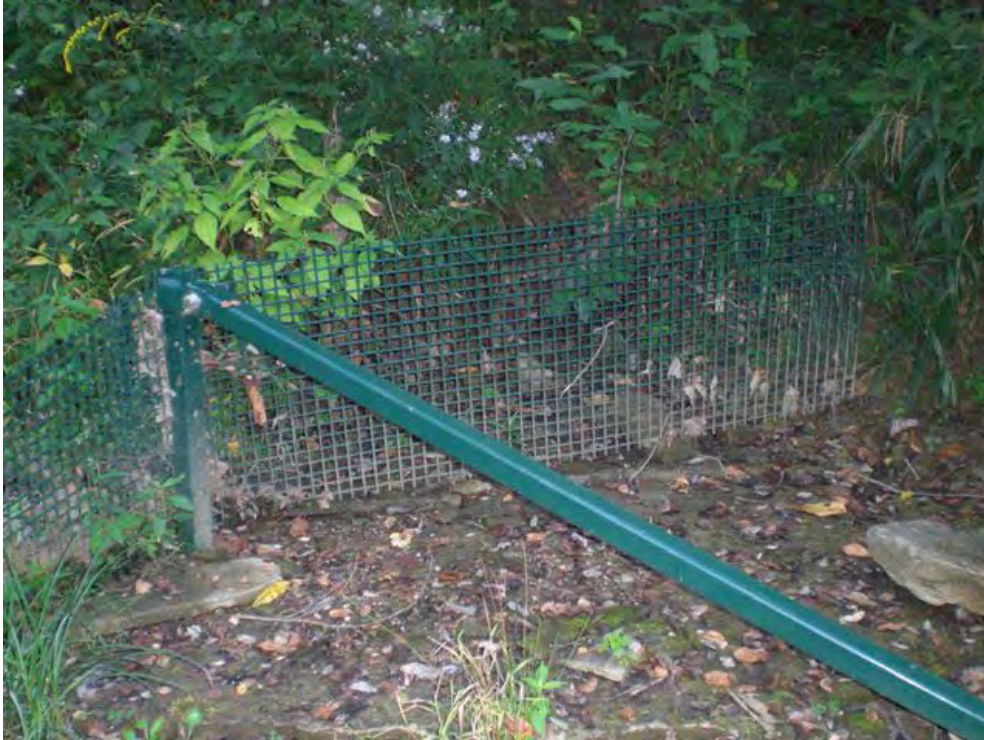
Photo 3: Downstream barrier, north end panel (2 September 2009, before O&M)

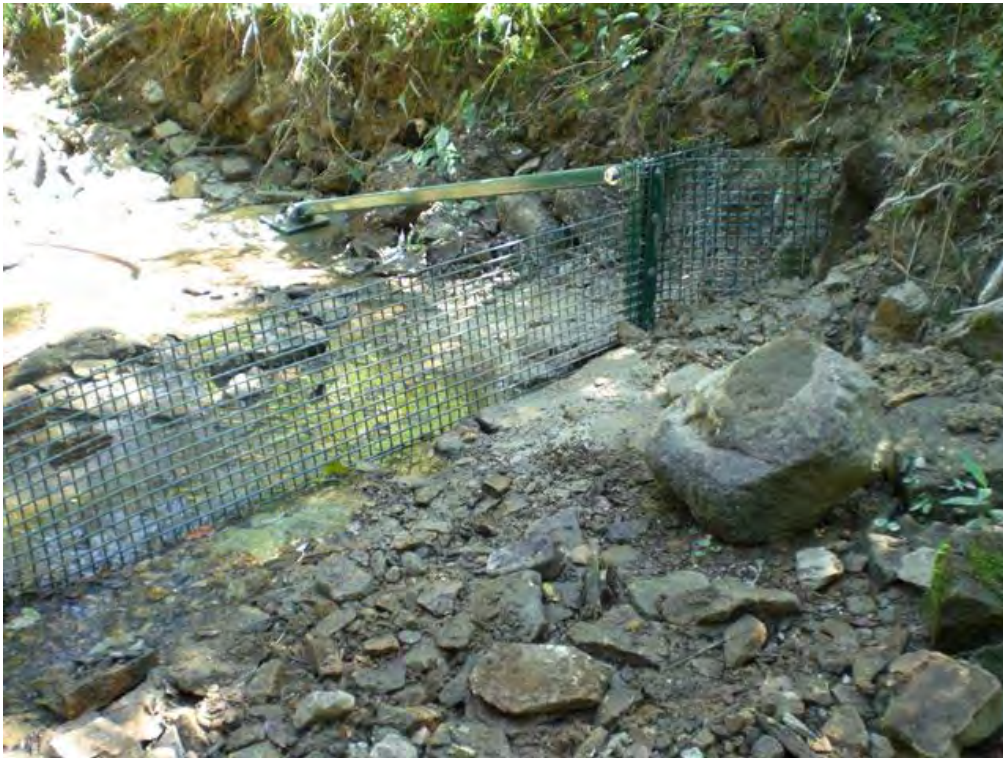
Photo 4: New post and panel at south end of downstream barrier (2 September 2009)

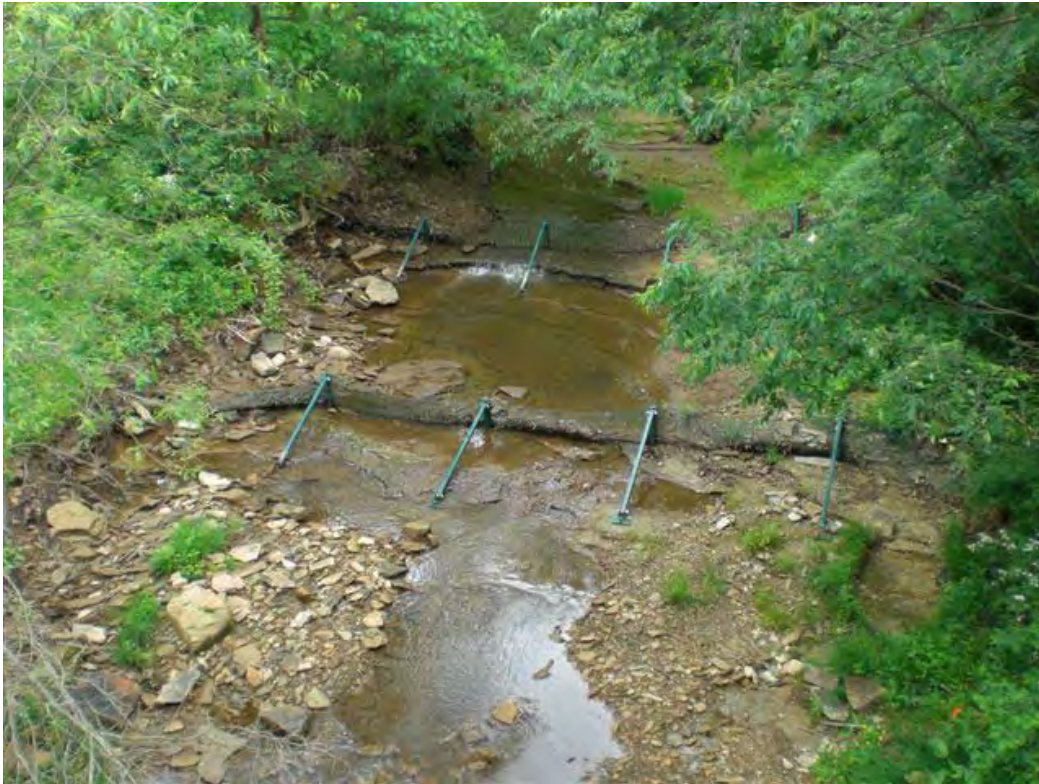
Photo 1: Sand Creek Barrier System (27 May 2009)

**Materials found on the screens:** Leaves, branches, sticks, sand and gravel. No munitions-related materials were found on the screens (see Photo #1).

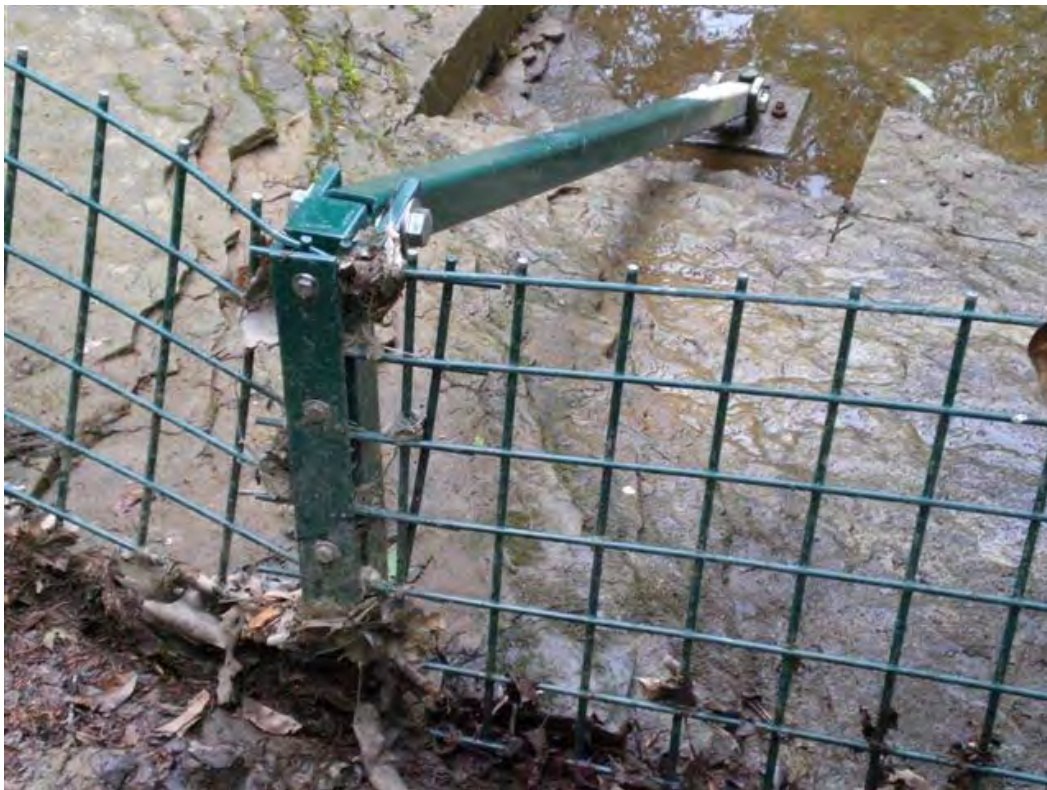
**Upstream (3-inch grid) barrier:** All posts and back braces are intact (see Photo #2). All barrier elements are in place and there are no gaps between the screen panels and creek bed and banks. The ends of the top two horizontal wires of the second panel from the south have detached from the post clamping system (see Photo #3). The tops of the panels are bowed in the direction of the water flow.

Photo 2: Upstream barrier, post and back brace (27 May 2009)

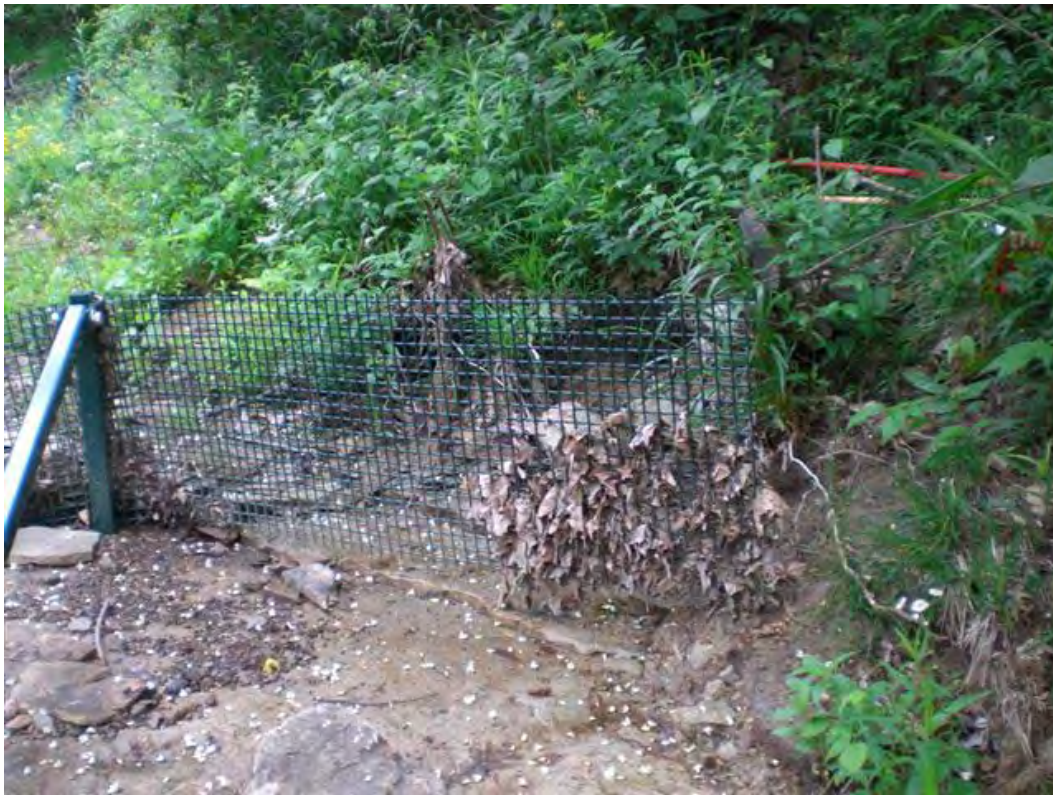
**Downstream (1-inch grid) barrier:** All posts and back braces are intact. The end panels have detached from the creek banks (see Photos #4 and #5). The tops of the panels are bowed in the direction of the water flow. Sand and gravel, approximately 2-3 inches deep, has accumulated in front of the third panel from the south.

Photo 5: Downstream barrier, north end panel (27 May 2009)
