# CY 2009

Operations and Maintenance Trip Reports and Quarterly Effectiveness  
Evaluation Reports Time Critical Response Action for the Rocket Ridge  
Area at RVAAP-004-R-01 Open Demolition Area #2

## Trip Report

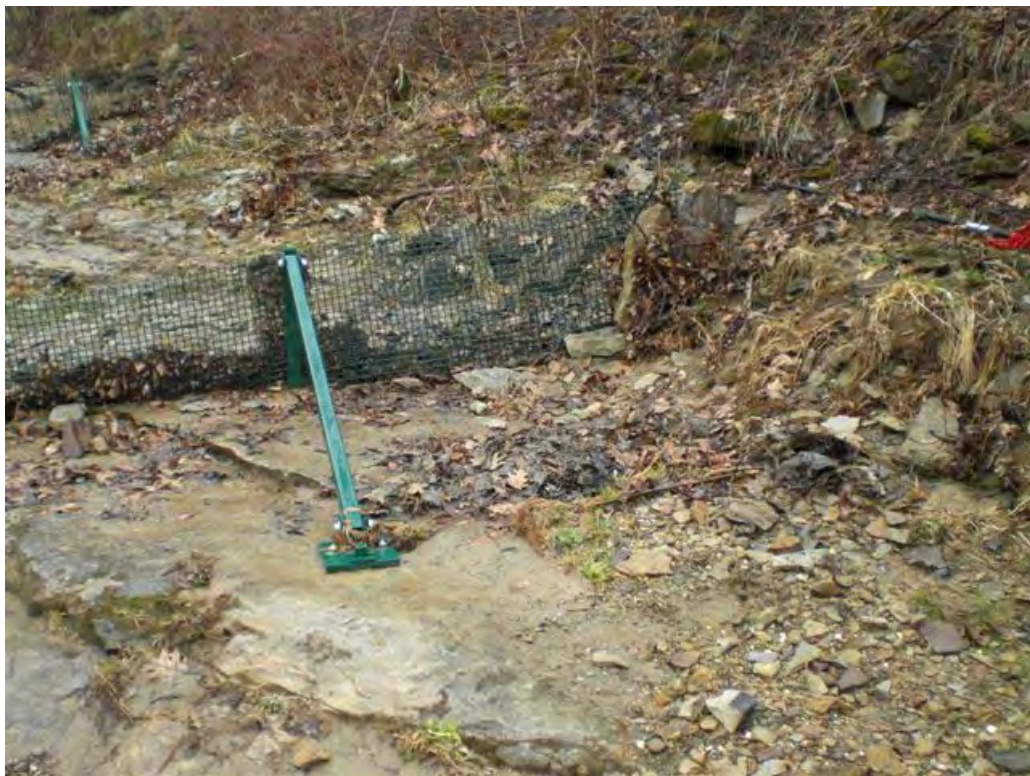
**Downstream (1-inch grid) barrier:** All posts and back braces are intact. The end of the first panel from the south has detached from the creek bank and left a gap of several inches between the panel and the creek bank (see Photo #3). During the 25 March 2009 site visit, e<sup>2</sup>M filled the gap with stones from the creek bed. The panel at the north end is no longer keyed firmly into the bank (see Photo #4) but still functional. The tops of the panels are bowed in the direction of the water flow.

Photo 4: Downstream barrier, north end panel (25 March 2009)

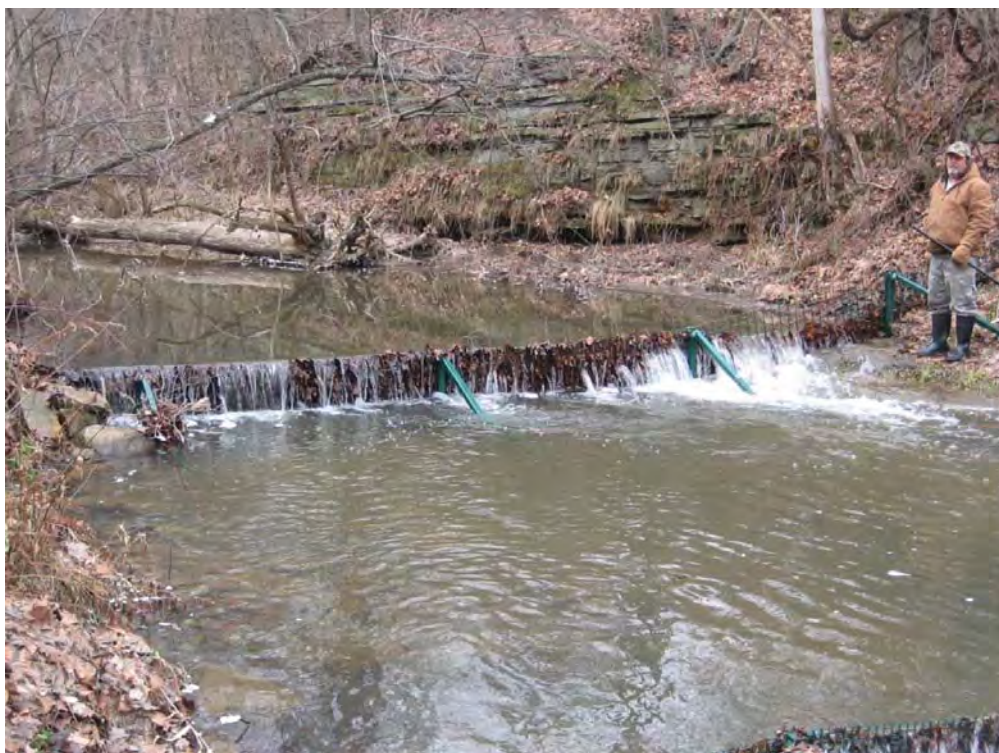
**Barrier integrity:** There is no damage to the barrier elements. Barrier screens are slightly bowed due to water pressure on leaf-covered screens. Photos 1 and 2 (taken on 16 December 2008) show the barrier screens almost completely loaded with leaves. The limited scouring observed and repaired during the 23 October 2008 QEE visit appears to have subsided. This may be due to the bowing of the screens, which creates a preferential water overflow in the central portion of the panels and away from the creek banks. The ice observed during the 5 February 2009 QEE visit covering most of the barriers did not appear to impact the integrity of the system. Photo 3 shows a portion of the downstream screen and a back brace encased in ice. Two posts, back braces, and base plates were uncovered and examined on 5 February 2009. No damage to their integrity or anchoring was observed (Photos 4 and 5).

Photo 1: Upstream barrier loaded with leaves (12 December 2008)

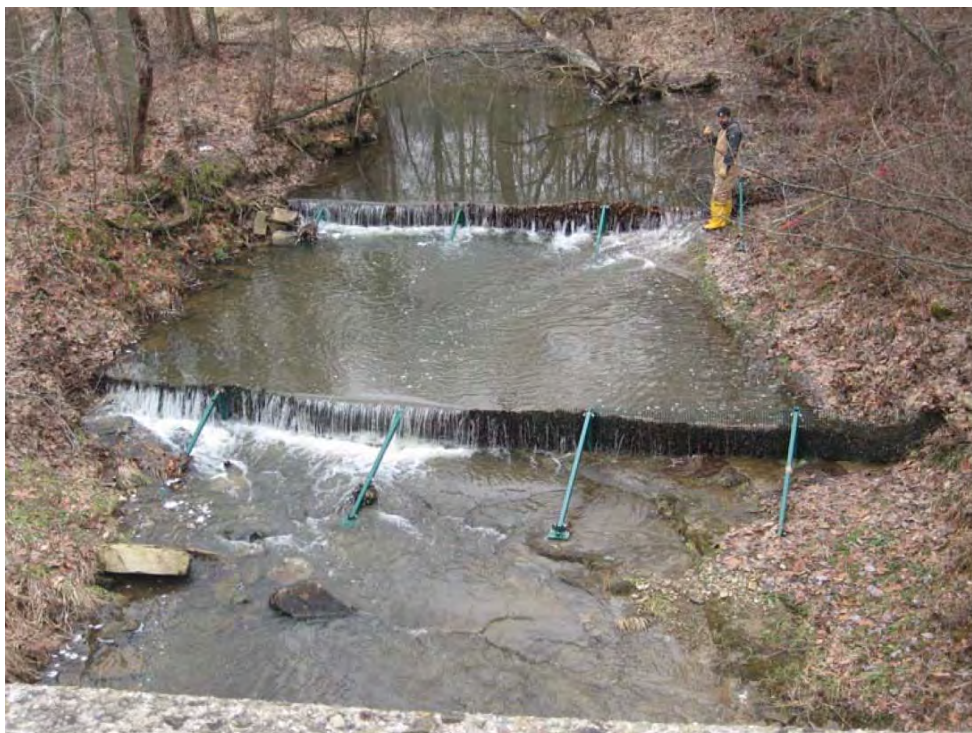
Photo 2: Water overflowing the barriers (12 December 2008)

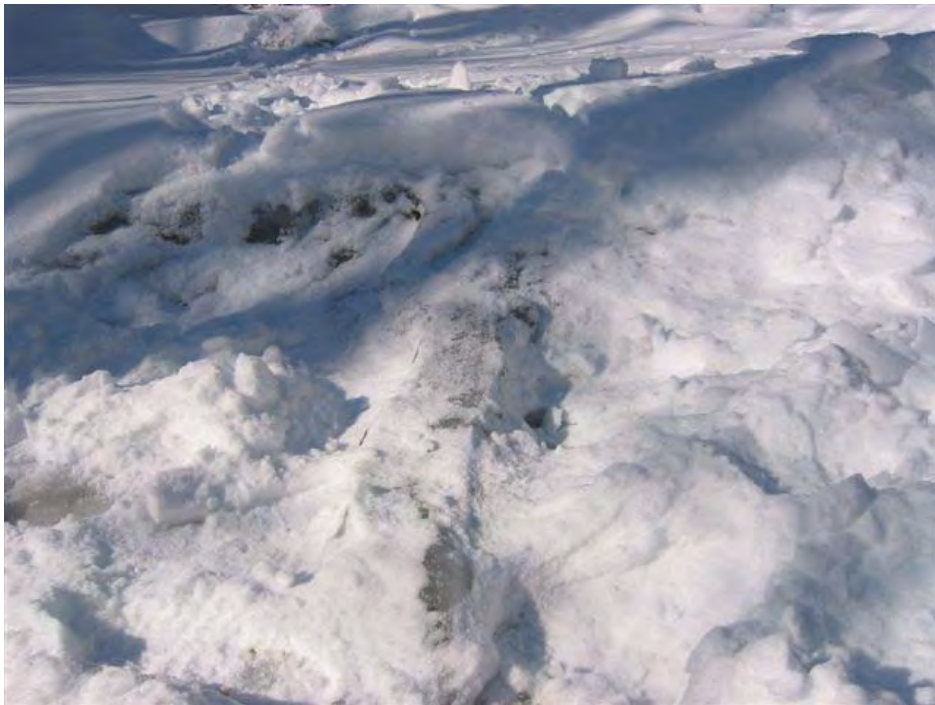
Photo 3: Screen and back brace encased in ice (5 February 2009)

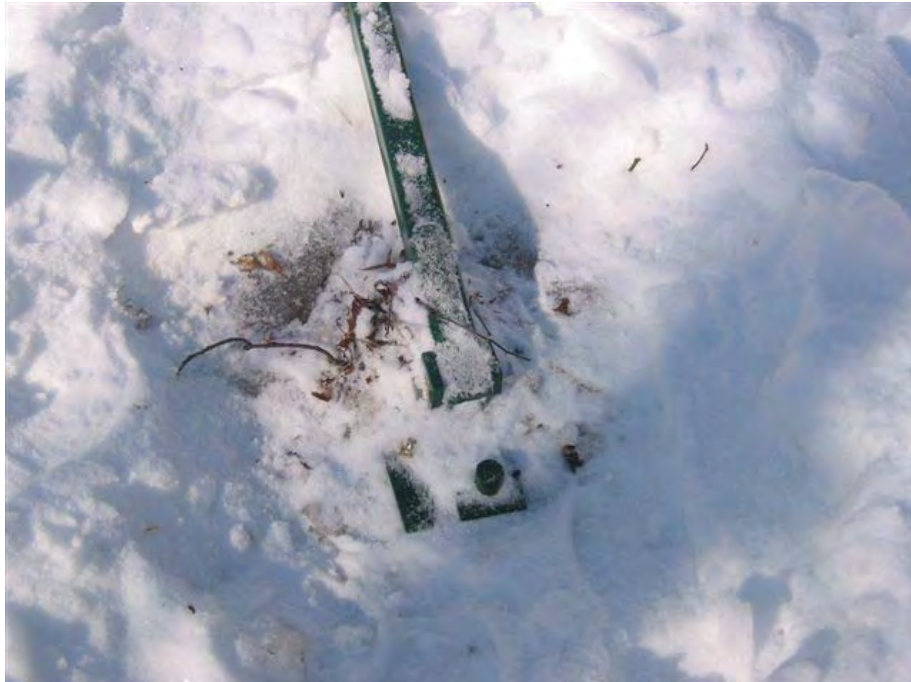
Photo 4: Base plate (12 December 2008)

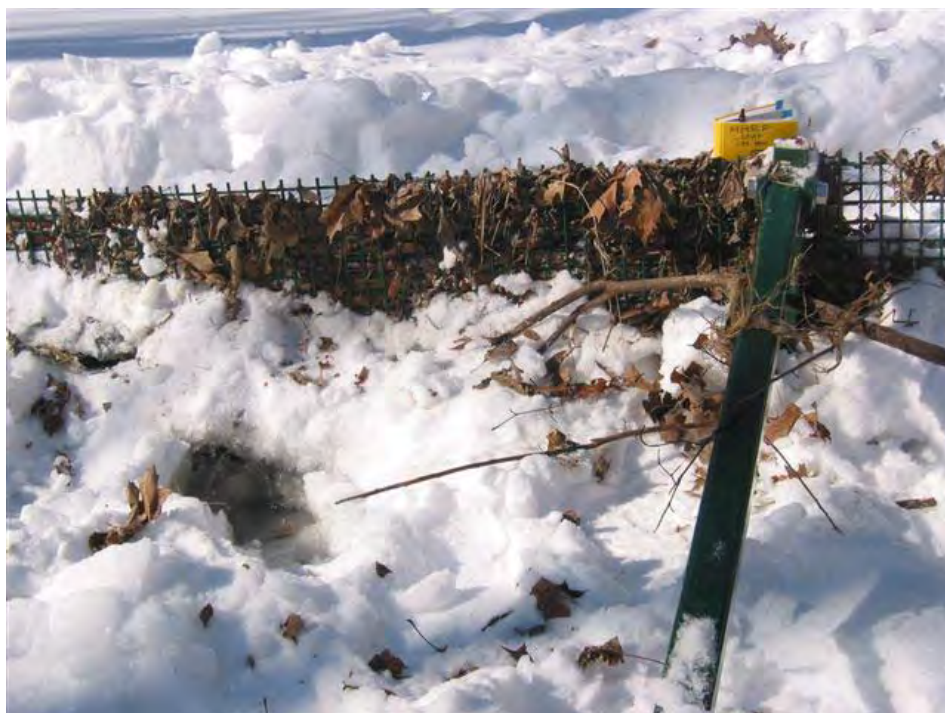
Photo 5: Post, back brace, and screen (12 December 2008)

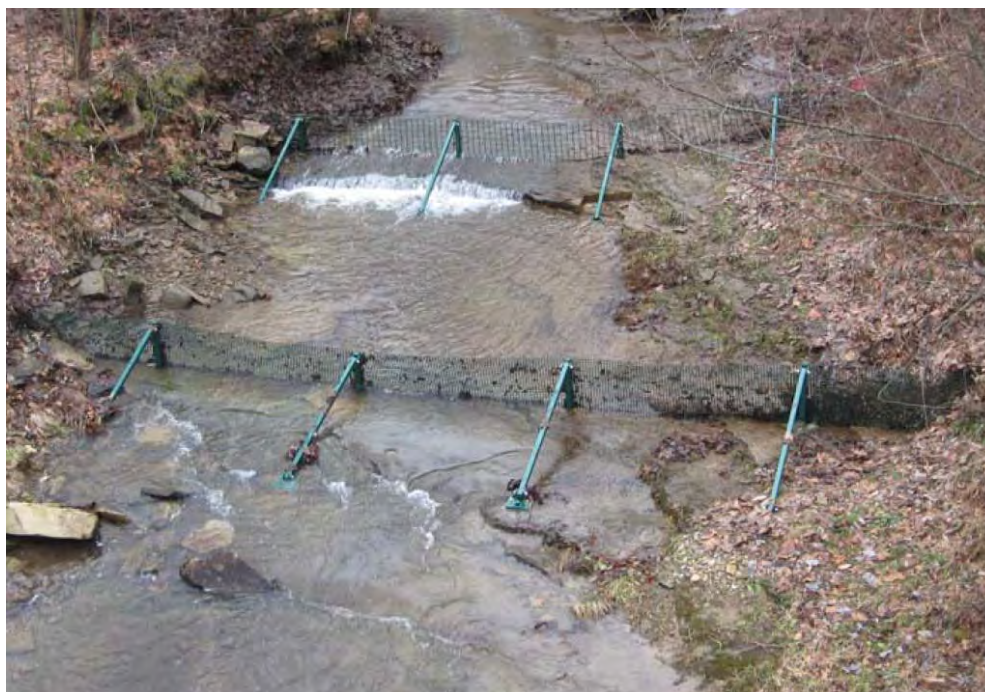
All posts, back braces, and anchor plates appear to be intact and solidly anchored. No gaps have developed between the bottom of the screens and the creek bed. Most of the screen panels have been slightly bowed by water pressure (Photo 6). No significant scouring on the creek banks was observed during the QEE 2 period.

Photo 6: Barrier System after the 16 December 2008 O&M cleaning

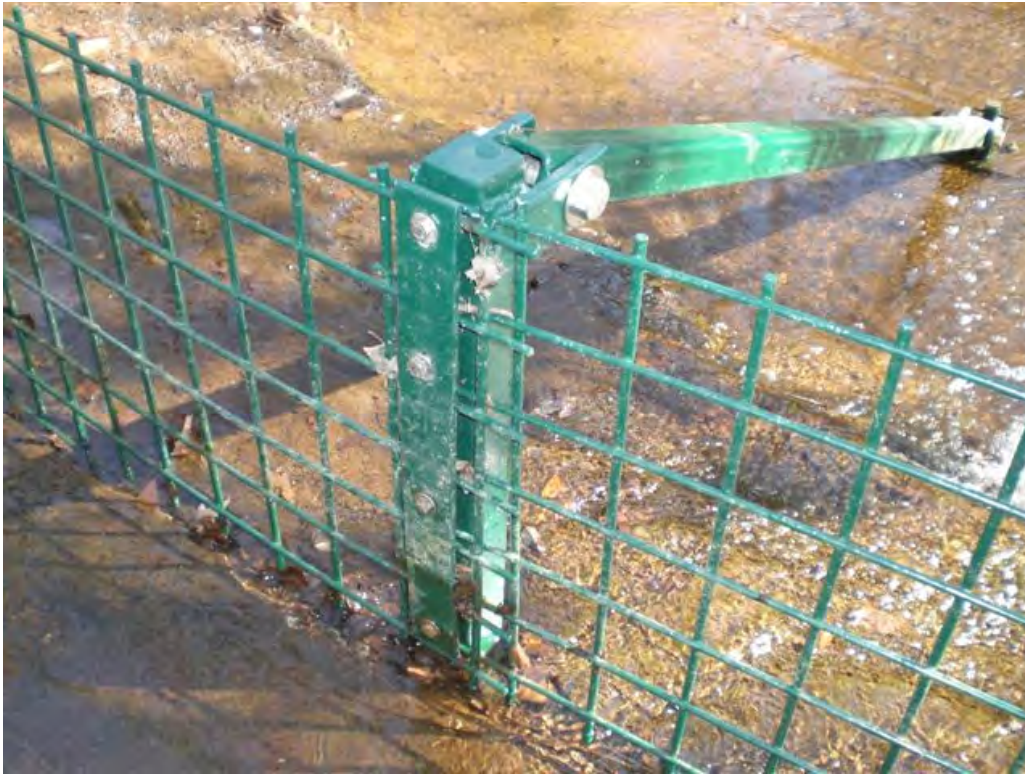
<p><b><u>Barrier System Effectiveness Evaluation</u></b></p> <p><b>Barrier System condition:</b>  All posts, back braces, and anchor plates are intact and solidly anchored (Photos 1 and 2). Most of the screen panels have been slightly bowed by water pressure (Photo 3). During storm events, leaves build up on the screens, generating pressure that increases with water depth. As a result, the maximum screen deflection is observed at the top of the screens. The maximum deflection reaches 2 inches on the 3-inch opening barrier and 4 inches on the 1-inch opening barrier. The difference is due to the larger amount of leaves on the barrier with smaller grid opening. The screen panel deflection appears to have been stabilized within the first couple of months after construction. At the time of the QEE visit, before the O&amp;M debris removal work, the leaves accumulated on the barriers were 7 - 8 inches deep (Photo 4).</p> <p>Creek bank scouring was observed at the south end of each of the two barriers, where the creek is deeper and the creek bank is steep (Photo 5). The scouring features are located</p>

Photo 1: Upstream barrier post and back brace

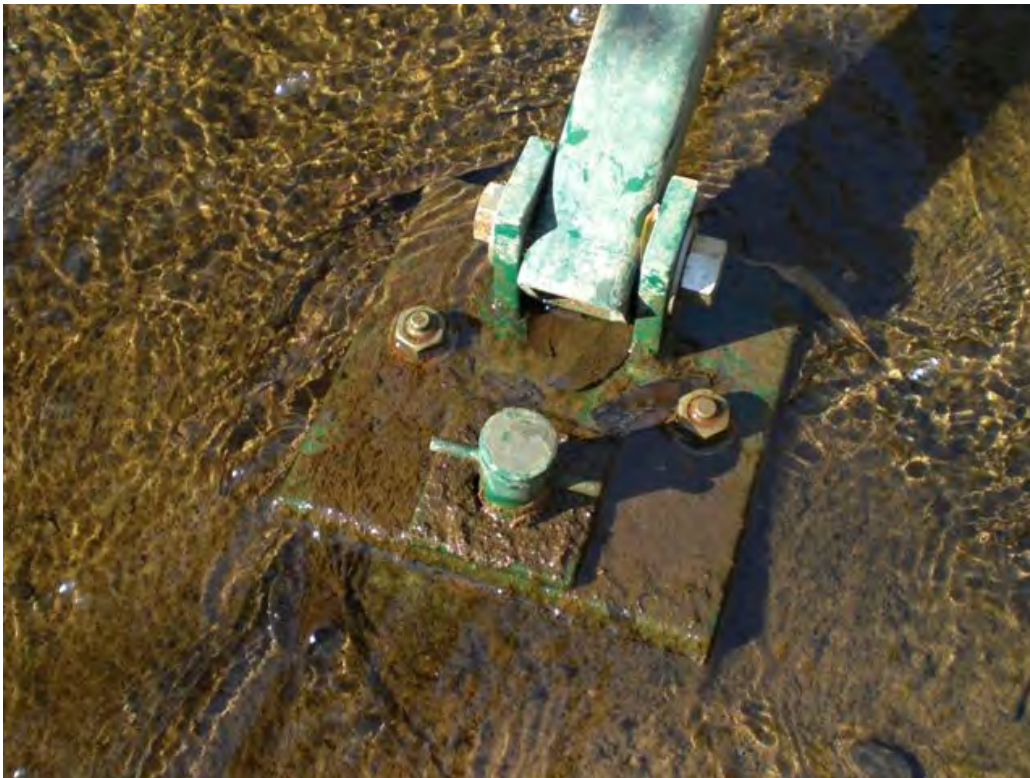
Photo 2: Anchor plate

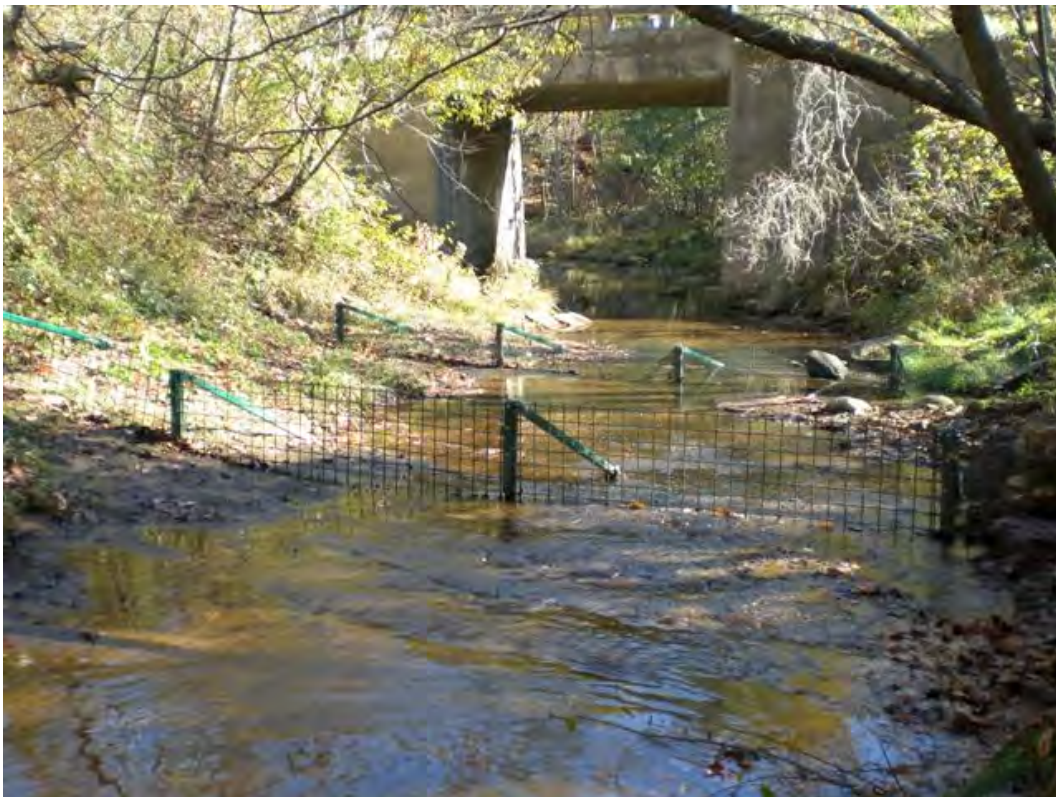
In the first three months of operation, the Barrier System has effectively performed as designed (Photos 6 and 7).

Photo 6: Barrier System, looking downstream

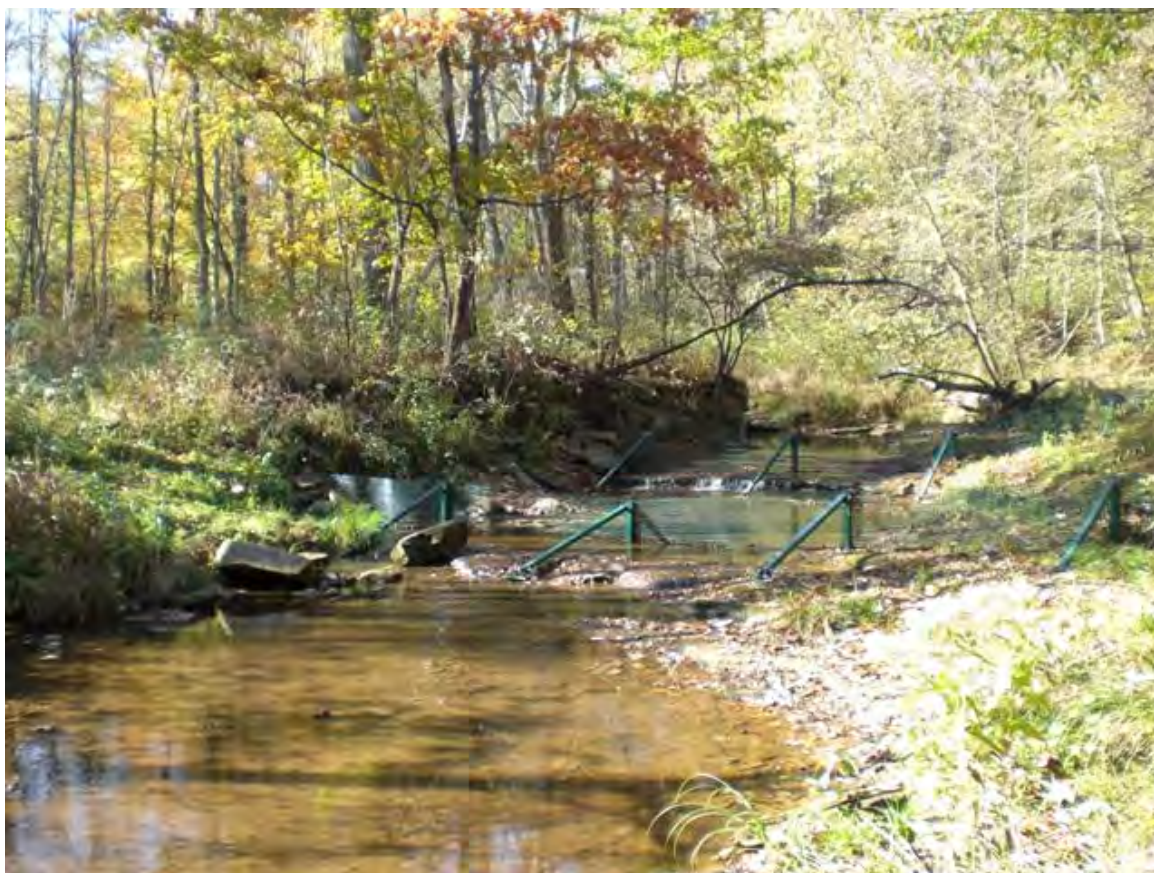
Photo 7: Barrier System, looking upstream
