CY 2011

Operations and Maintenance Trip Reports and Quarterly Effectiveness
Evaluation Reports Time Critical Response Action for the Rocket Ridge
Area at RVAAP-004-R-01 Open Demolition Area #2

Trip Report

Quarterly Effectiveness Evaluation Report
Sand Creek Barrier System
Time Critical Response Action (TCRA) for the Rocket Ridge Area of
Open Demolition Area #2

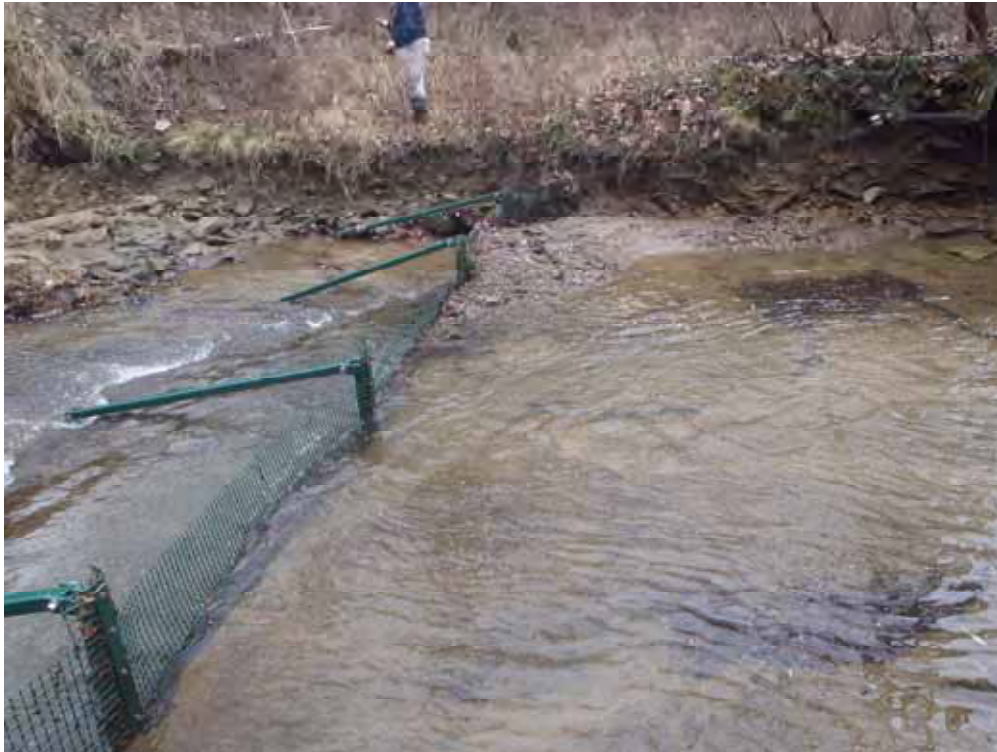
PICTURE SHOWING SILT BEGINNING TO ACCUMULATE DOWNSTREAM BARRIER (LEFT SIDE).

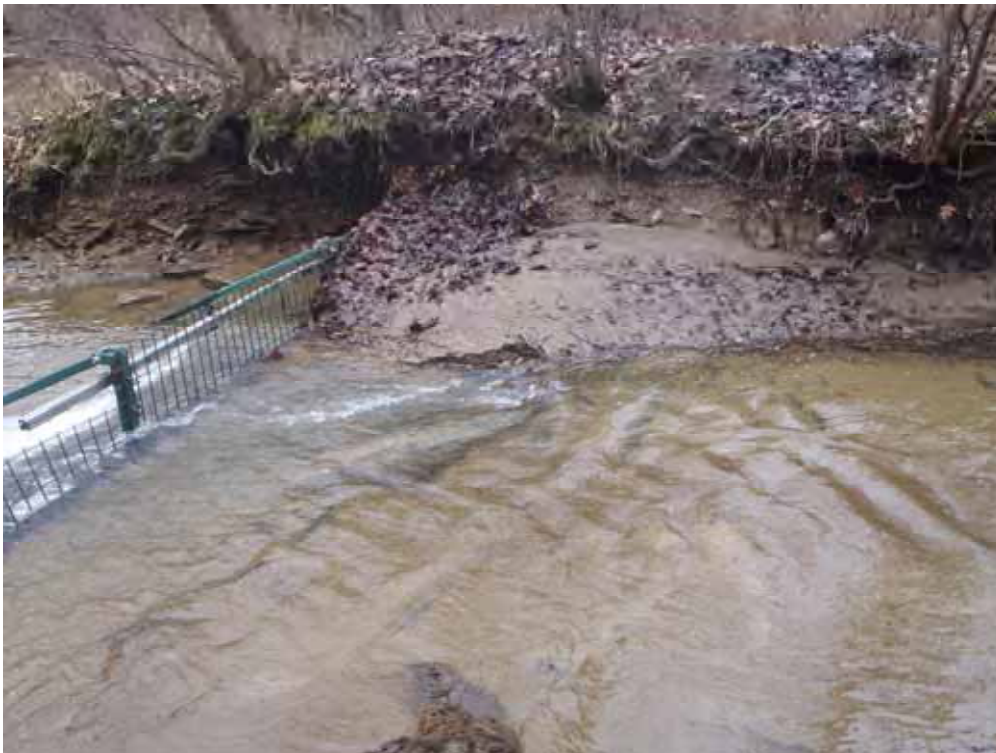
PICTURE SHOWING SILT BEGINNING TO ACCUMULATE UPSTREAM BARRIER (RIGHT SIDE).

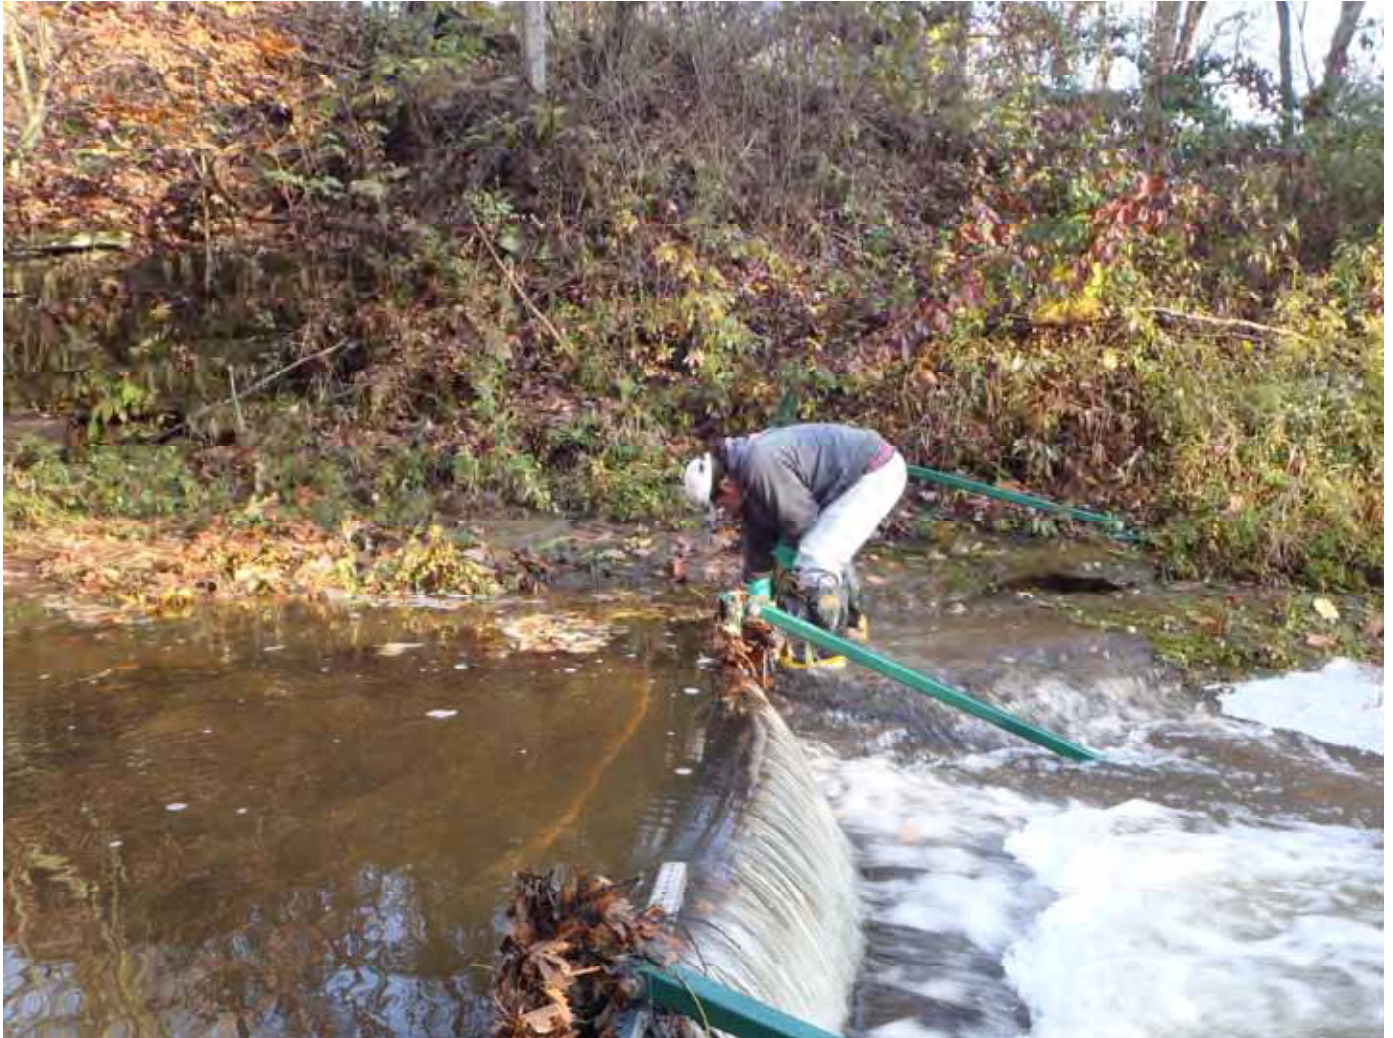
PICTURE SHOWING UXO TECHNICIAN REMOVING ACCUMULATED DEBRIS FROM BARRIER

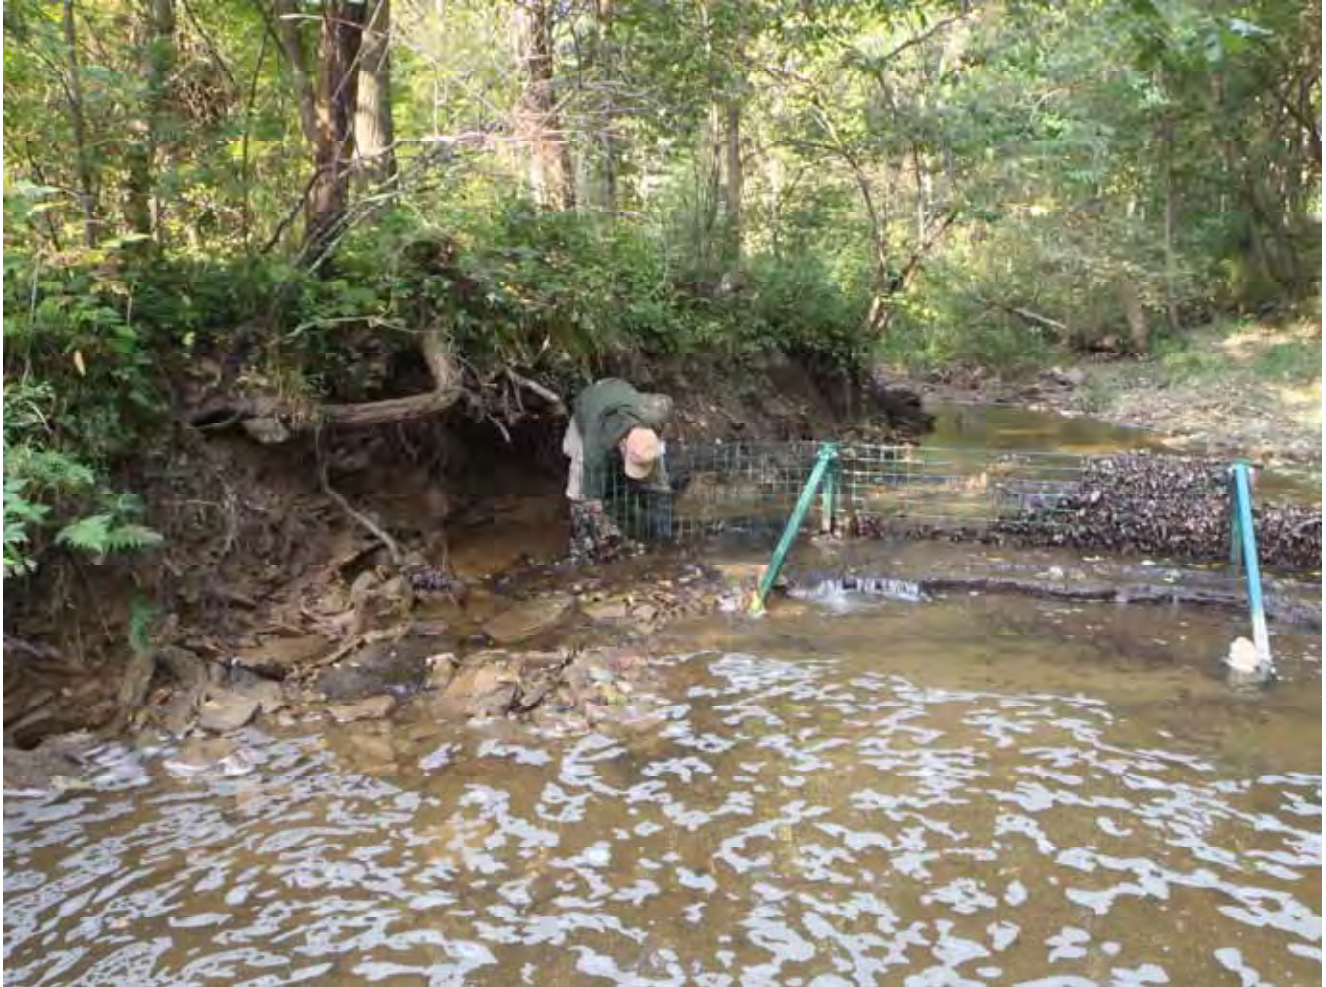
PICTURES SHOWING UXO TECHNICIAN REMOVING ACCUMULATED DEBRIS FROM BARRIER

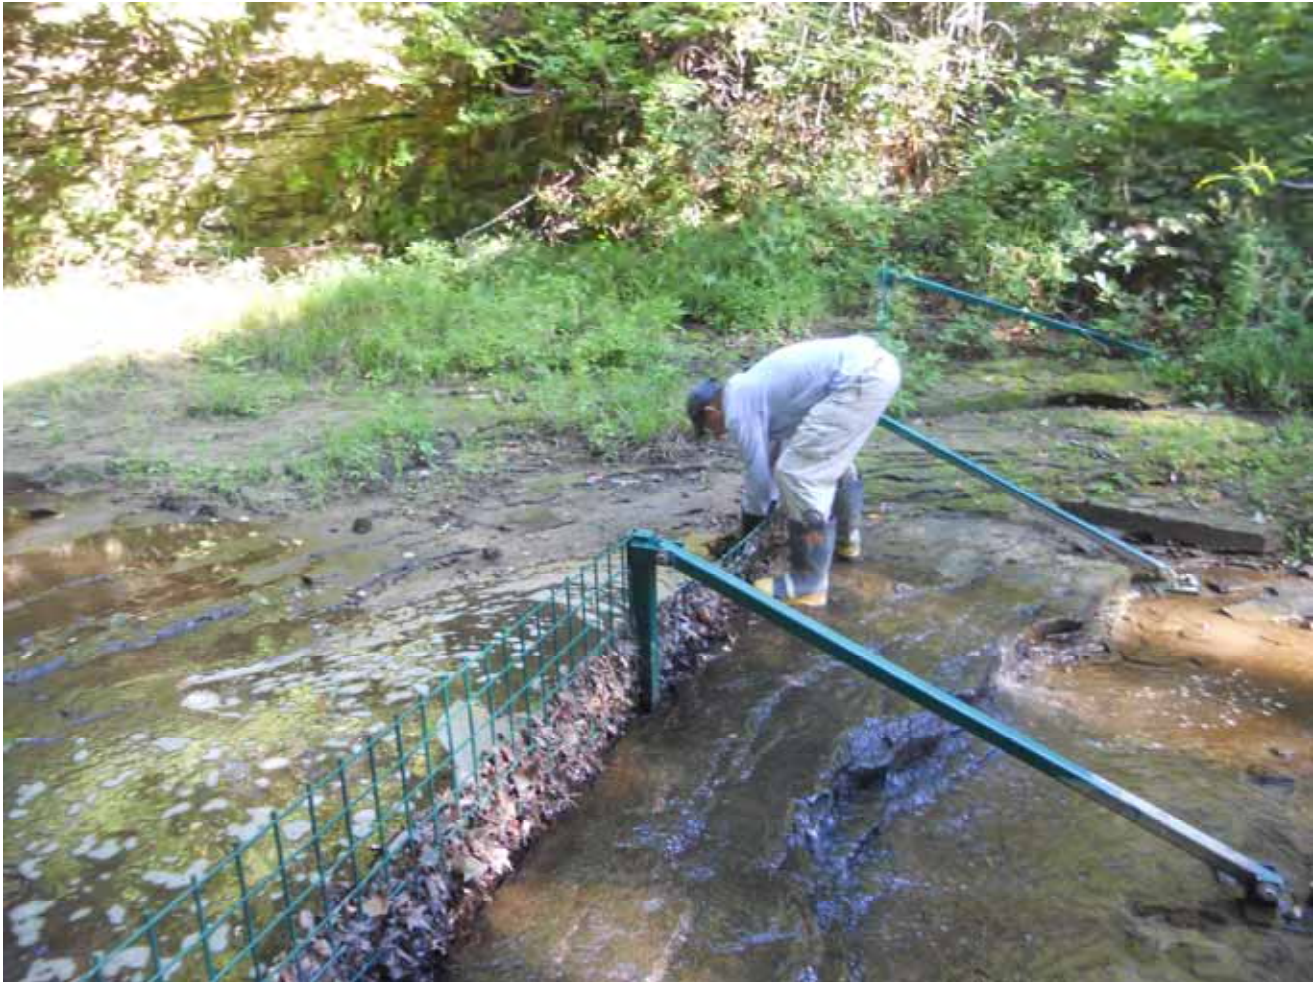
PICTURES SHOWING UXO TECHNICIAN REMOVING ACCUMULATED DEBRIS FROM BARRIER

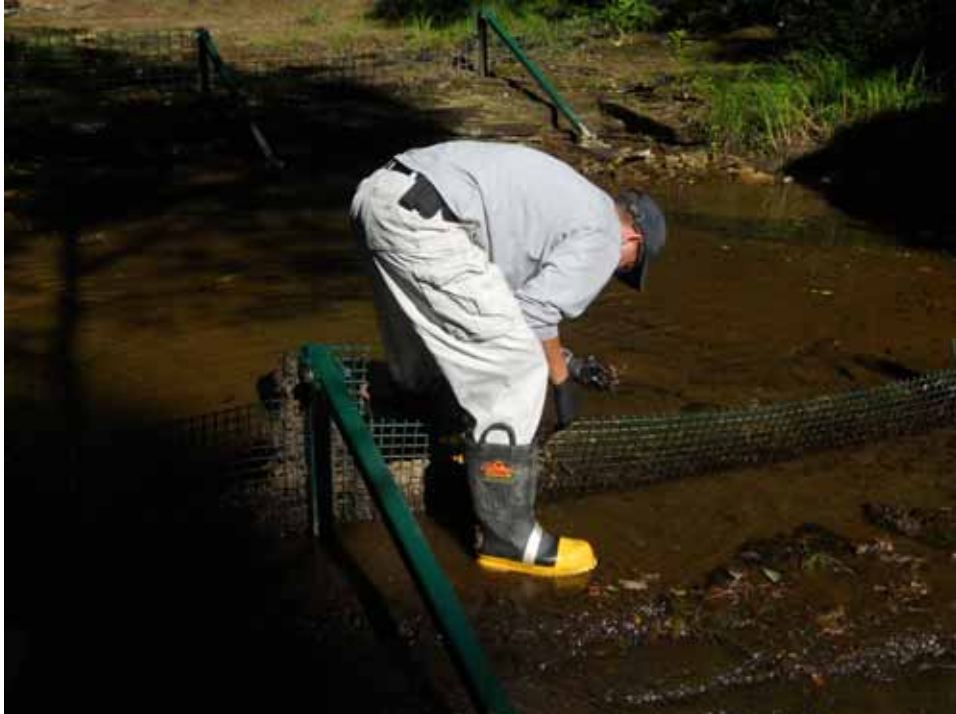
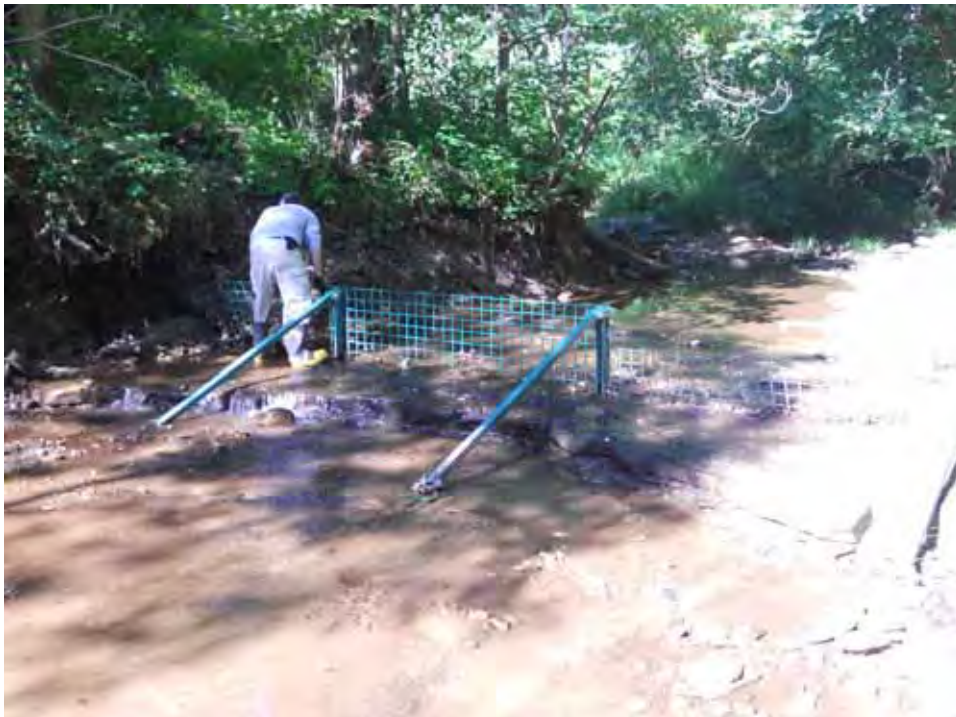
PICTURES SHOWING UXO TECHNICIAN REMOVING ACCUMULATED DEBRIS FROM BARRIER

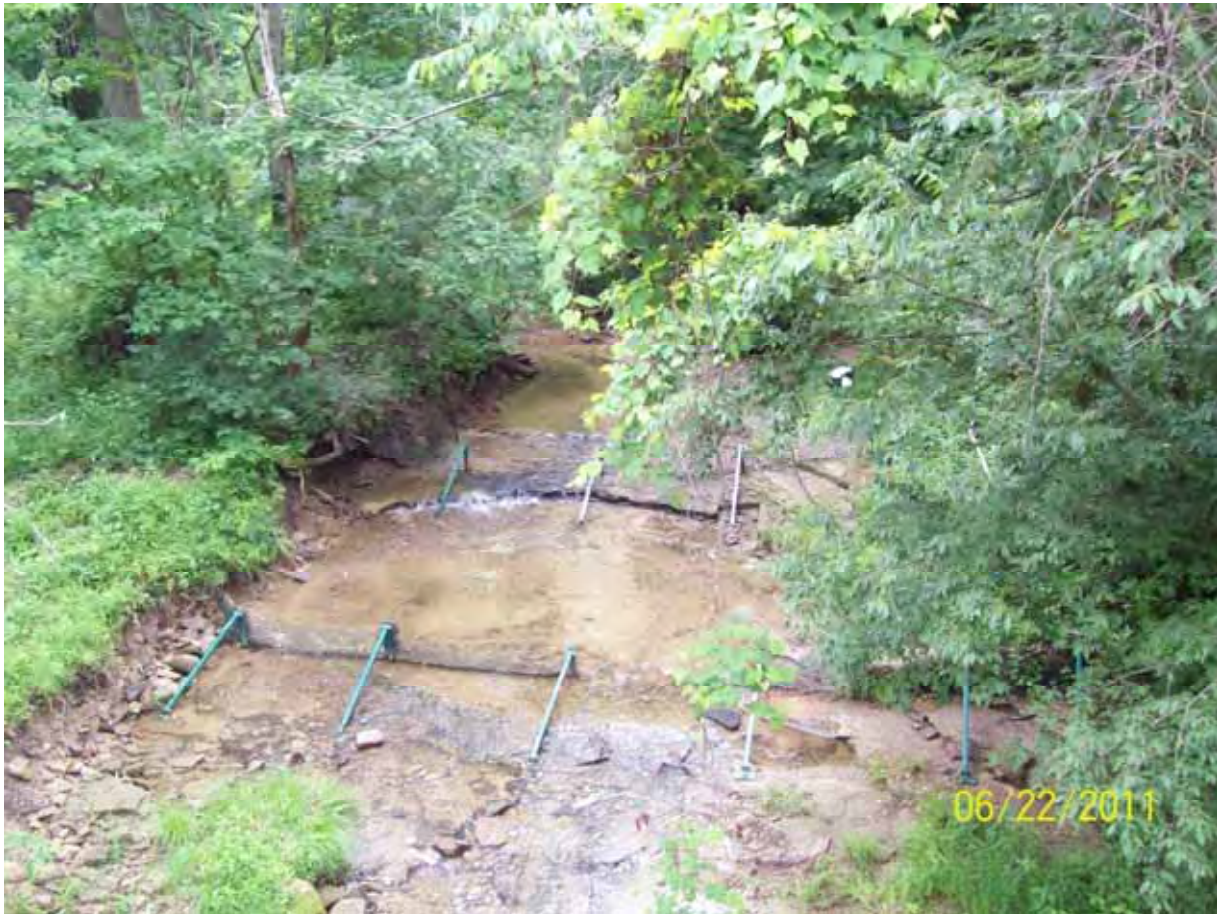
PICTURES SHOWING BARRIERS AFTER REPAIRS

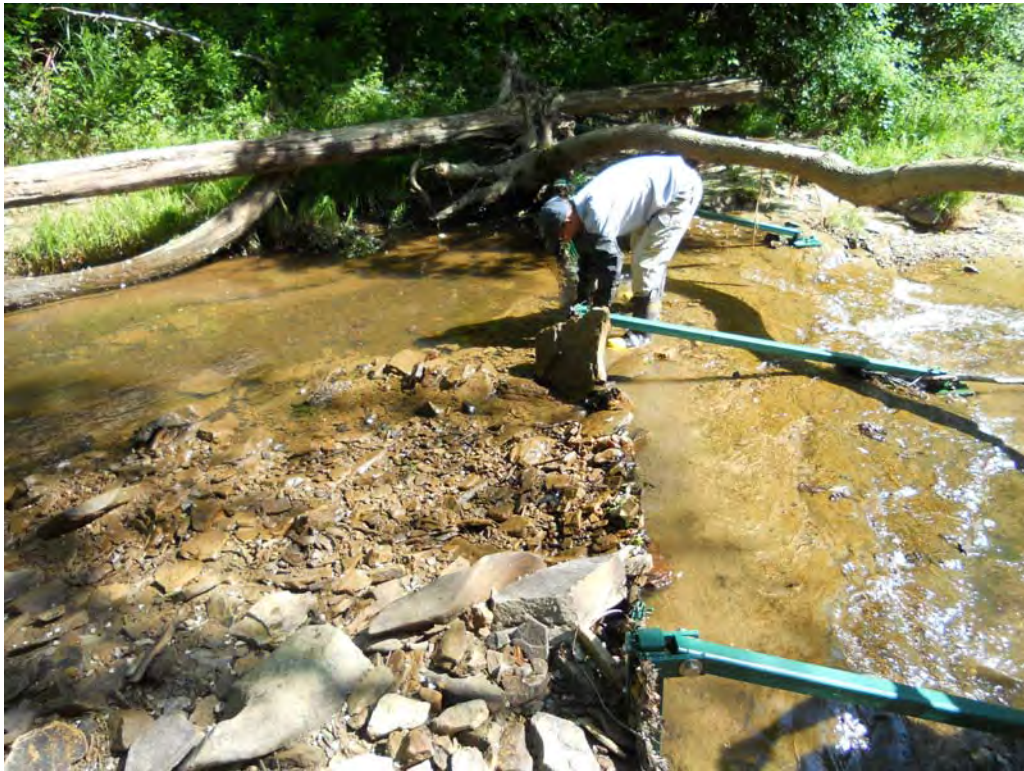
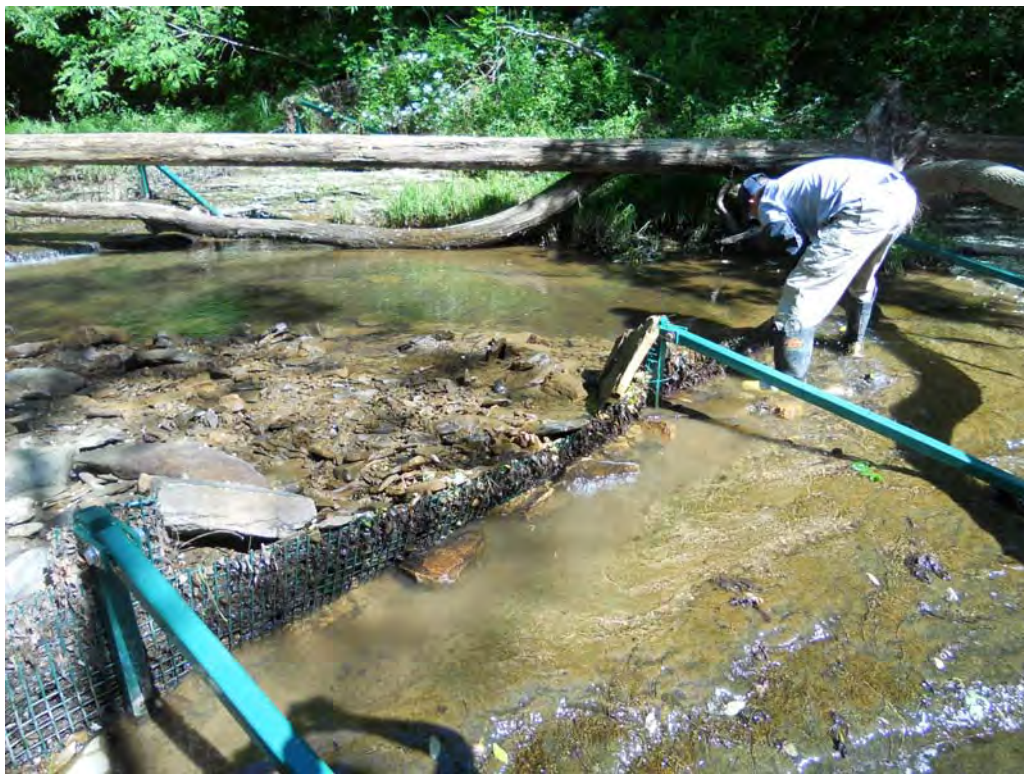
PICTURES SHOWING UXO PERSONNEL CLEANING DEBRIS FROM BARRIERS

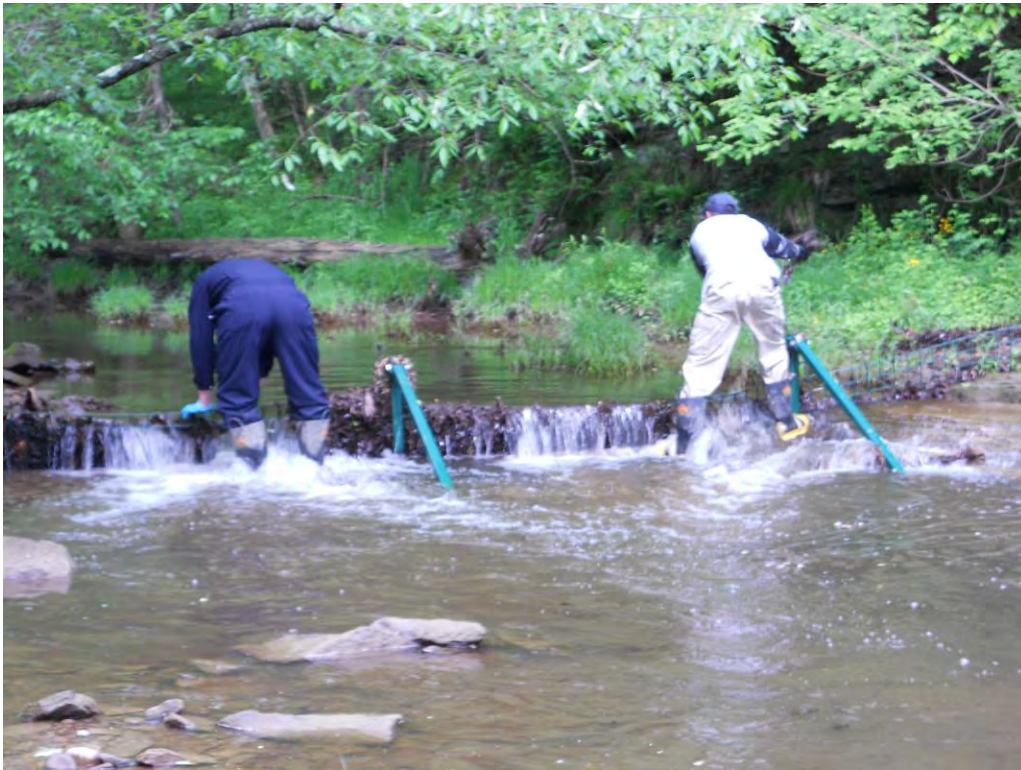
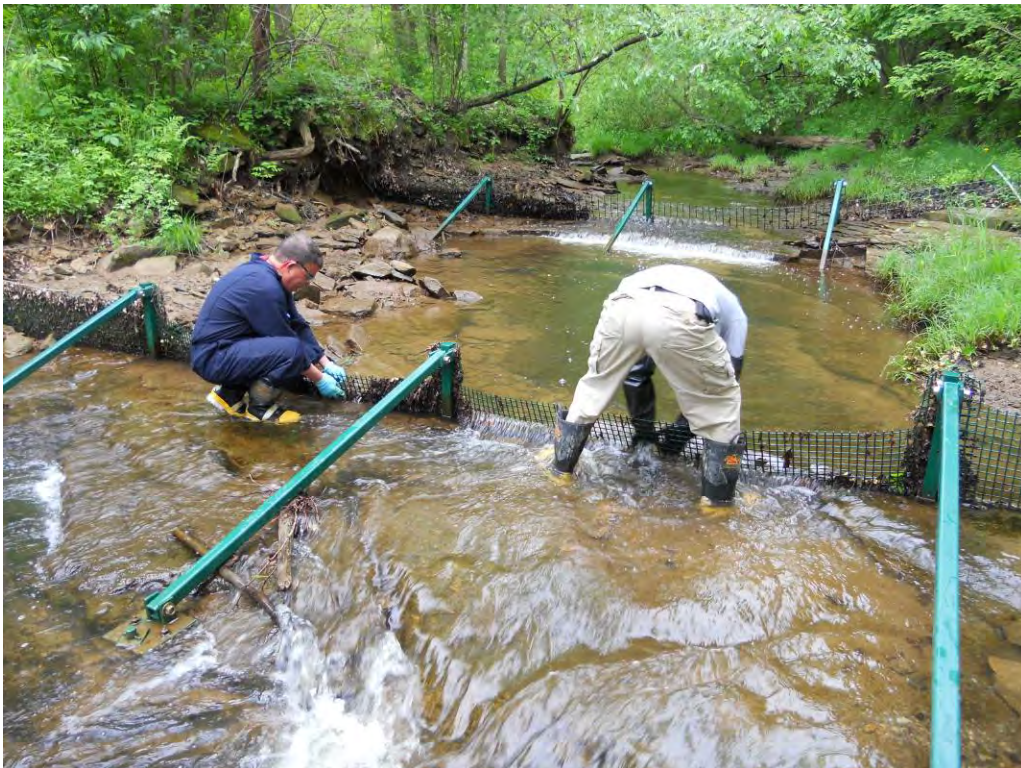
PICTURES SHOWING UXO TECHNICIANS REMOVING DEBRIS FROM BARRIERS.

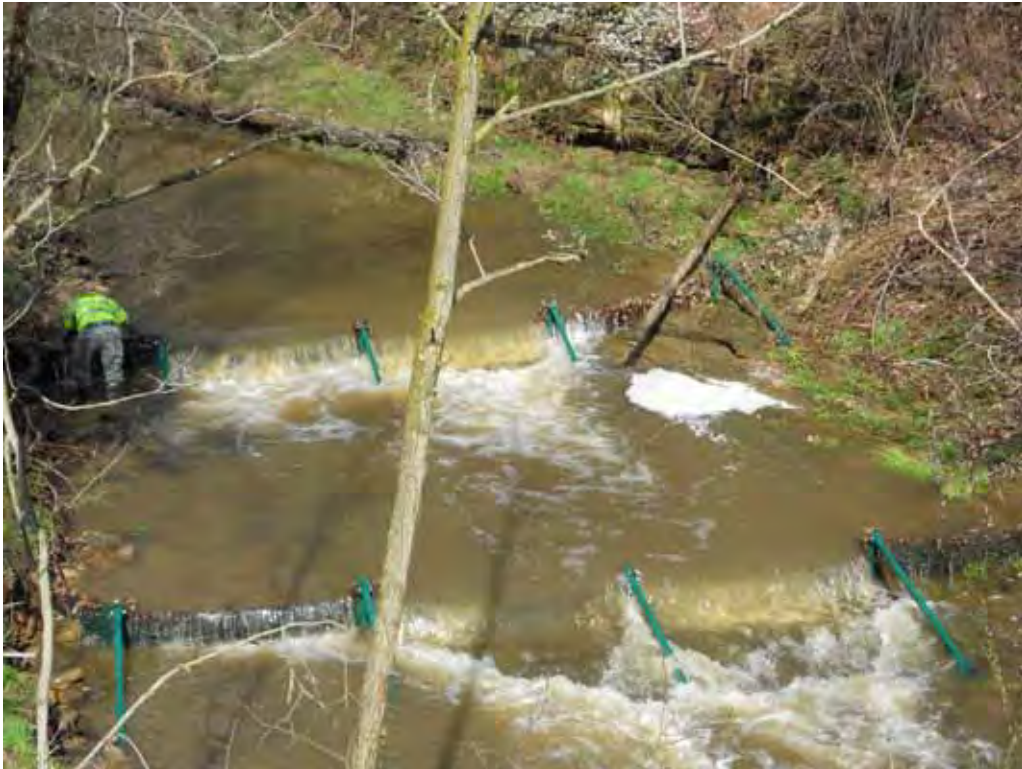
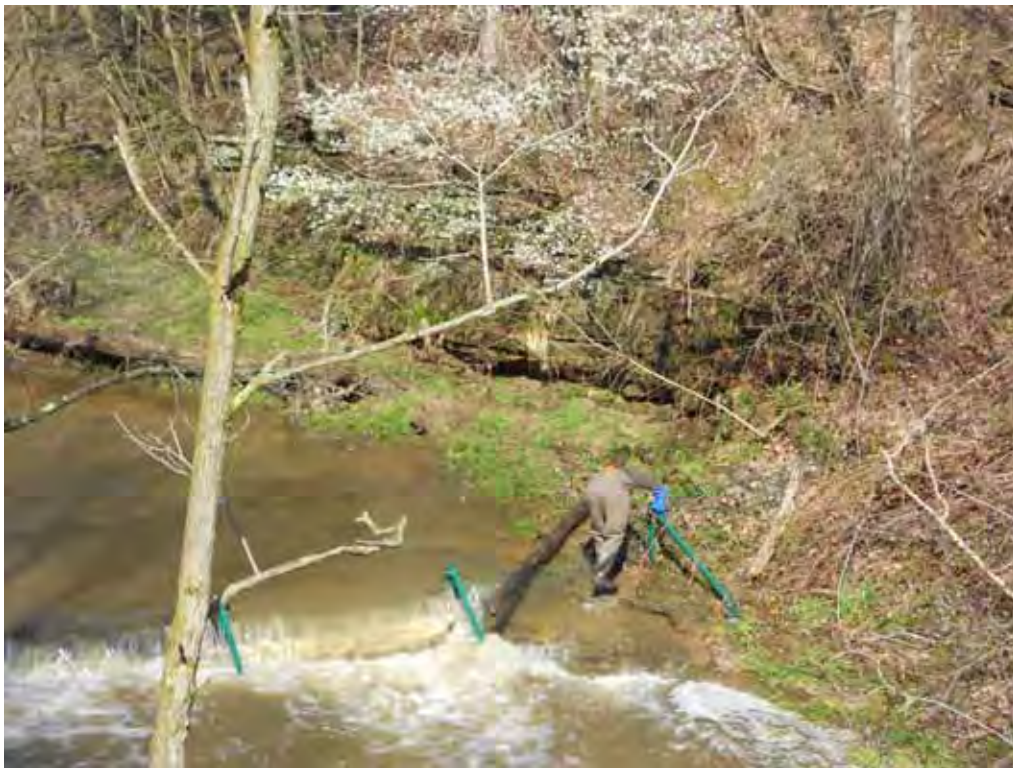
PICTURE SHOWING UXO TECHNICIAN REMOVING DEBRIS FROM BARRIERS.

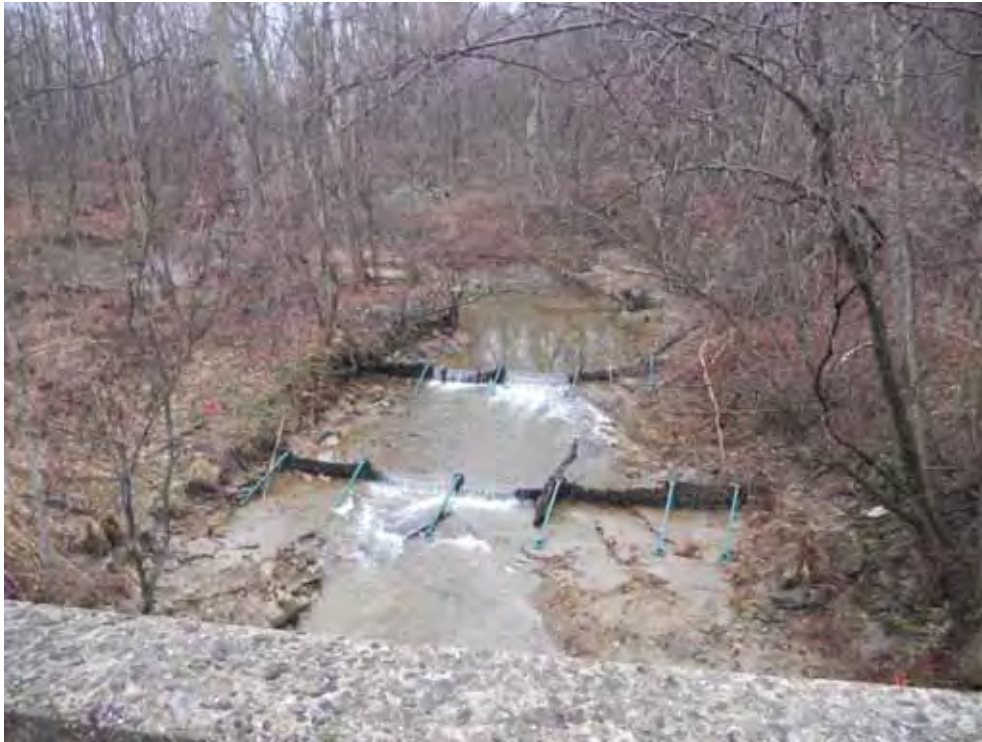
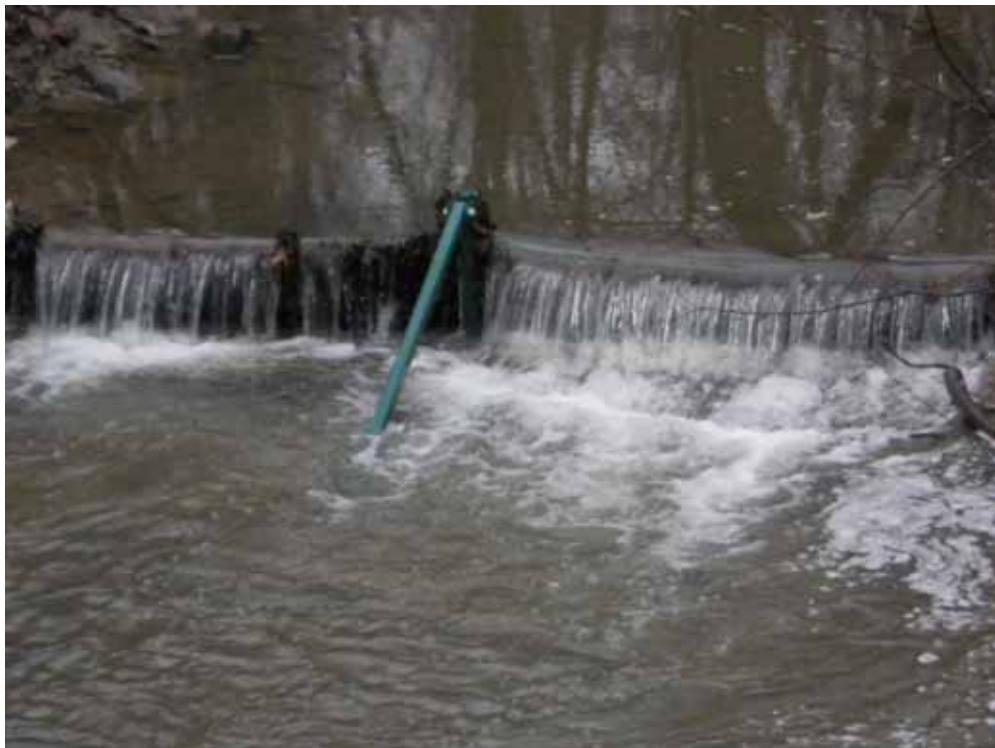
PICTURES OF SAND CREEK BARRIERS UPON ARRIVAL.

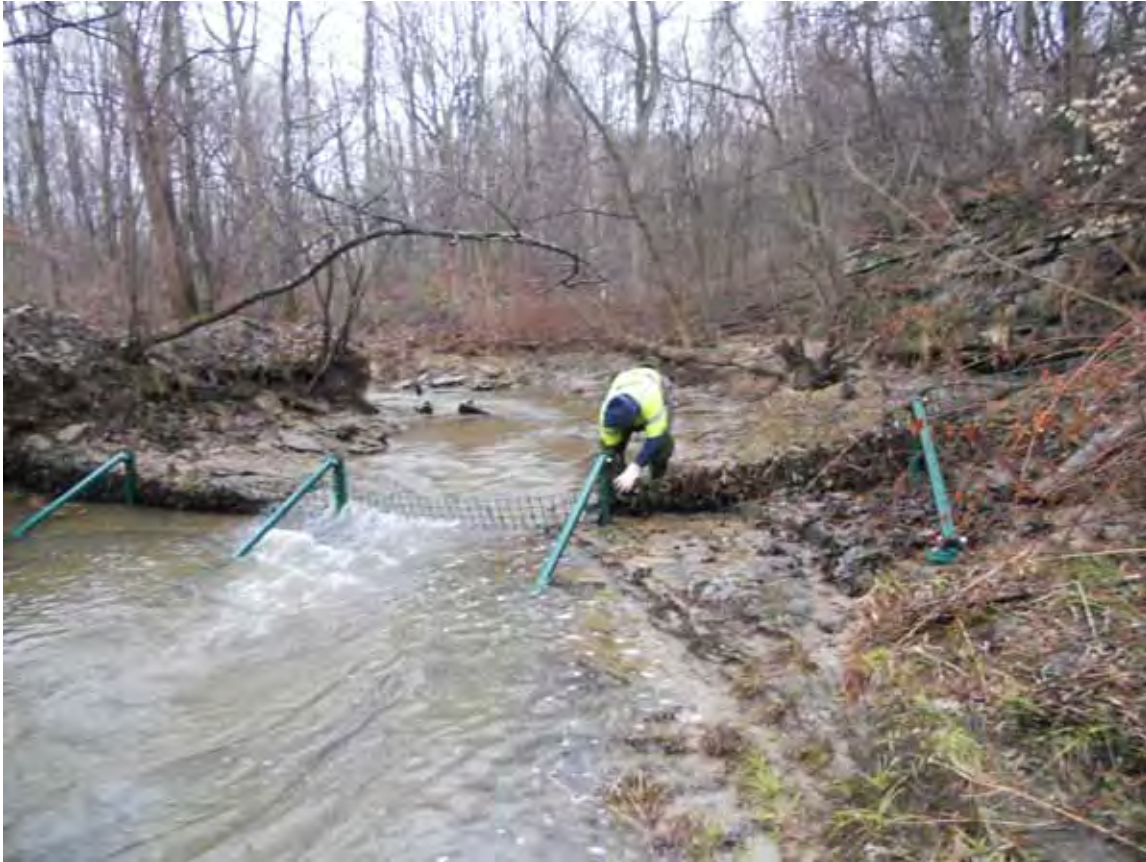
PICTURING SHOWING UXO TECHNICIAN REMOVING DEBRIS FROM BARRIER.

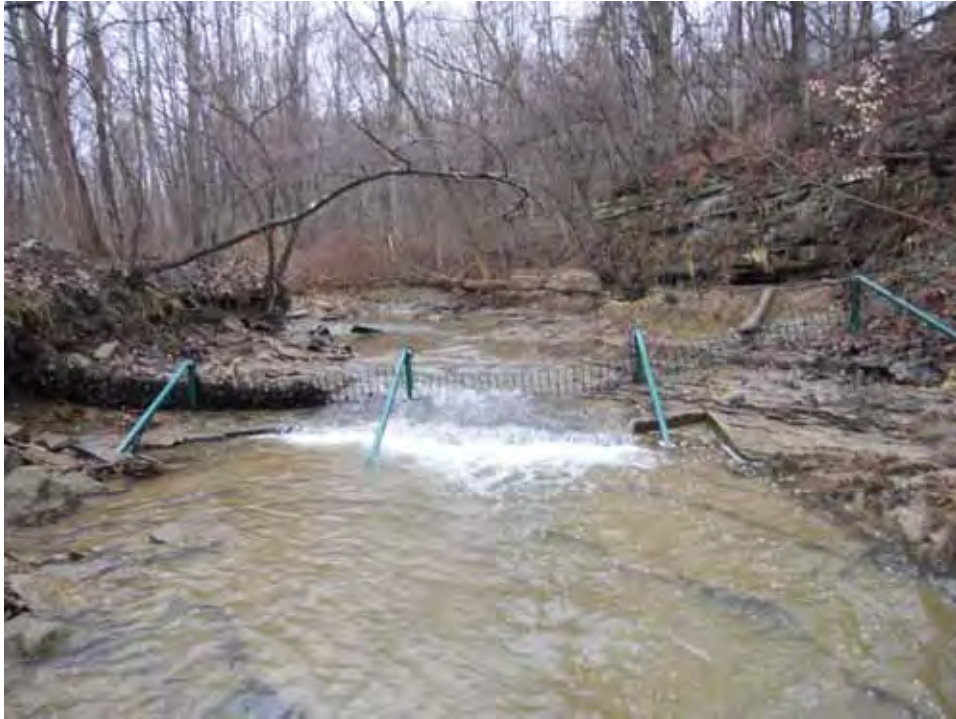
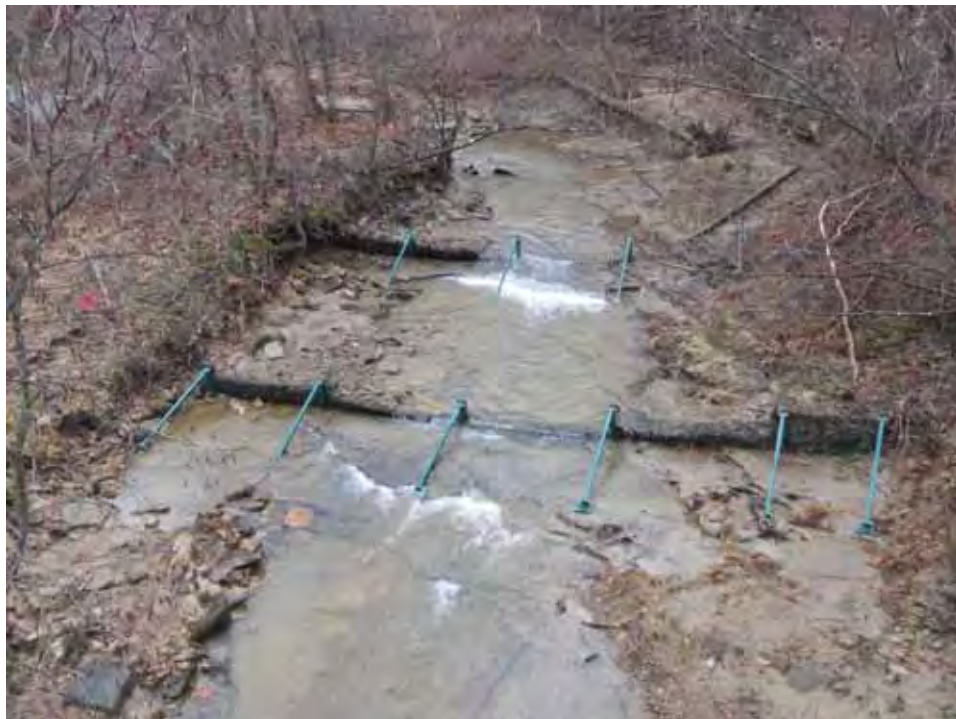
OVERVIEW OF BARRIERS UPON DEPARTURE.

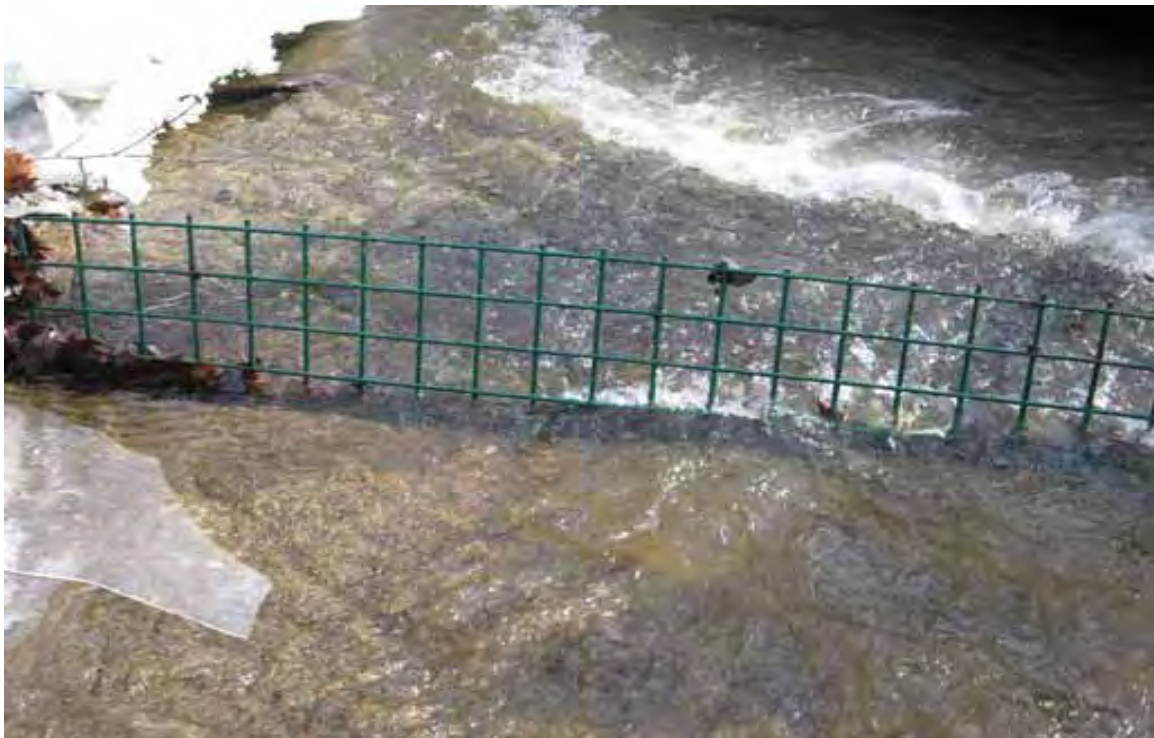
Barrier integrity: Barrier screens are bowed due to water pressure on leaves-covered screens. No broken or cracked barrier structure components were observed. (See photos)

CLOSEUP OF UPSTREAM BARRIER FOLLOWING CLEANUP.

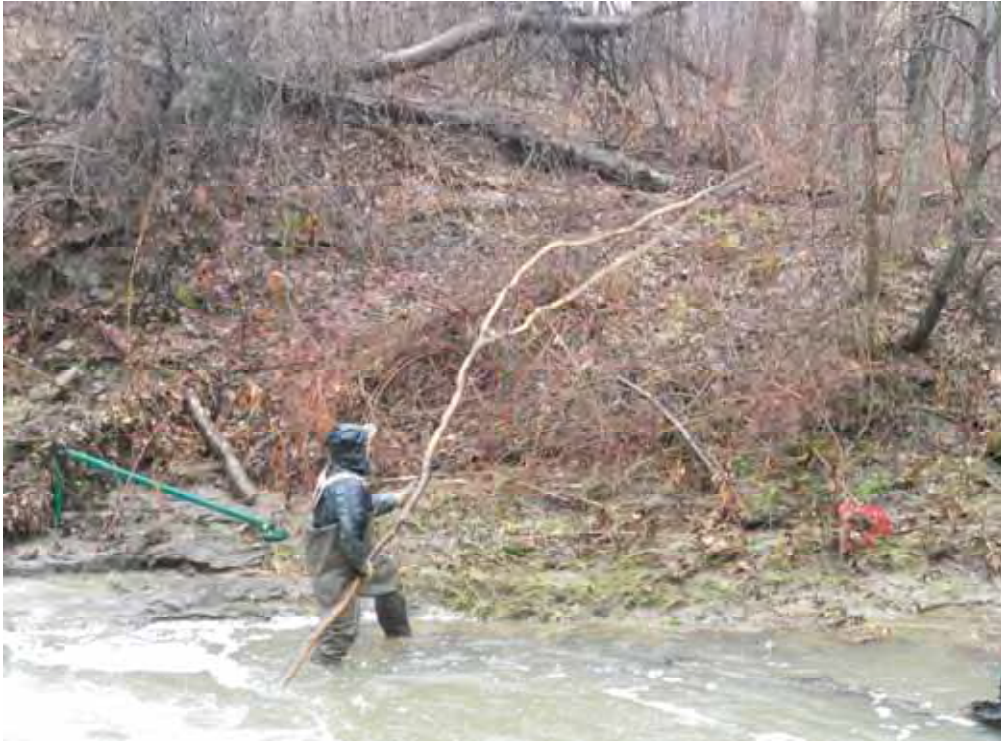
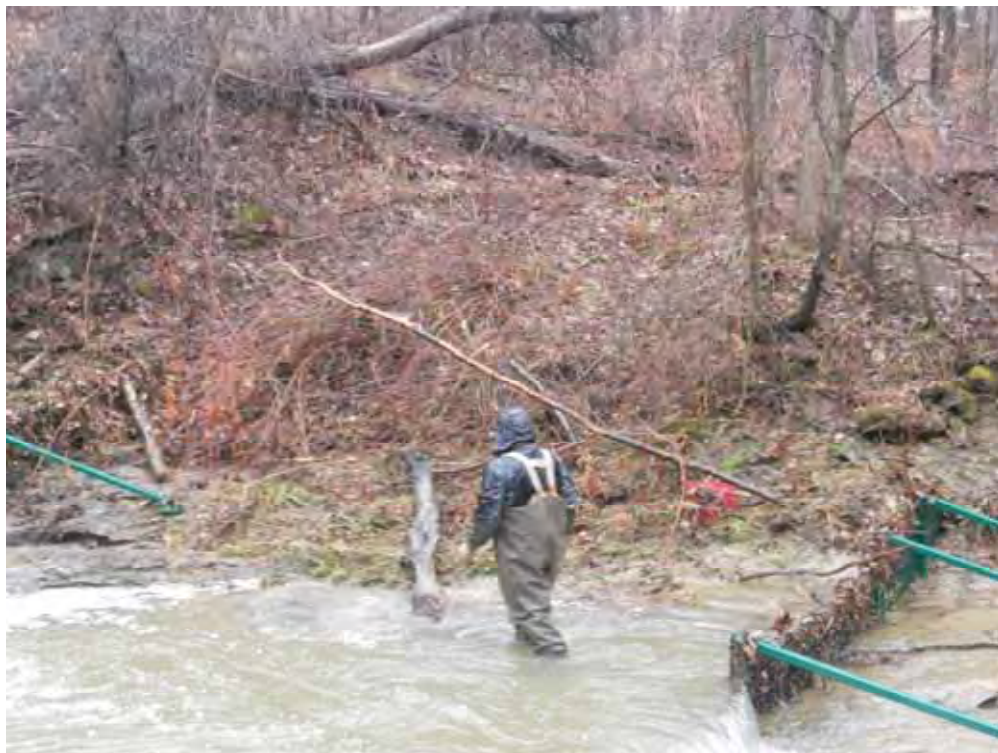
PICTURING SHOWING UXO TECHNICIAN REMOVING DEBRIS FROM BARRIER.

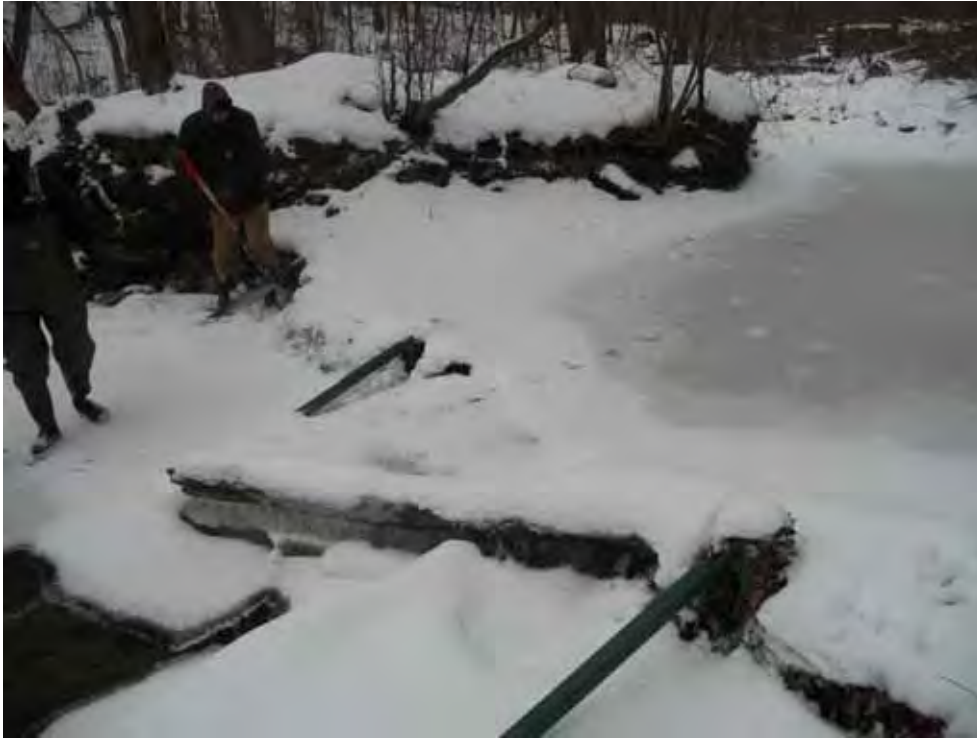
LOG LODGED IN UPSTREAM BARRIER

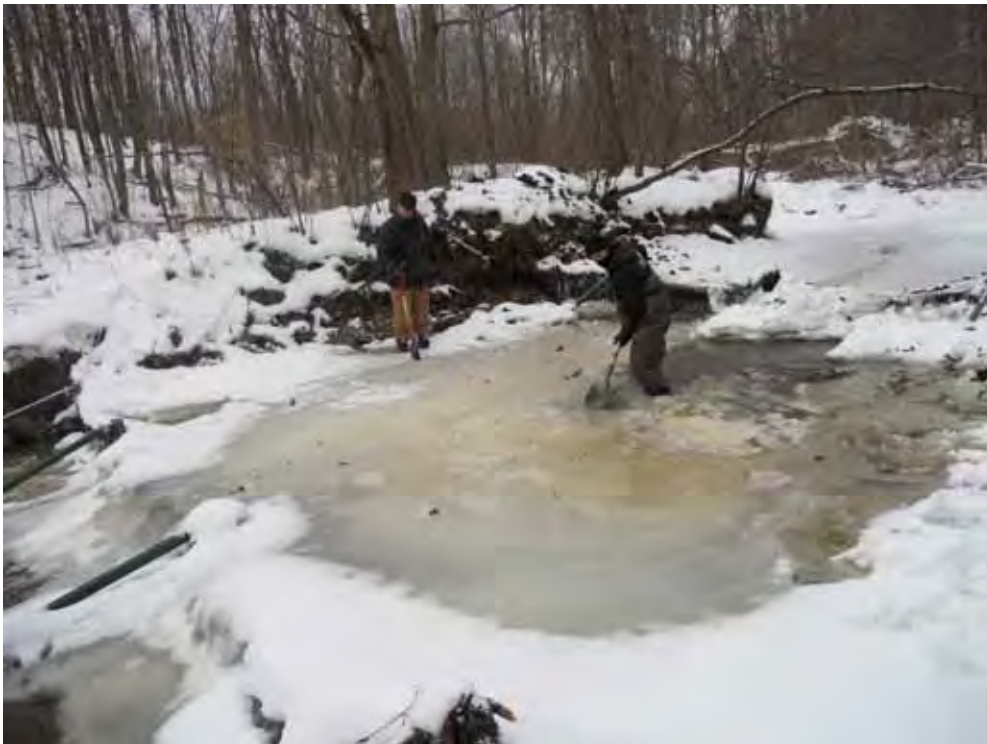
LOG REMOVED FROM UPSTREAM BARRIER

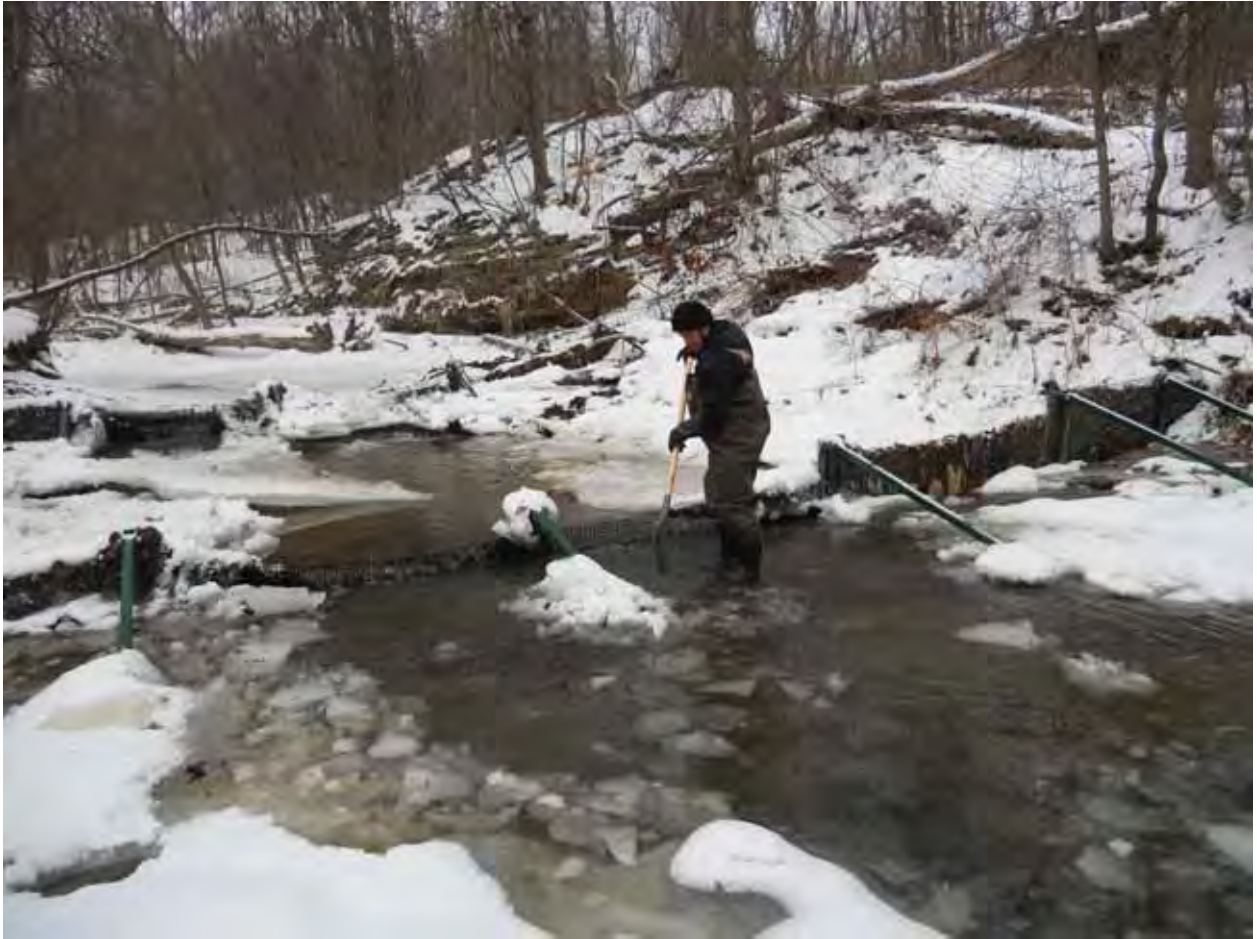
REMOVING ACCUMULATED DEBRIS, ICE AND SNOW FROM BARRIER.

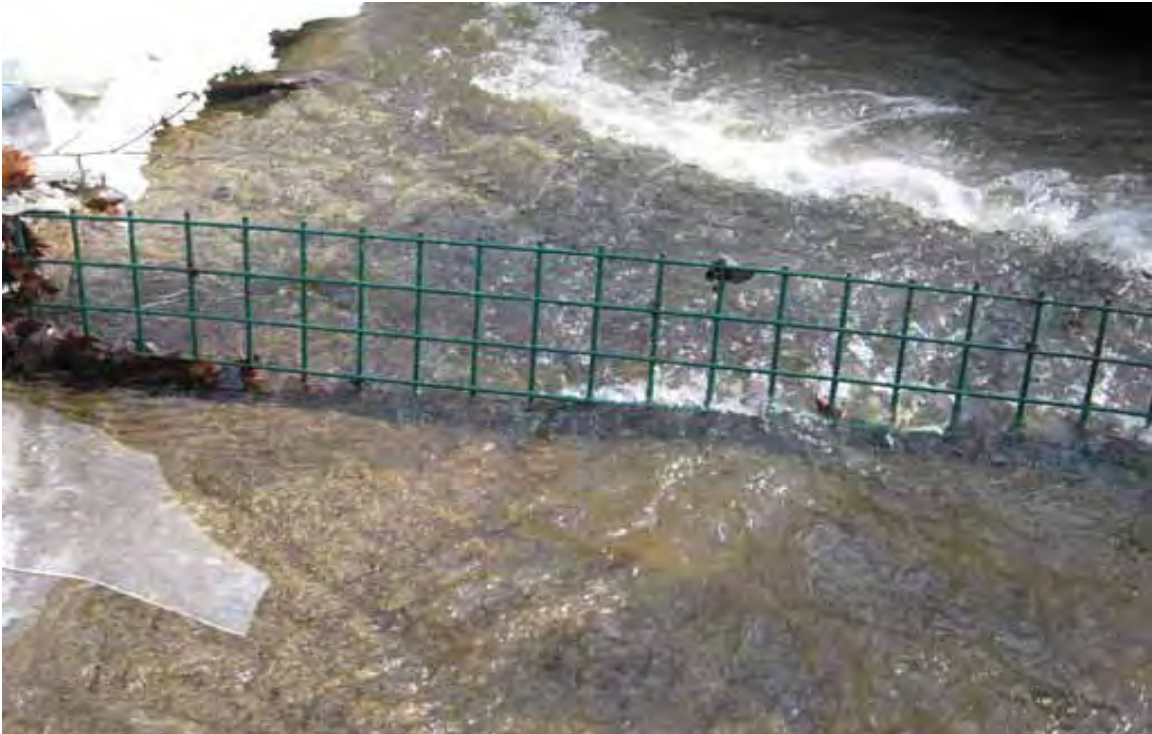
Barrier integrity: Barrier screens are bowed due to water pressure on leaves-covered screens. No broken or cracked barrier structure components were observed. See photos.

CLOSEUP OF UPSTREAM BARRIER FOLLOWING CLEANUP.
