CY 2011

Operations and Maintenance Trip Reports and Quarterly Effectiveness
Evaluation Reports Time Critical Response Action for the Rocket Ridge
Area at RVAAP-004-R-01 Open Demolition Area #2

Trip Report

Quarterly Effectiveness Evaluation Report
Sand Creek Barrier System
Time Critical Response Action (TCRA) for the Rocket Ridge Area of
Open Demolition Area #2

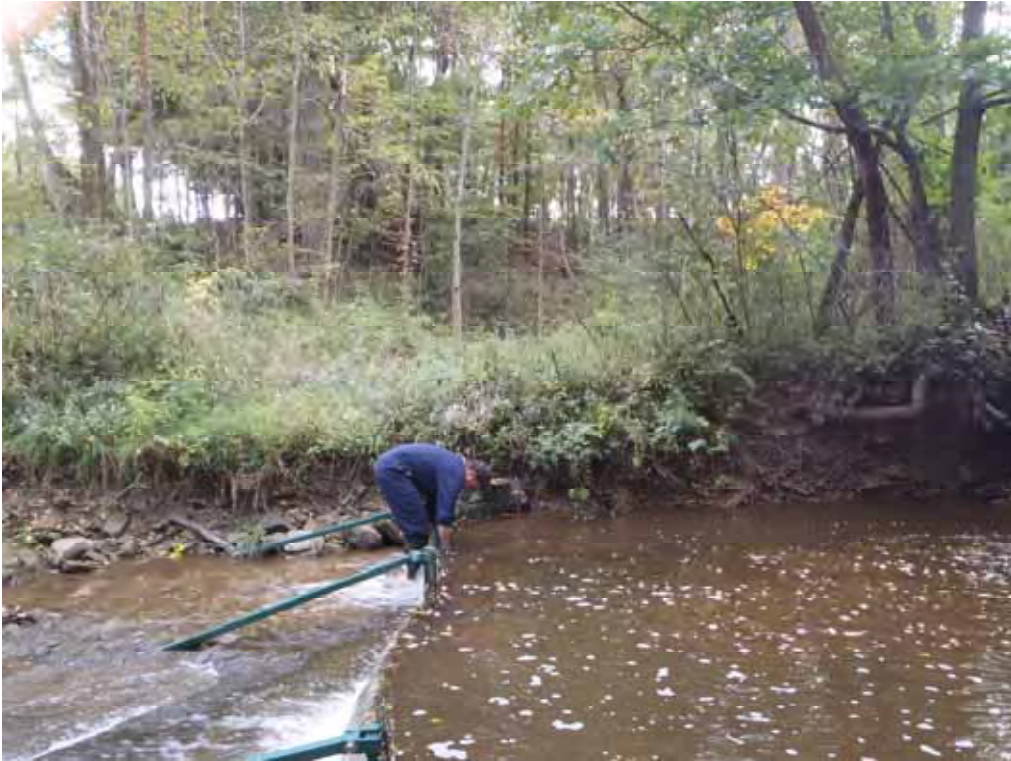
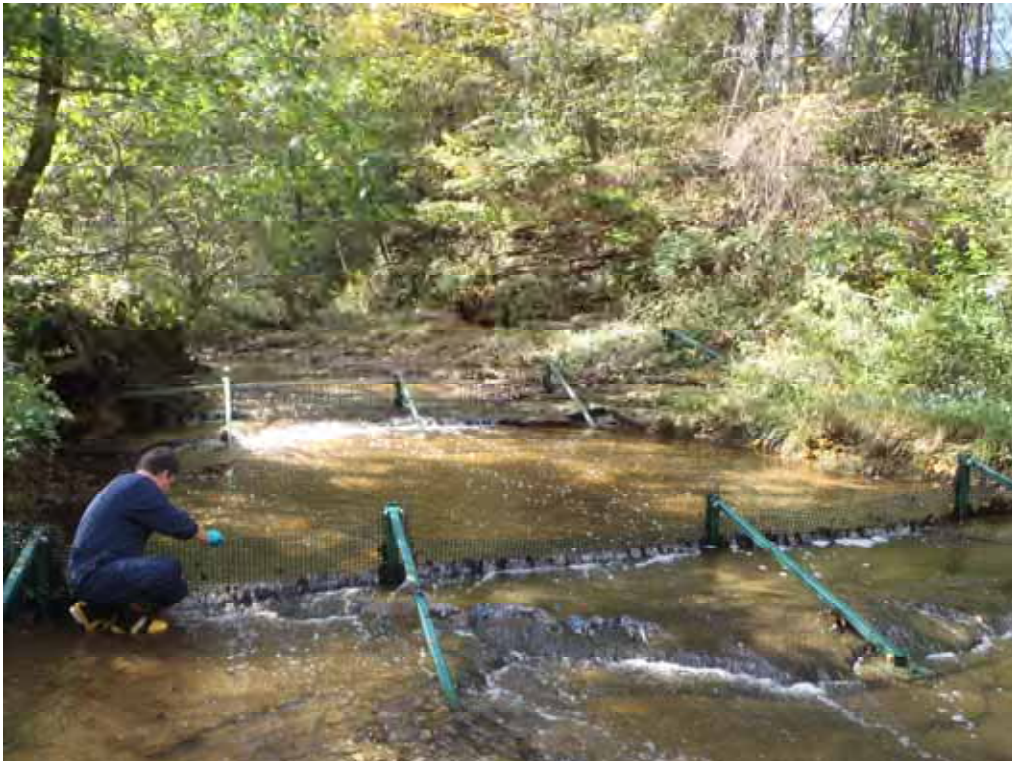
PICTURES SHOWING UXO TECHNICIAN REMOVING ACCUMULATED DEBRIS FROM BARRIERS

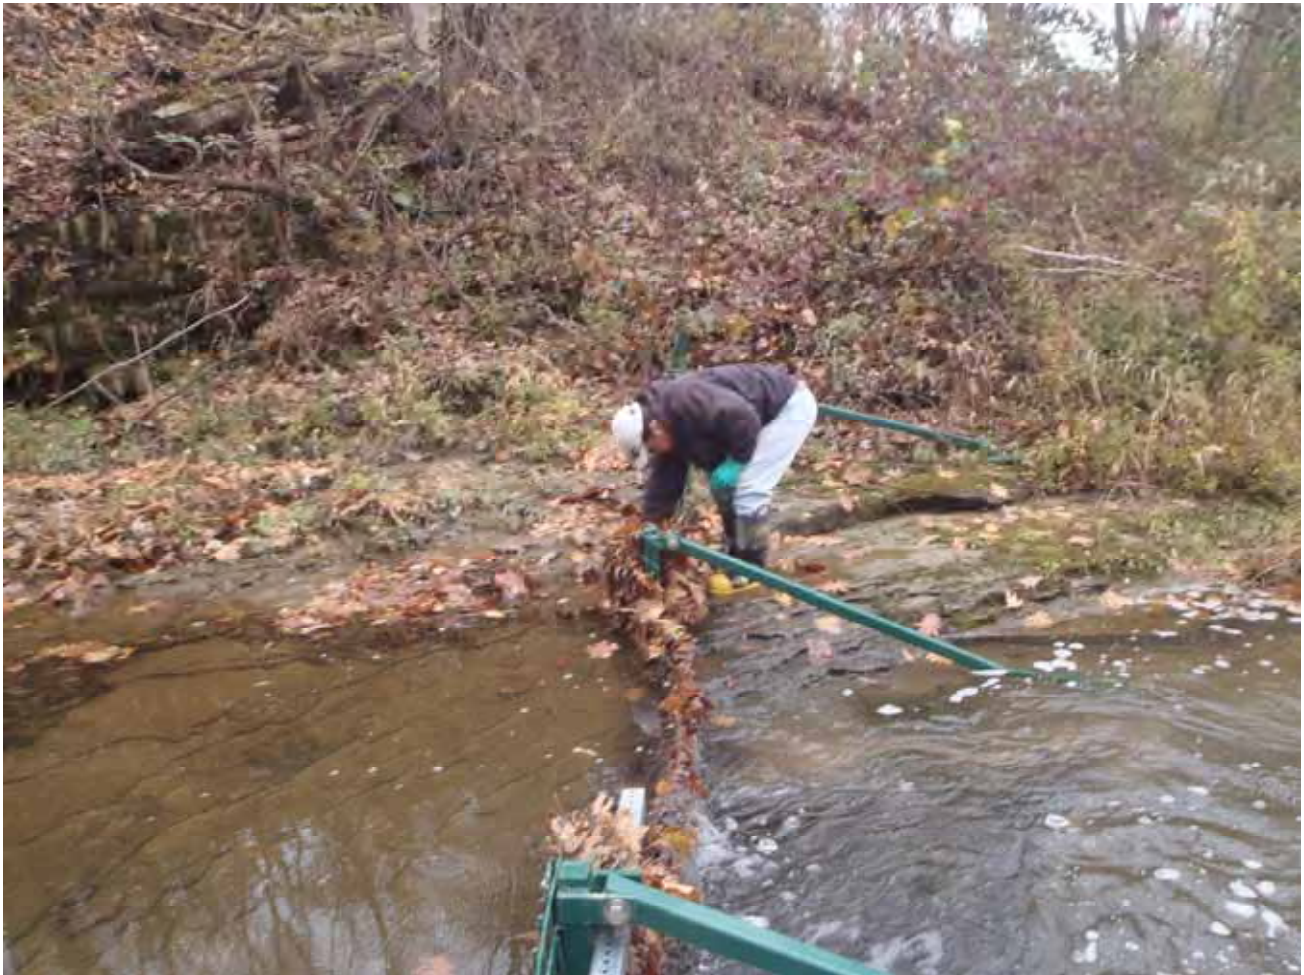
PICTURE SHOWING UXO TECHNICIAN REMOVING ACCUMULATED DEBRIS FROM BARRIERS
